CERTIFICATE OF APPROPRIATENESS

Applicant: Jessie Enander, agent for, Bennie Davis, owner

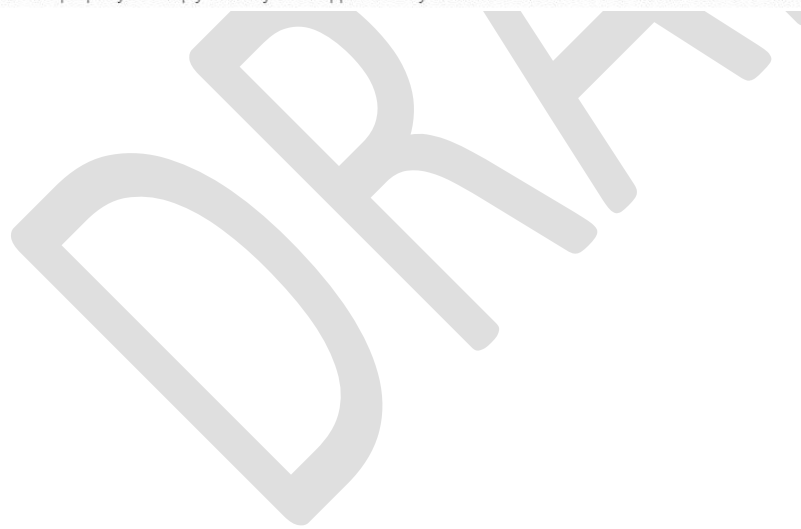
(c) In reviewing applications for certificates of appropriateness under this article, the HAHC or the director, respectively as appropriate, shall also consider any elements of the proposed activity that may be necessary to enable the property to comply with any other applicable city ordinances or state or federal law so as to facilitate compliance with this ordinance and other applicable laws.

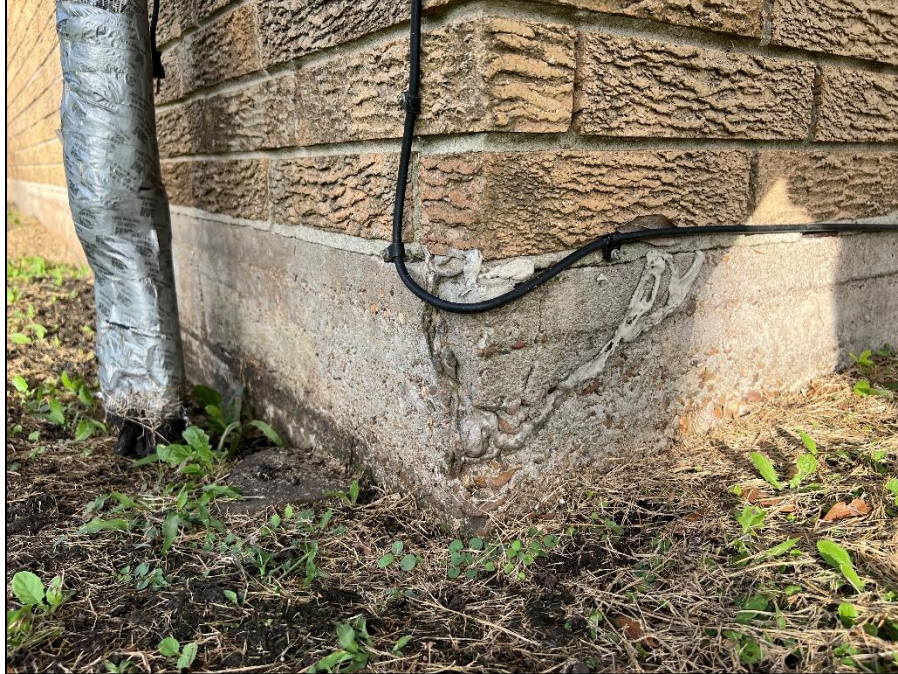
Photograph 5: Observation of foundation concrete corner cracking located at the front left of the residence.

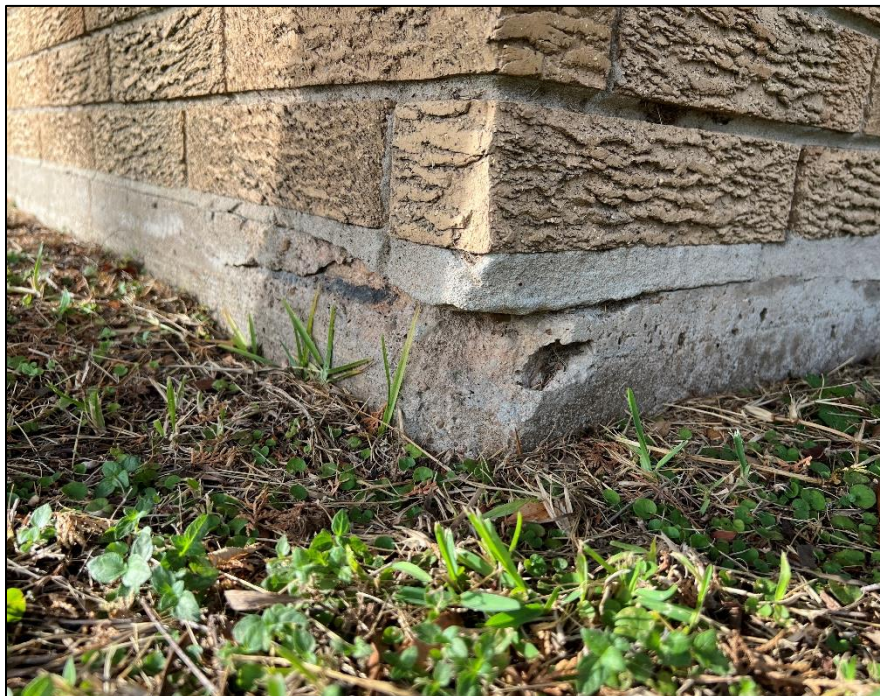
Photograph 6: Typical view of concrete corner spalling due to the corrosion of embedded reinforcing steel at the edge of the exterior foundation grade beam.

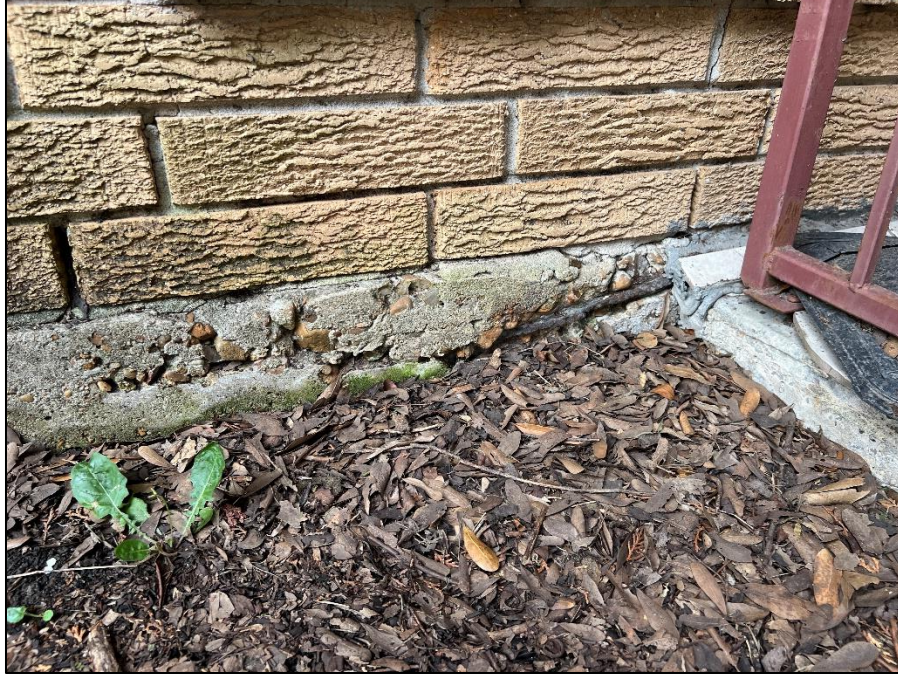
Photograph 7: Observation of concrete spalling due to the corrosion of embedded reinforcing steel at the edge of the exterior foundation grade beam.

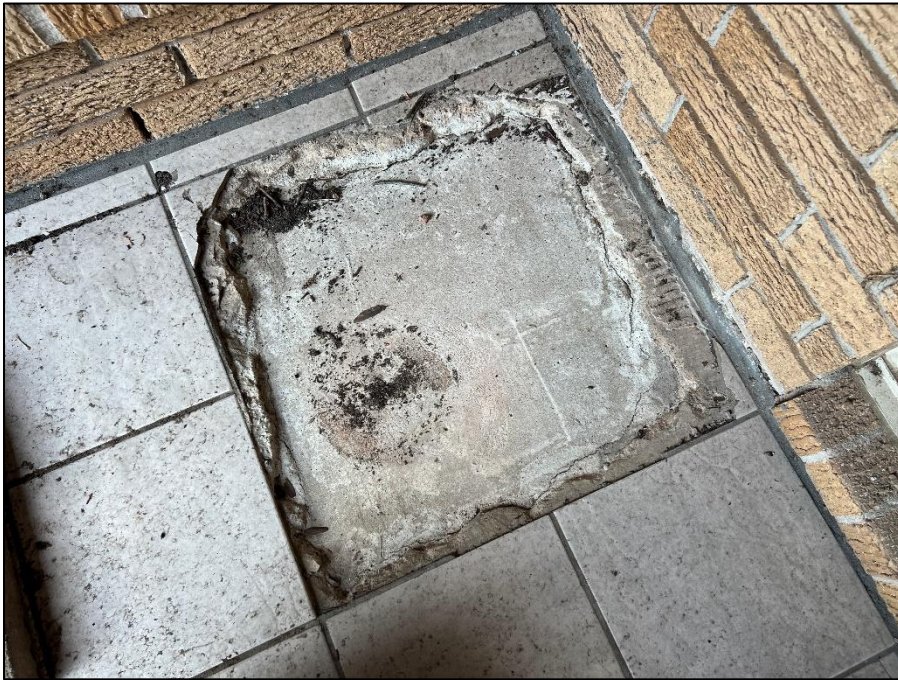
Photograph 8: Typical view of patched concrete flatwork indicating historical foundation repairs/leveling.

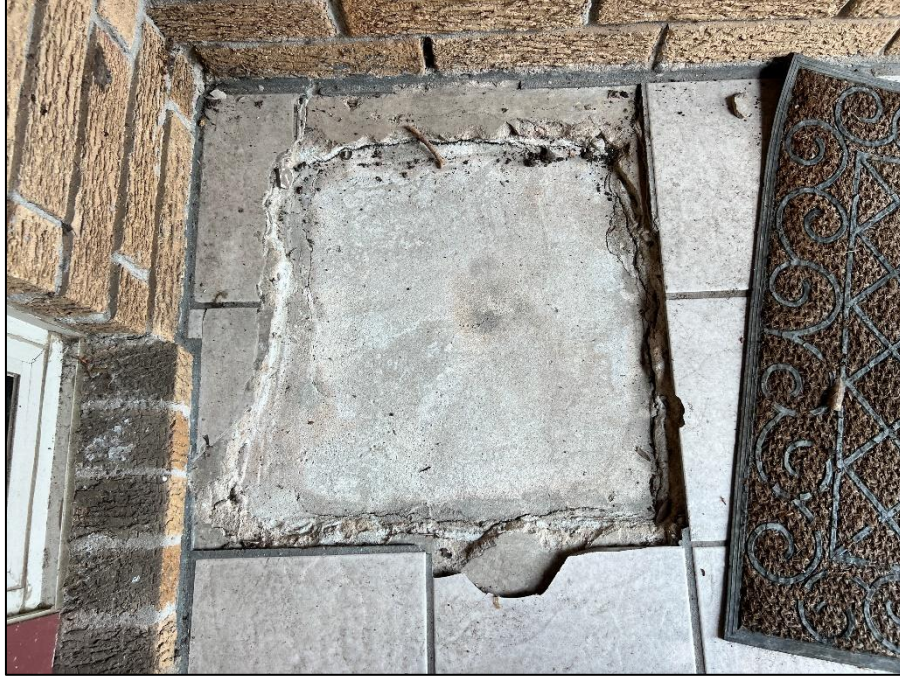
Photograph 9: Typical view of patched concrete flatwork indicating historical foundation repairs/leveling.

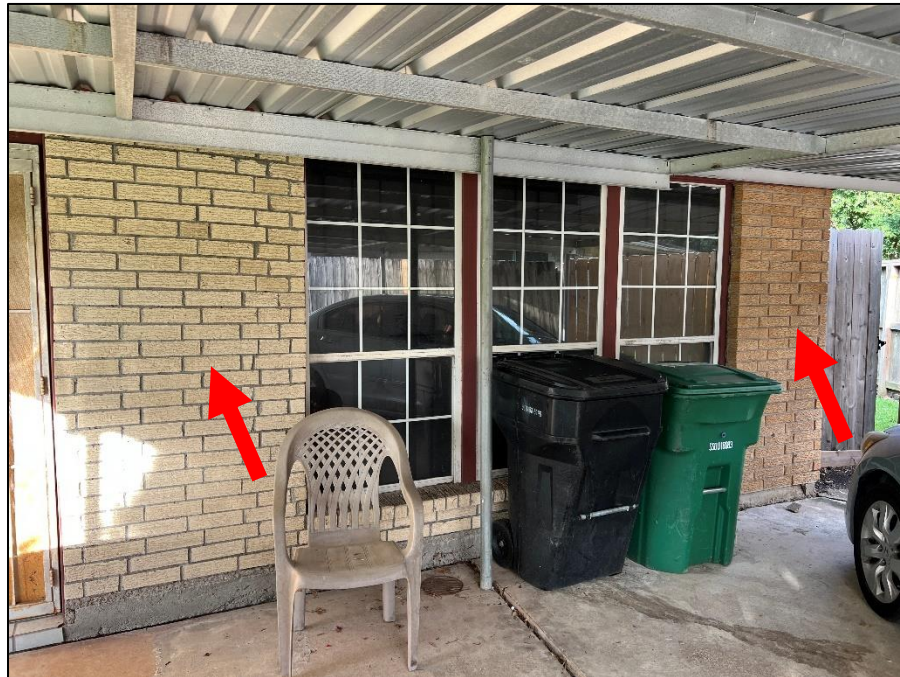
Photograph 10: Typical view of brick work at the front of the residence. *Notice the variation in brick color as indicated by the red arrows.*

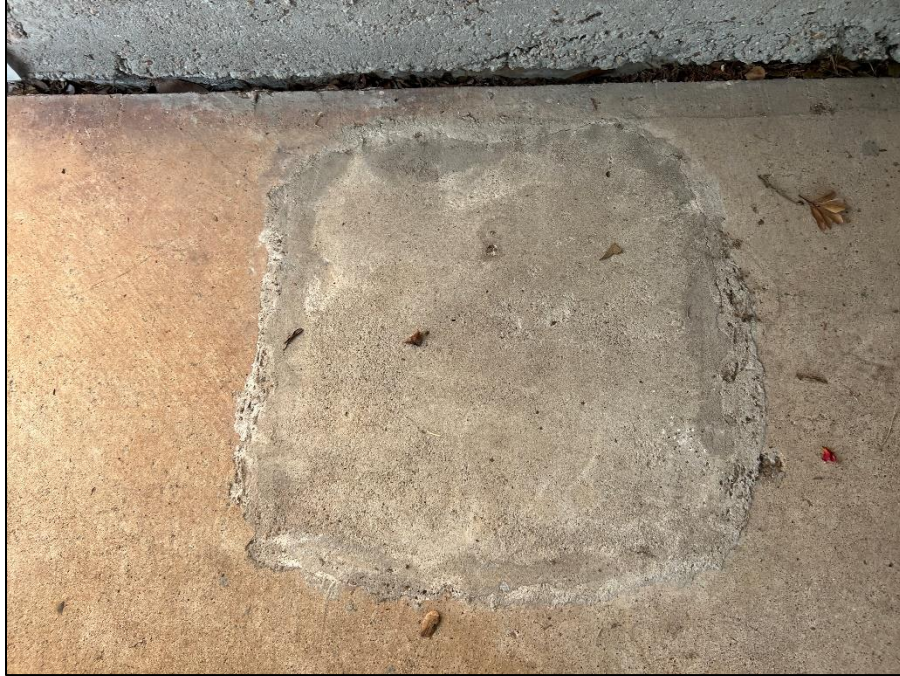
Photograph 11: Typical view of patched concrete flatwork indicating historical foundation repairs/leveling.

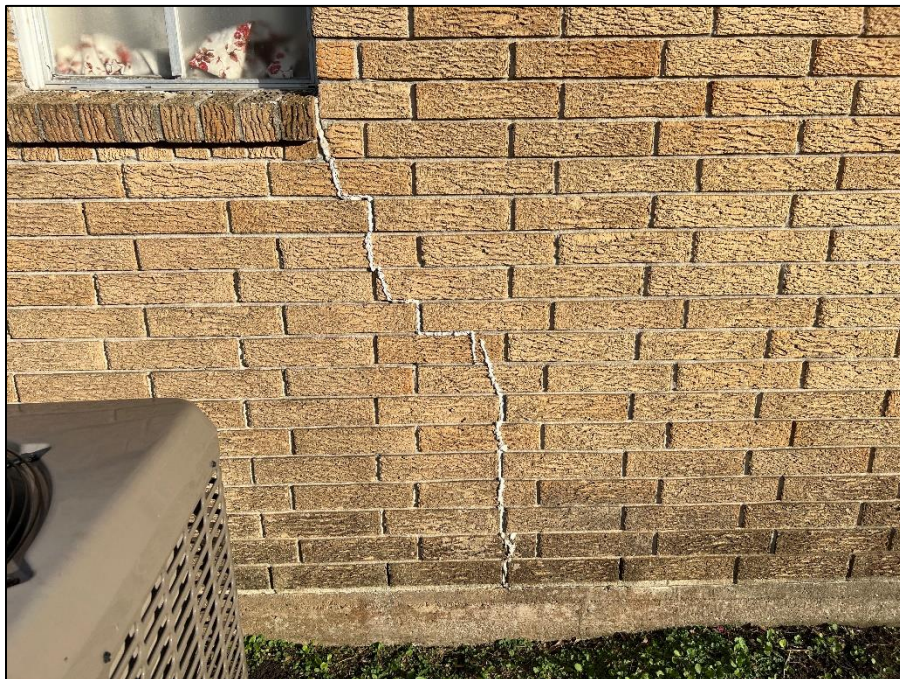
Photograph 12: Typical view of historical mortar repair.

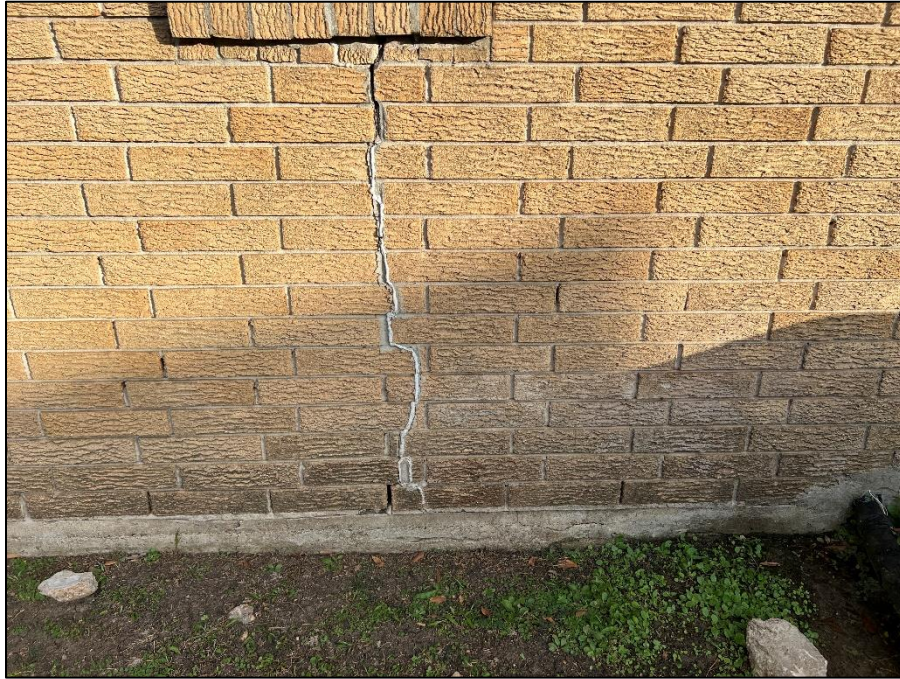
Photograph 13: Typical view of historical mortar repair.

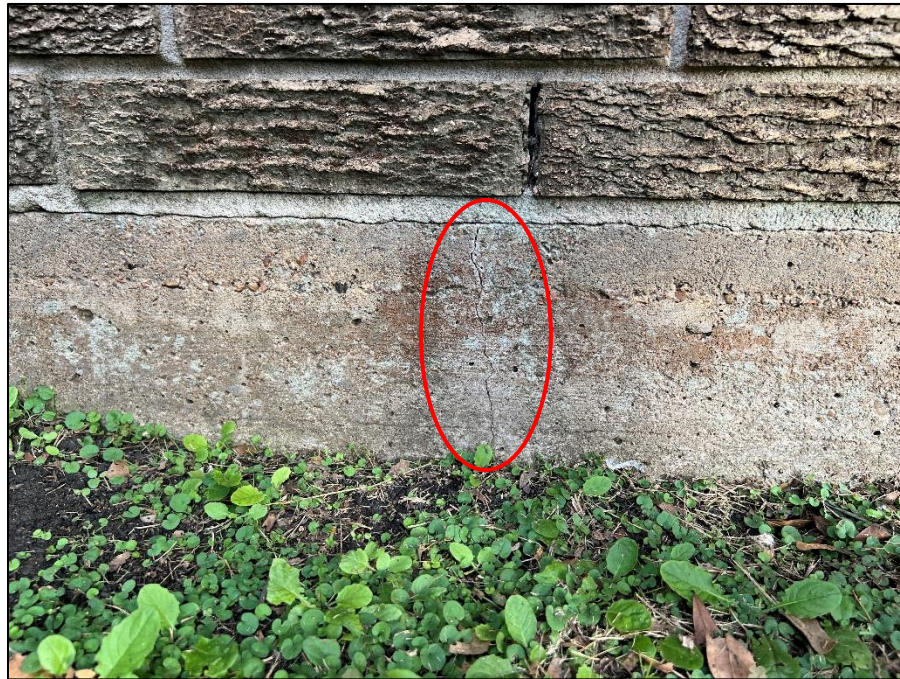
Photograph 14: Typical view of cracking on the exterior perimeter foundation grade beam at the left of the residence.

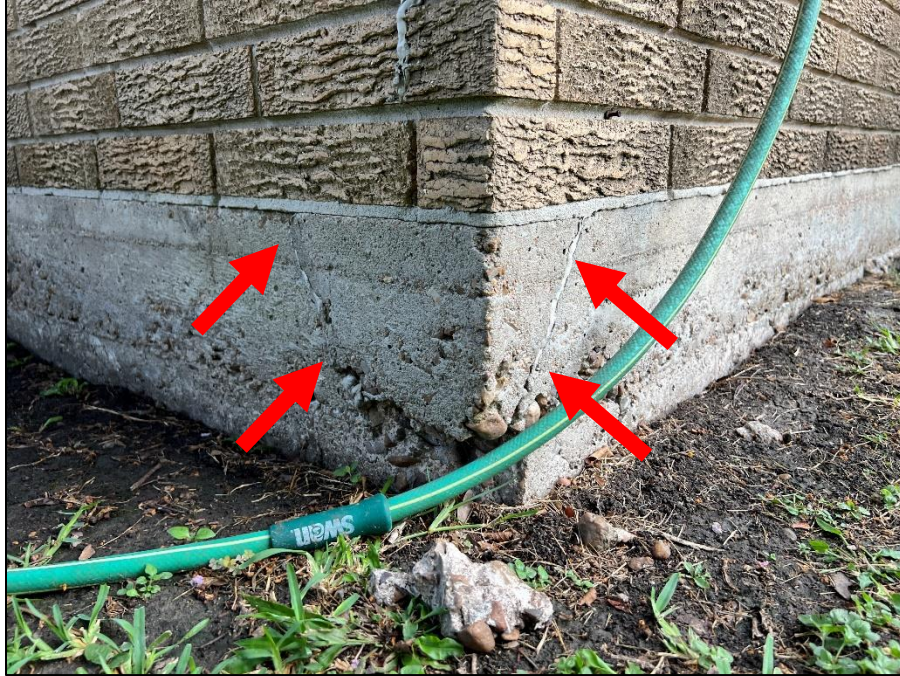
Photograph 15: Typical view of foundation concrete corner cracking located at the rear left of the residence.

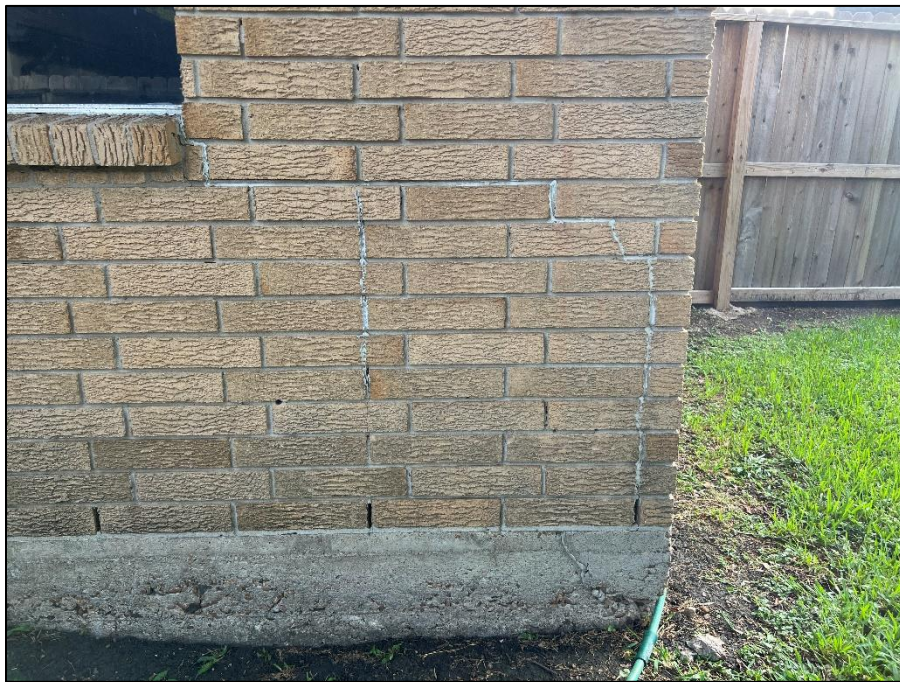
Photograph 16: Typical view of historical mortar repair.

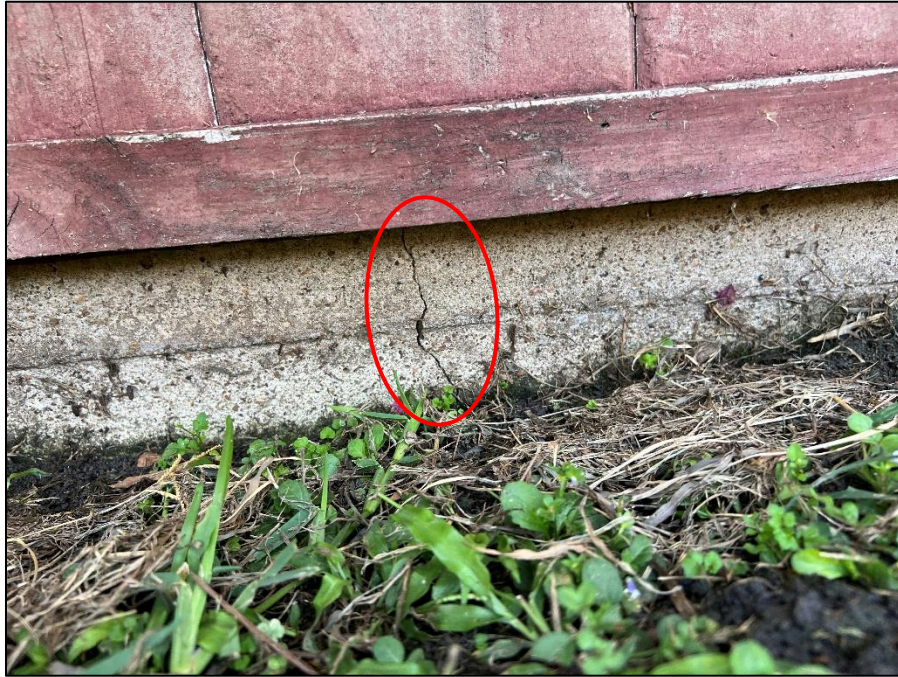
Photograph 17: Typical view of cracking on the exterior perimeter foundation grade beams at the rear of the residence.

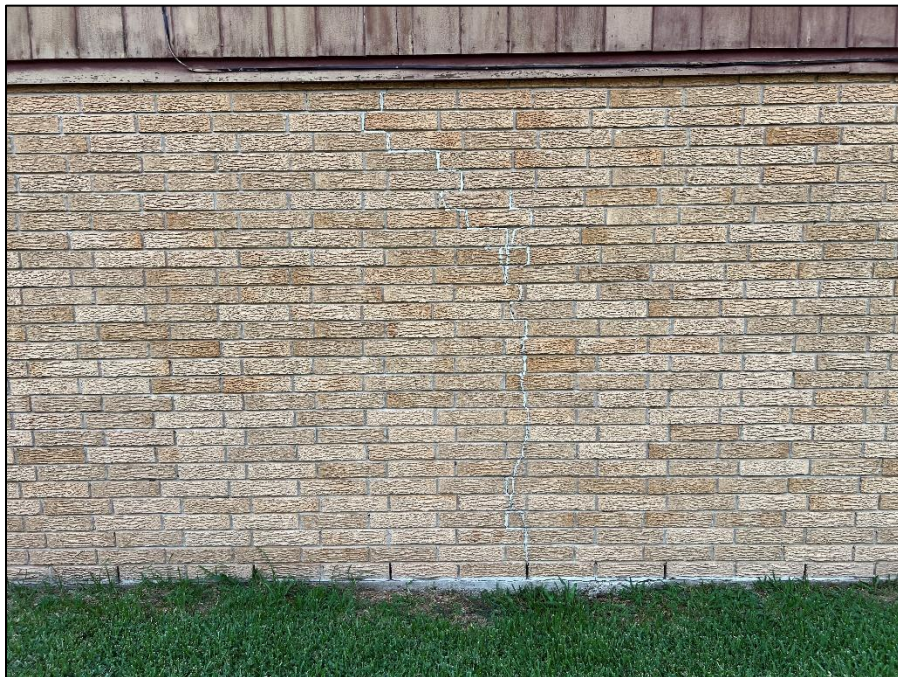
Photograph 18: Typical view of historical mortar repair at the right exterior wall of the residence.

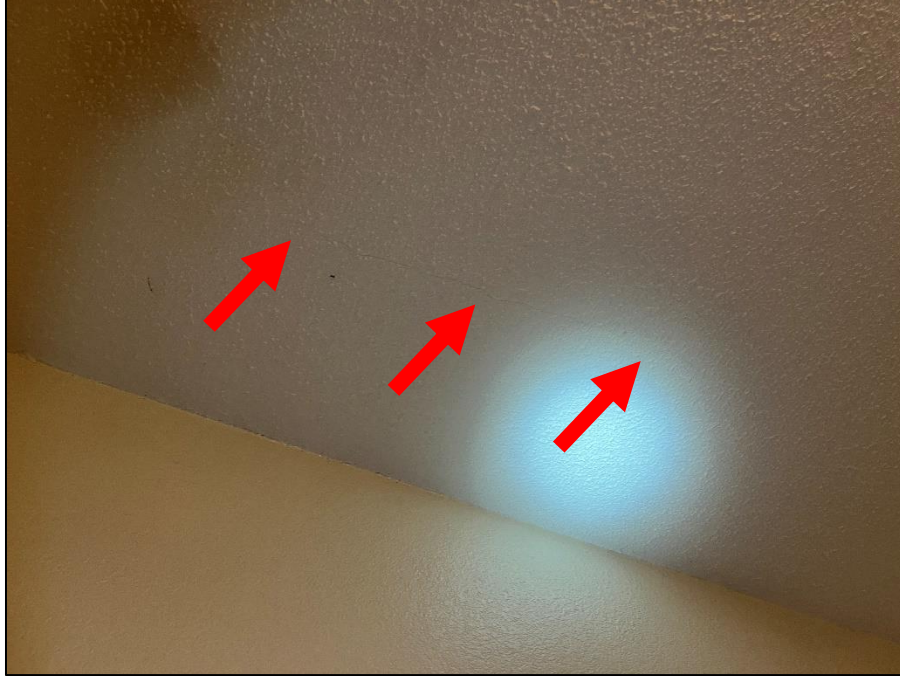
Photograph 19: Typical view of ceiling displaying drywall cracking in the foyer.

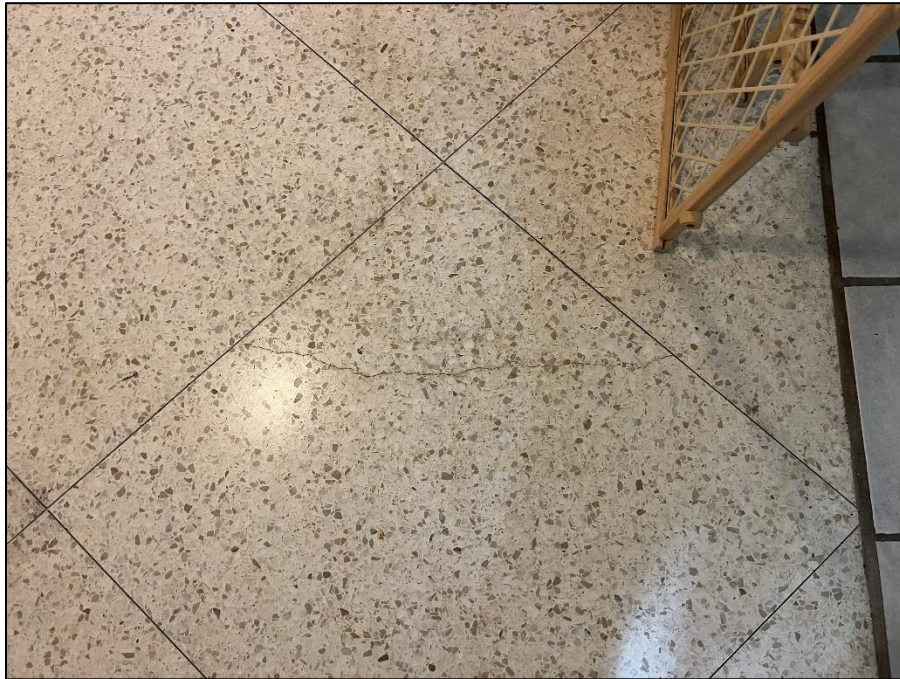
Photograph 20: Typical view of cracking within the terrazzo floor tile.

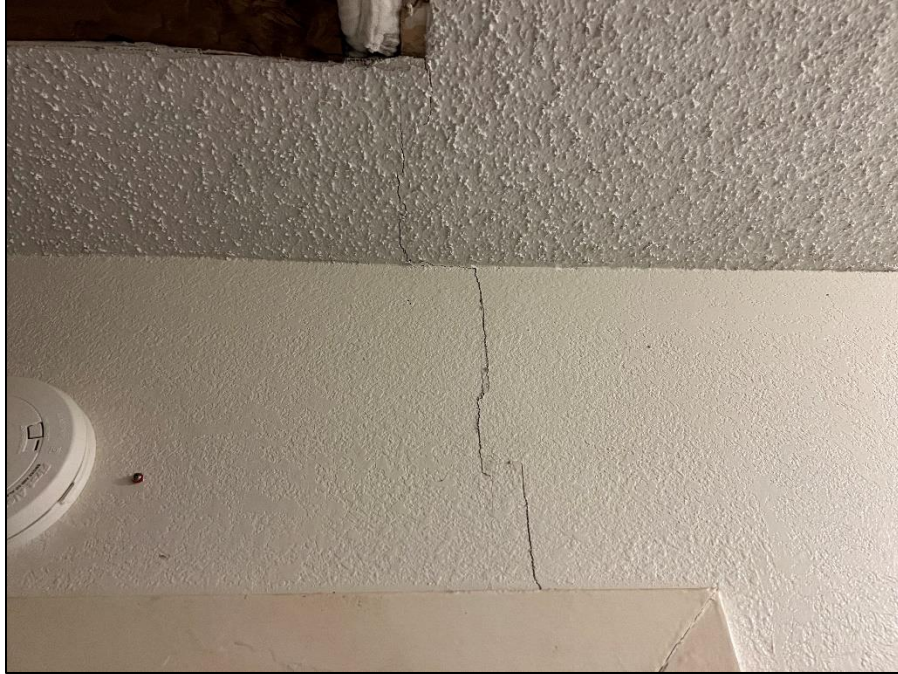
Photograph 21: Typical view of interior wall of the hallway (*adjacent to center bedroom*) displaying drywall cracking extending from the door header.

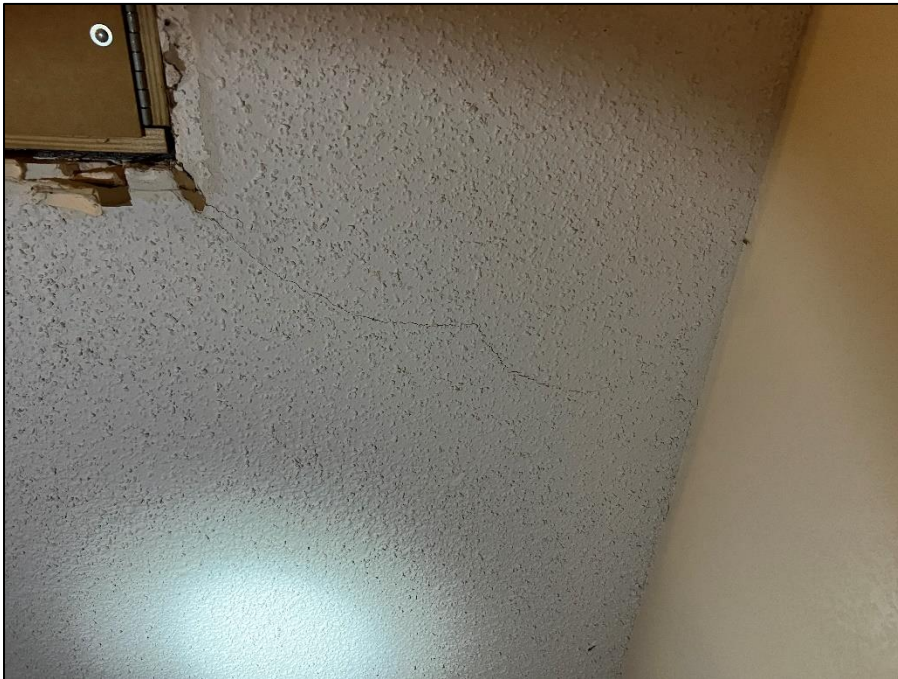
Photograph 22: Typical view of ceiling displaying drywall cracking extending from the attic access.

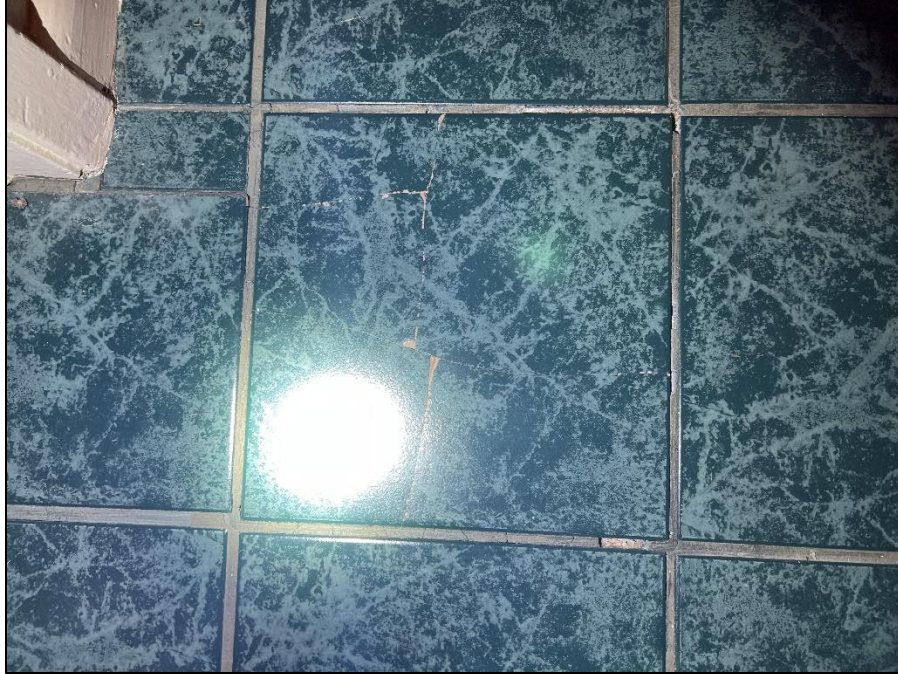
Photograph 23: Typical view of loose tile and cracking within the tile flooring.

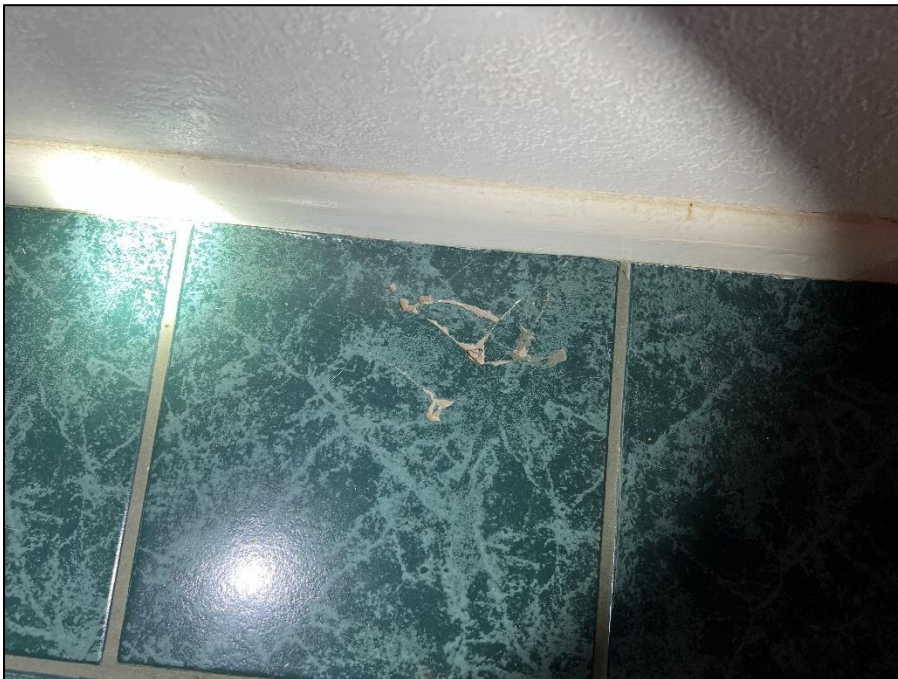
Photograph 24: Typical view of loose tile and cracking within the tile flooring.

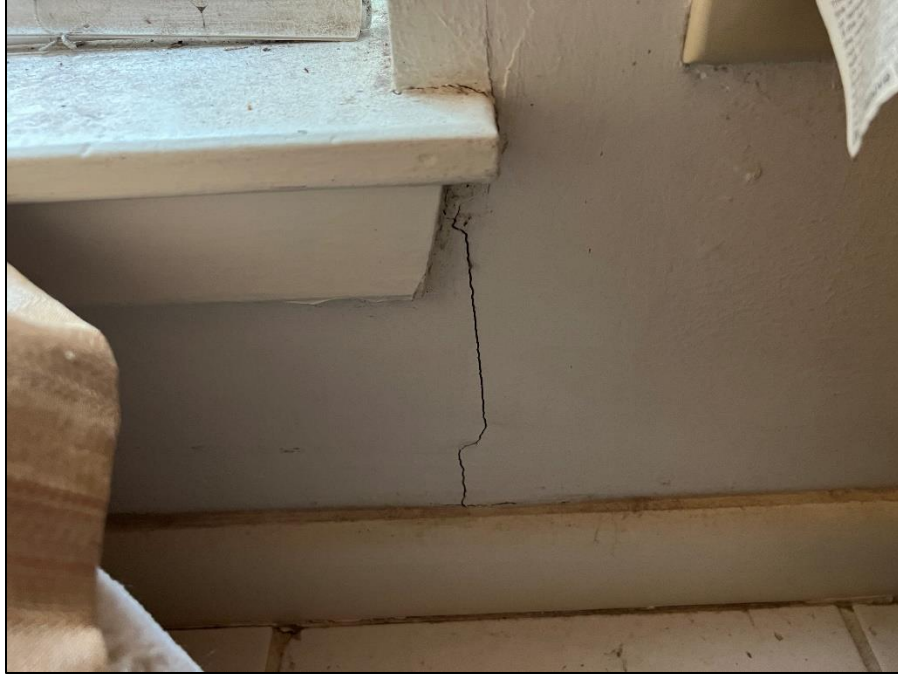
Photograph 25: Typical view of front exterior wall of the front left bedroom displaying drywall cracking extending from the windowsill.

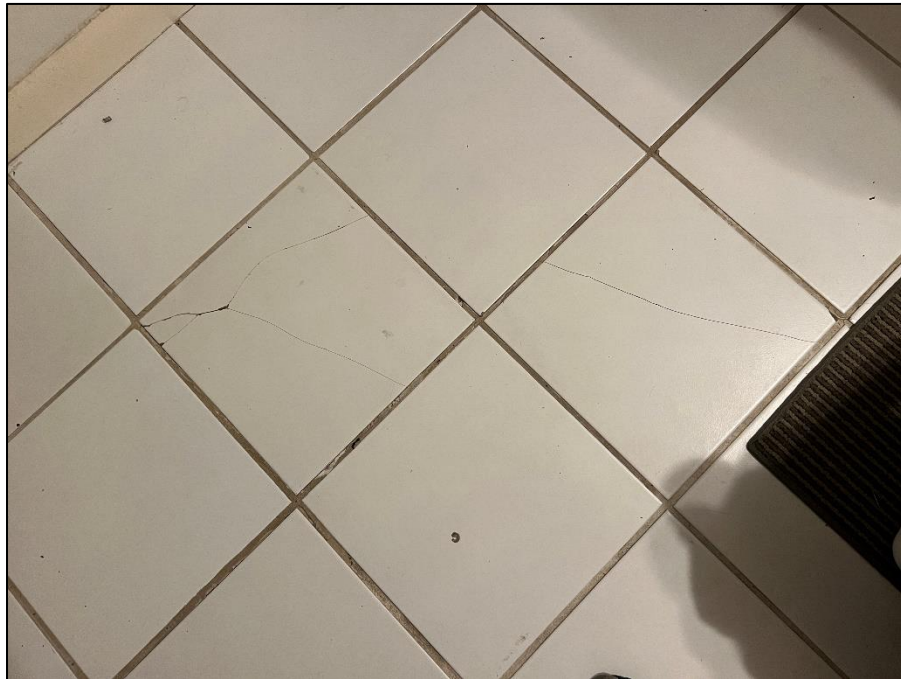
Photograph 26: Typical view of cracking within the tile flooring.

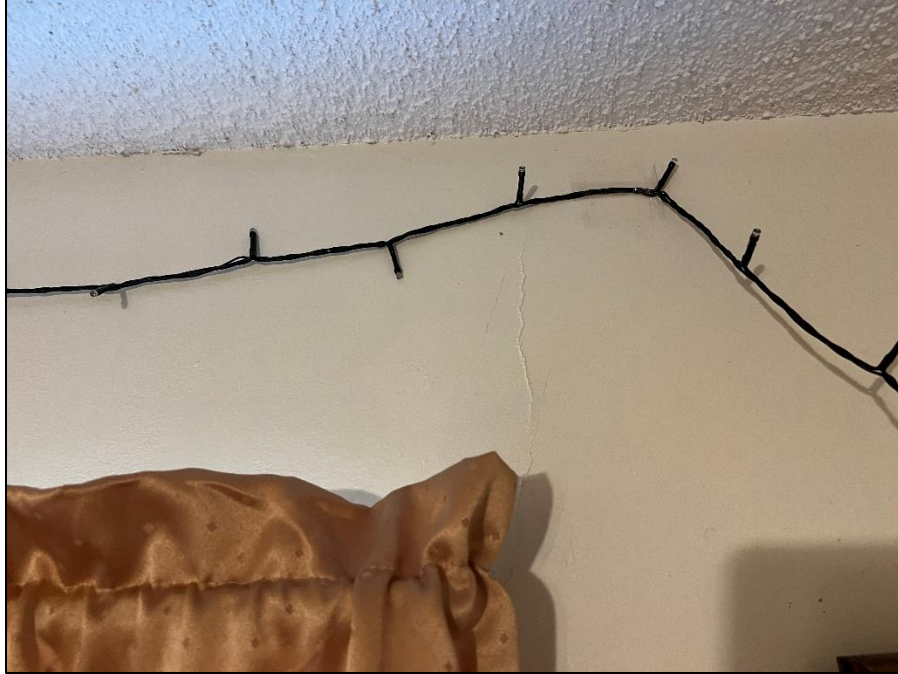
Photograph 27: Typical view of front exterior wall of the front left bedroom displaying drywall cracking extending from the window header.

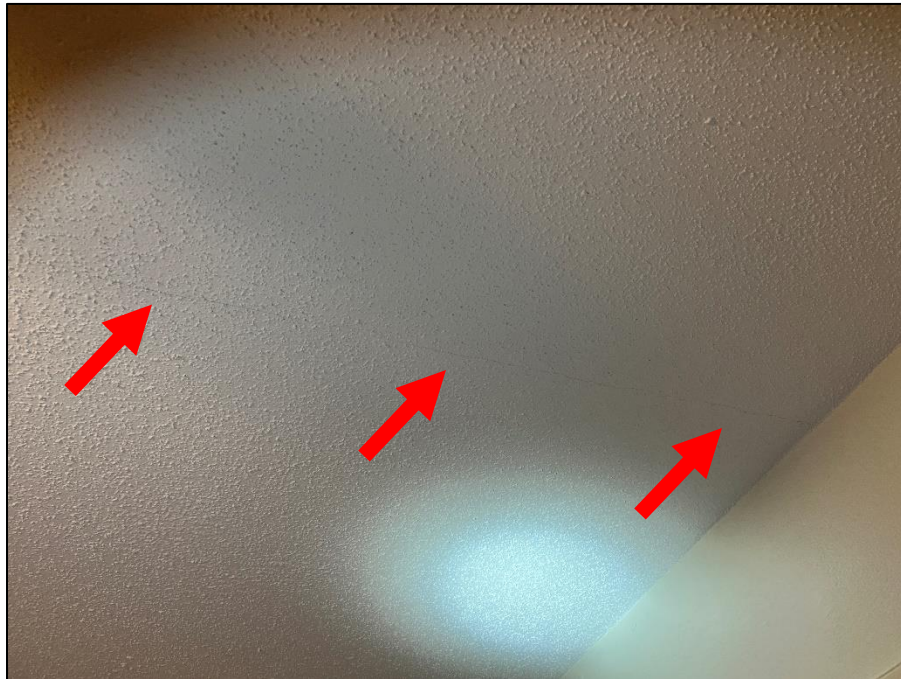
Photograph 28: Typical view of ceiling displaying drywall cracking.

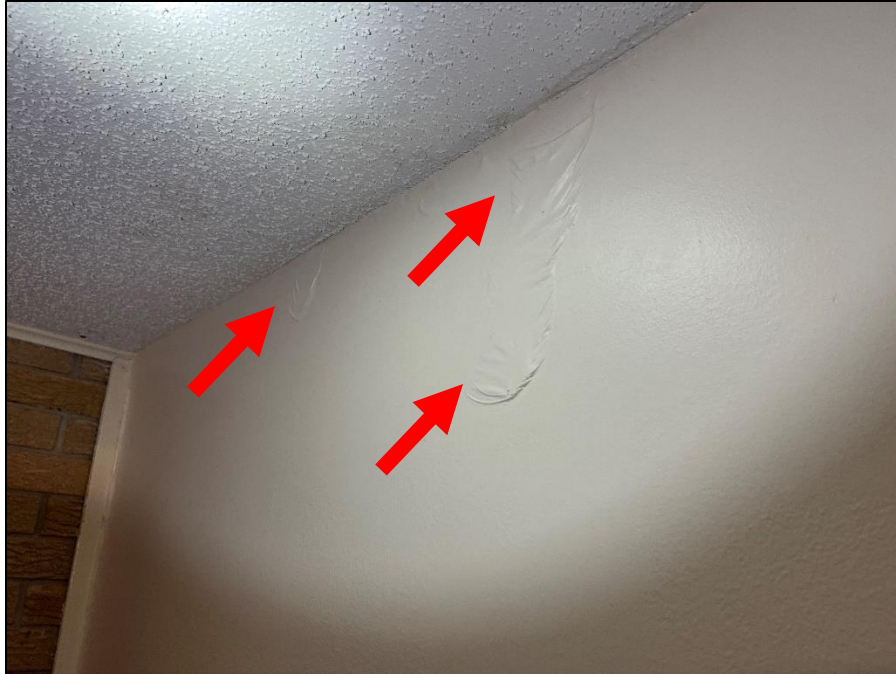
Photograph 29: Typical view of interior wall of the center bedroom (*adjacent to hallway*) displaying wrinkling and/or blistering paint.

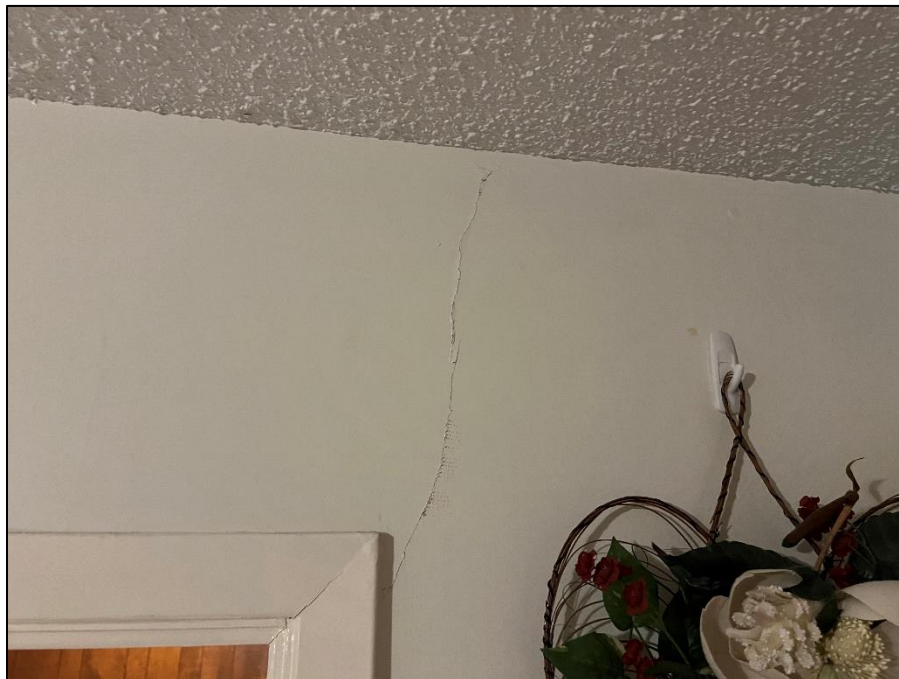
Photograph 30: Typical view of interior wall of the center bedroom (*adjacent to bedroom closet*) displaying drywall cracking extending from the door header.

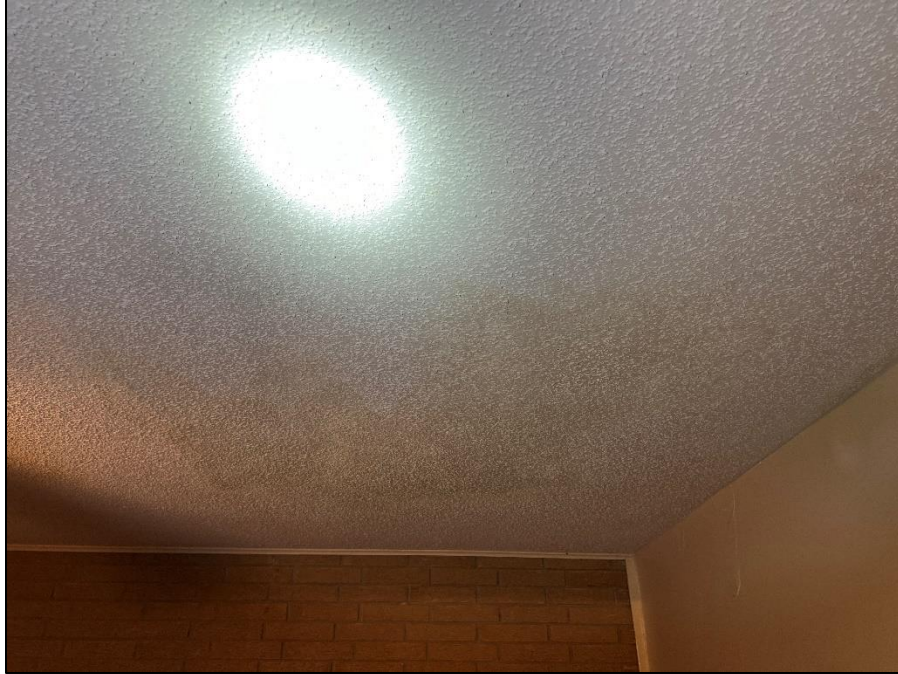
Photograph 31: Typical view of ceiling displaying moisture staining in the center bedroom.

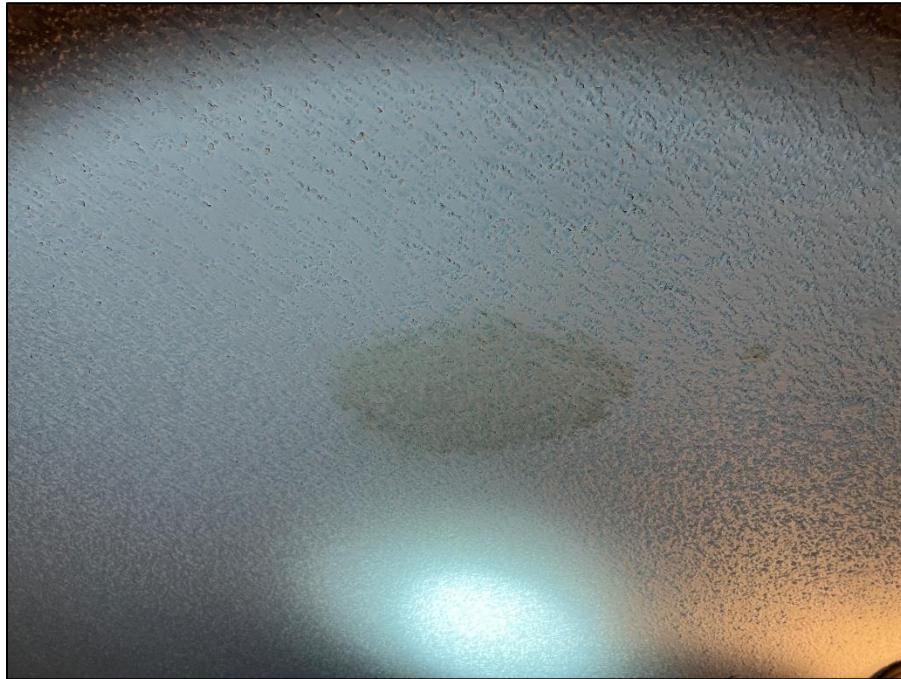
Photograph 32: Typical view of ceiling displaying moisture staining in the center bedroom.

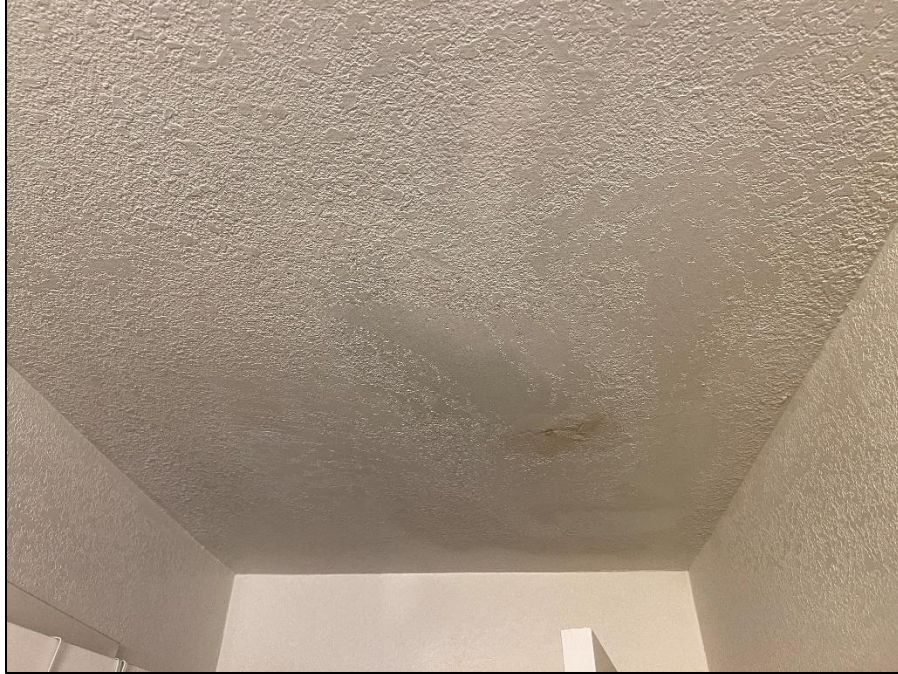
Photograph 33: Typical view of historical drywall ceiling repair.

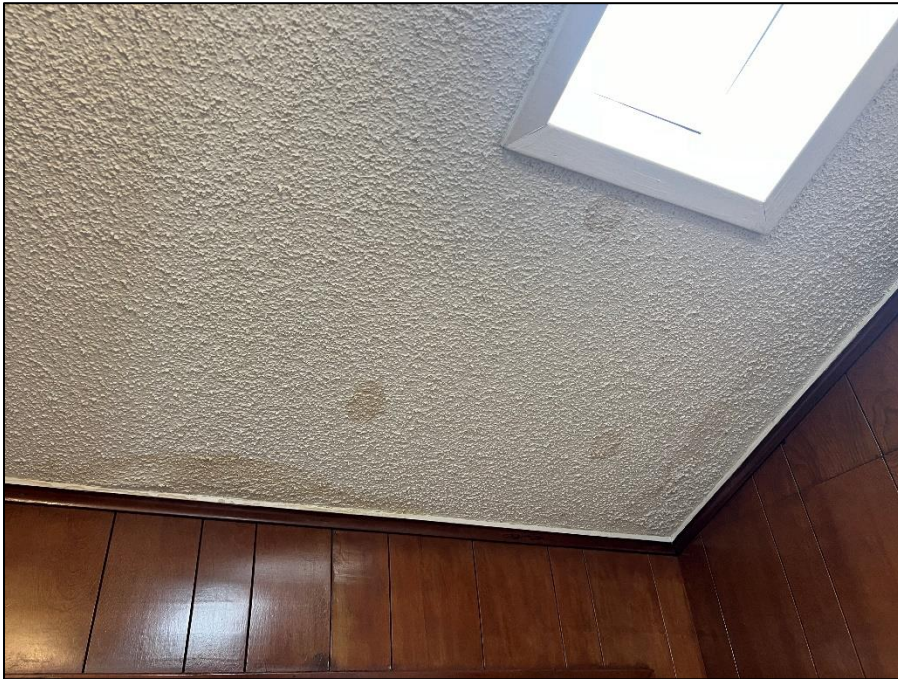
Photograph 34: Typical view of ceiling displaying moisture staining in the living room.

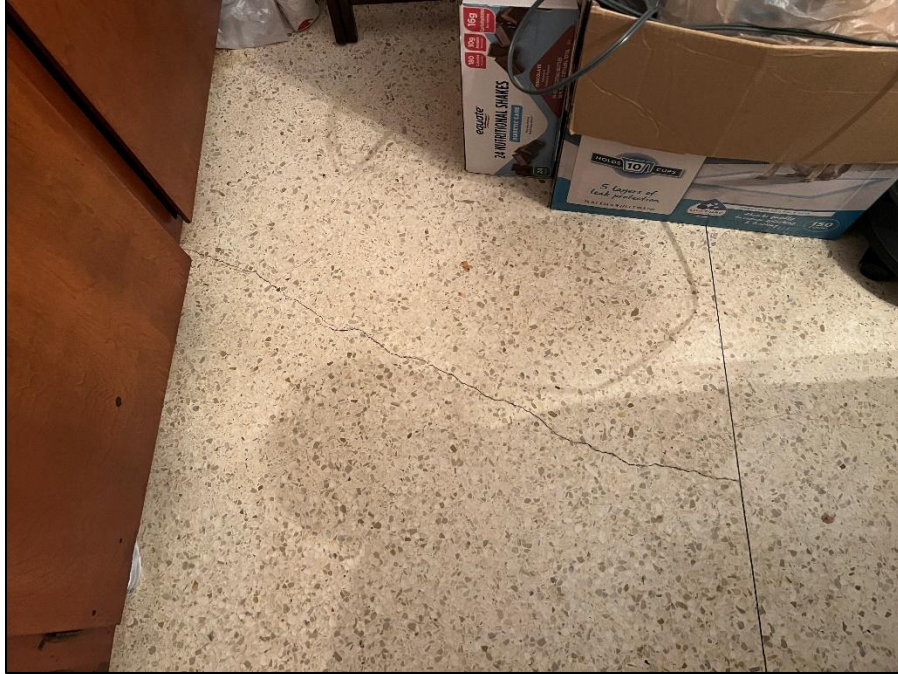
Photograph 35: Typical view of cracking within the terrazzo floor tile.

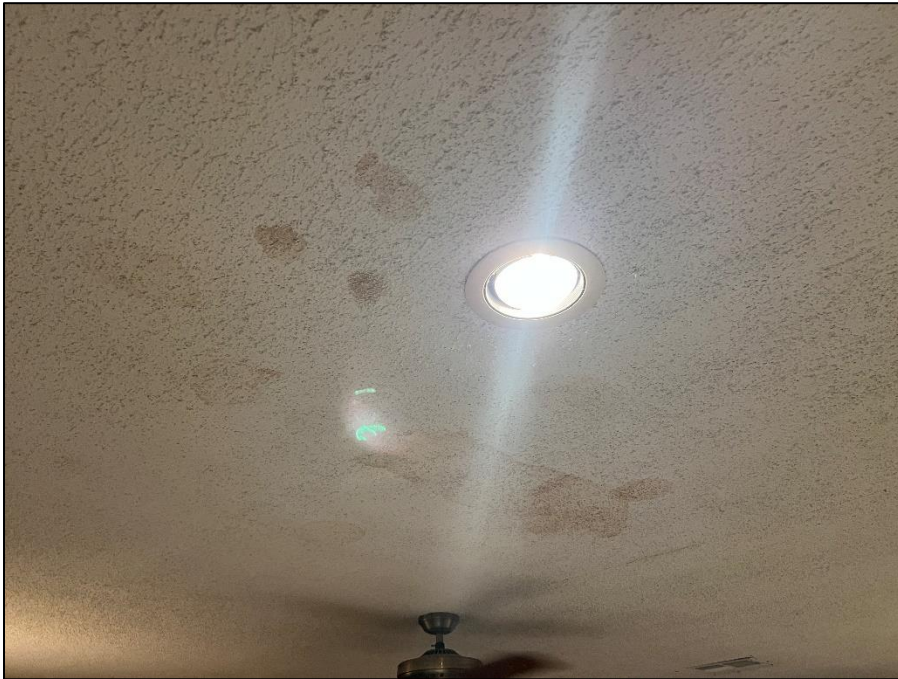
Photograph 36: Typical view of ceiling displaying moisture staining in the converted garage.

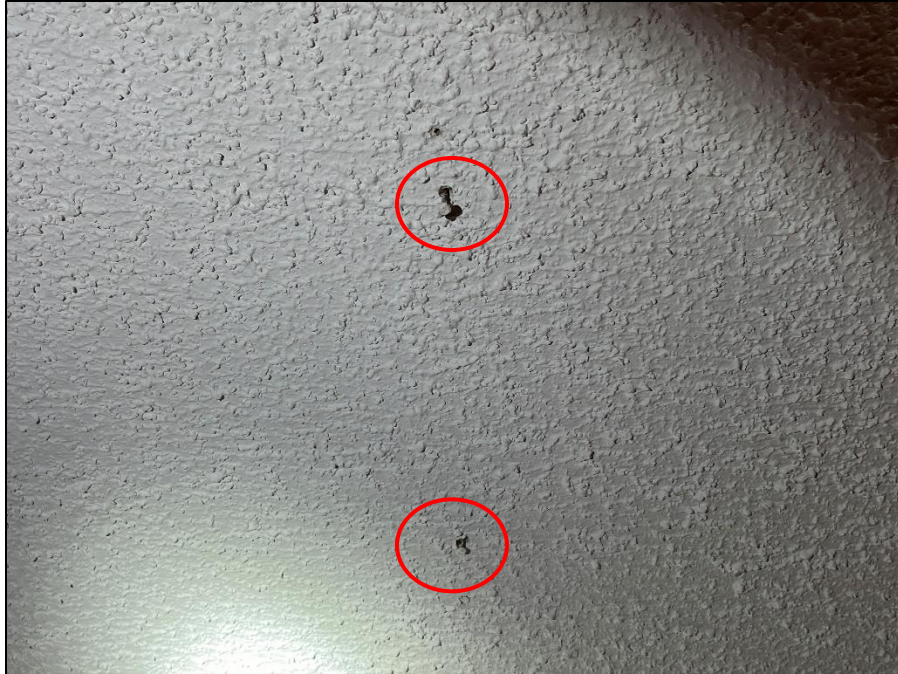
Photograph 37: Observation of ceiling displaying nail pops within the drywall.

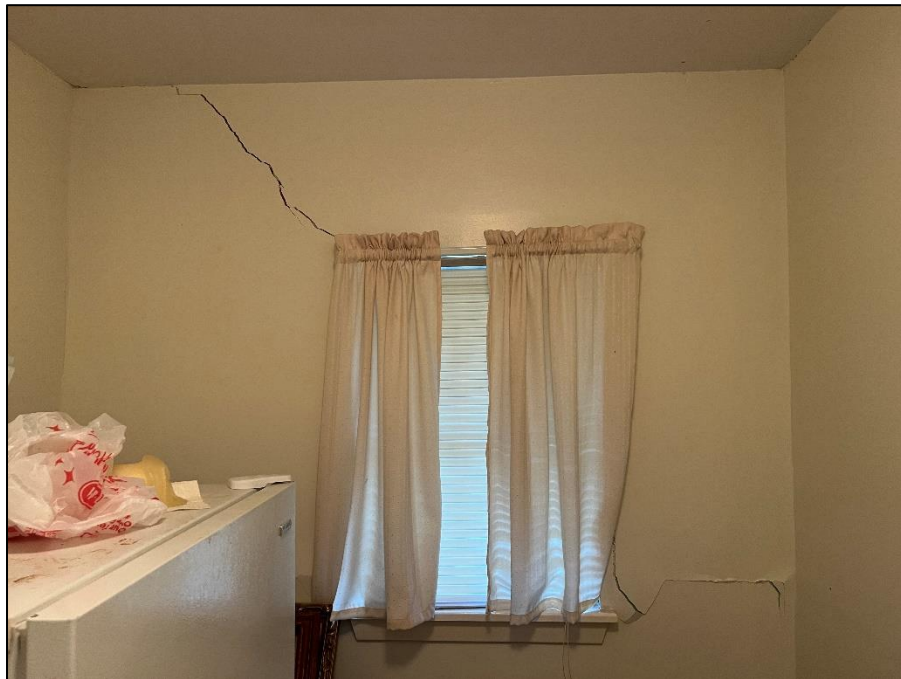
Photograph 38: Typical view of rear exterior wall of the laundry room displaying drywall cracking extending from the window header and windowsill.

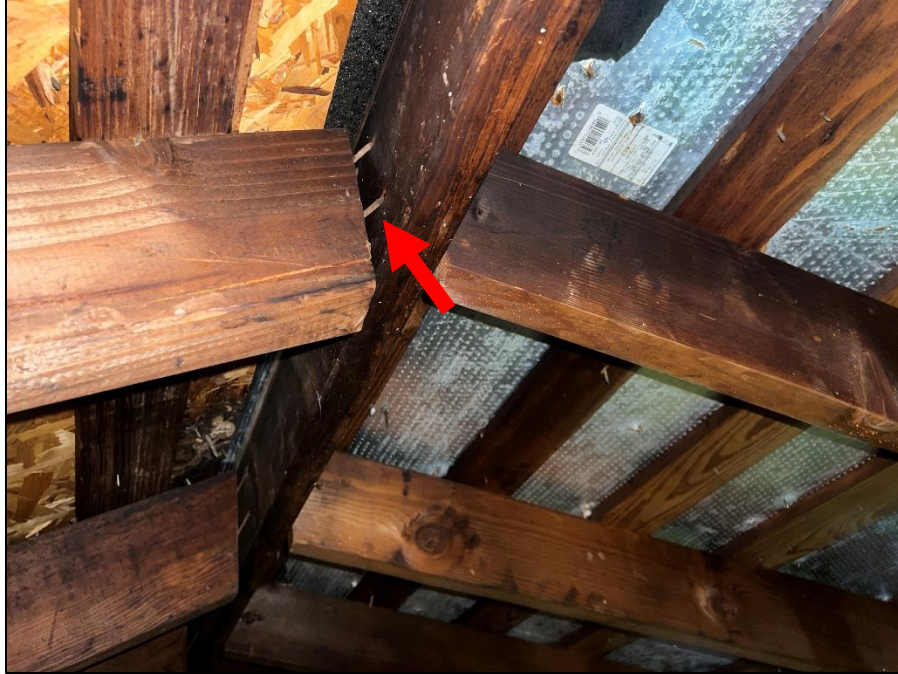
Photograph 39: Observation of roof rafters that have been detached from the ridge board.
