CERTIFICATE OF APPROPRIATENESS

Applicant: Jessie Enander, agent for, Bennie Davis, owner

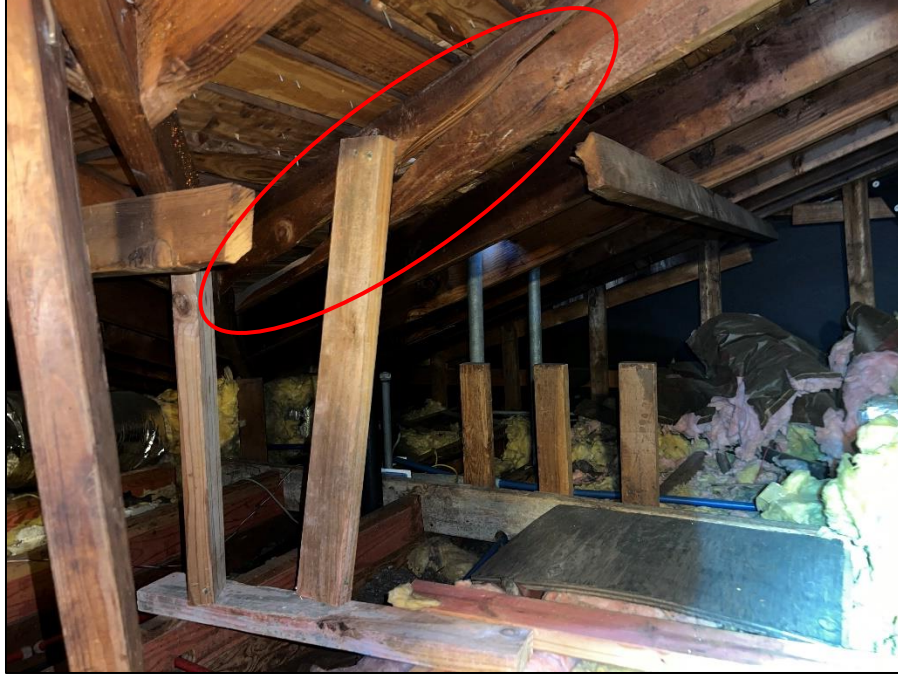
Photograph 41: Overview of roof and ceiling framing within the attic space at the front left of the residence. Notice the broken roof rafter where a two-by-four was installed as temporary support. Also, notice the lack of rafter and purlin bracing within the rafters.

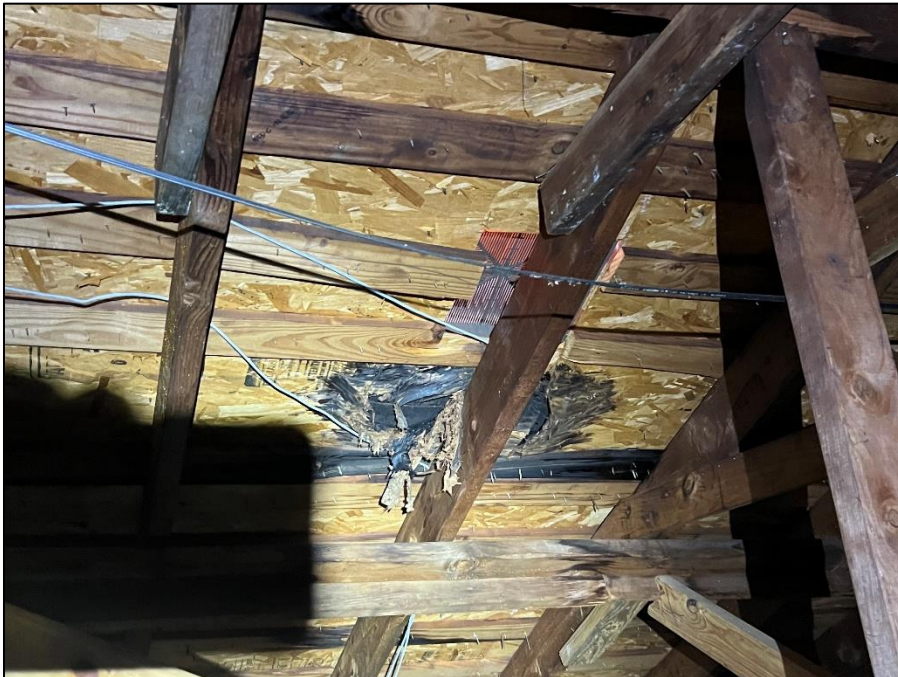
Photograph 42: Observation of roof decking decay indicating historical roof leaks.

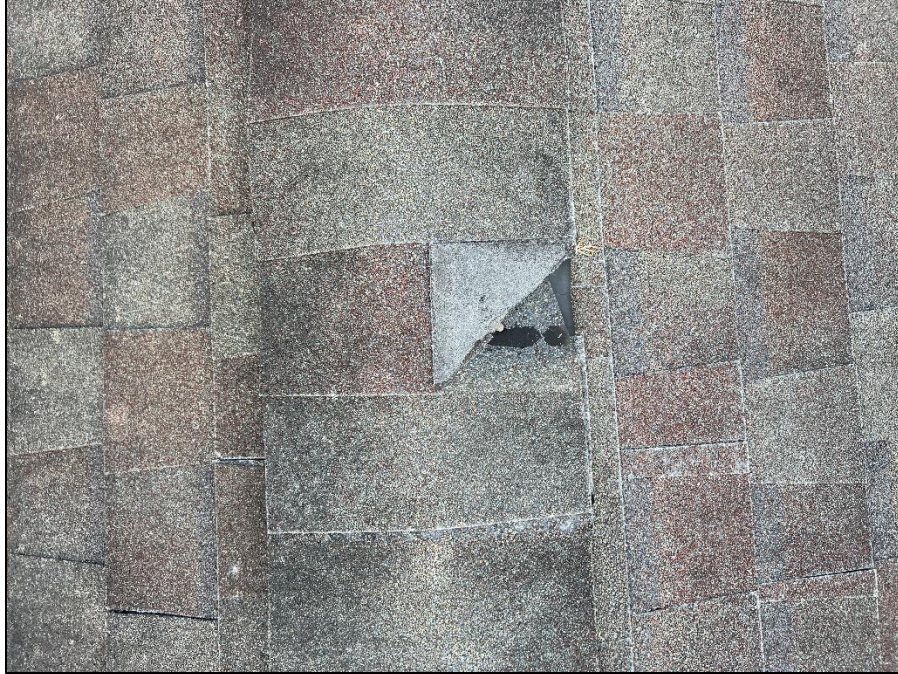
Photograph 43: Typical view of damaged, missing, and/or torn asphalt ridge caps on roof.

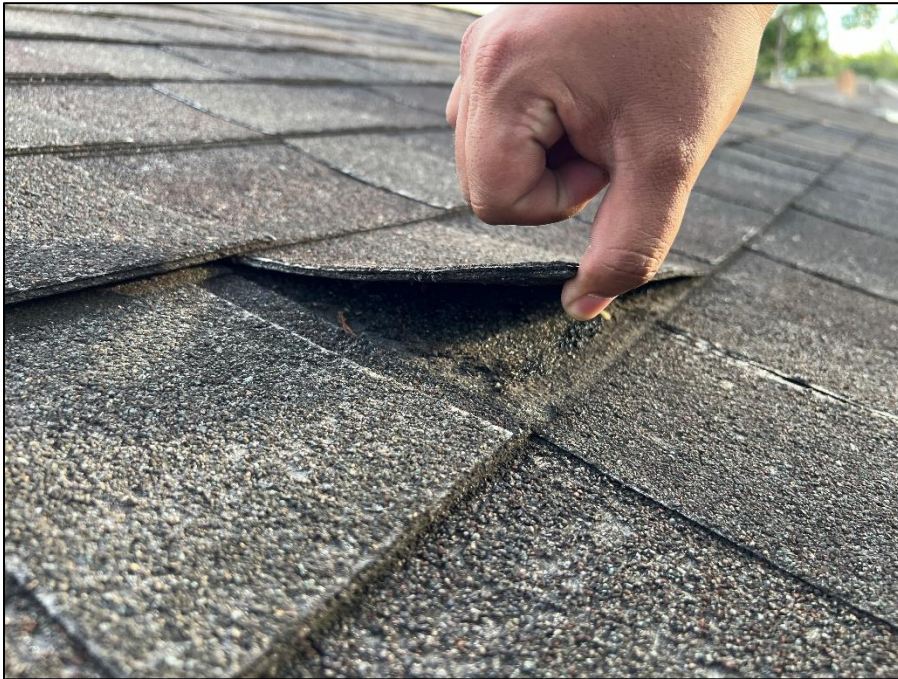
Photograph 44: Typical view of aged and deteriorated asphalt shingles on roof. Most shingles lacked a viable adhesive strip that would keep the overlying shingle bonded to the underlying shingle.

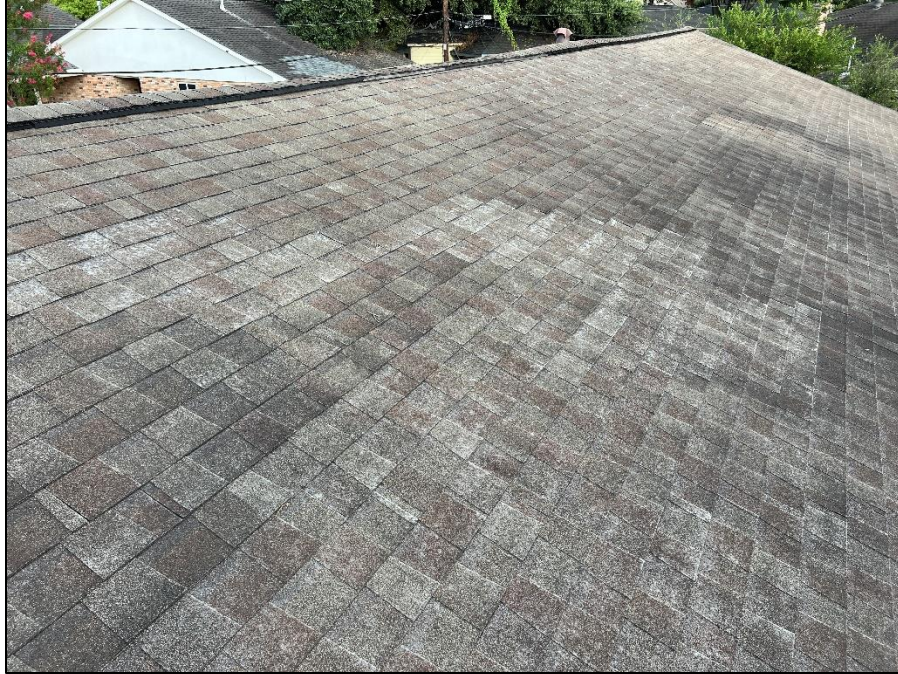
Photograph 45: Typical view of asphalt roof shingles displaying a loss of surface granules.

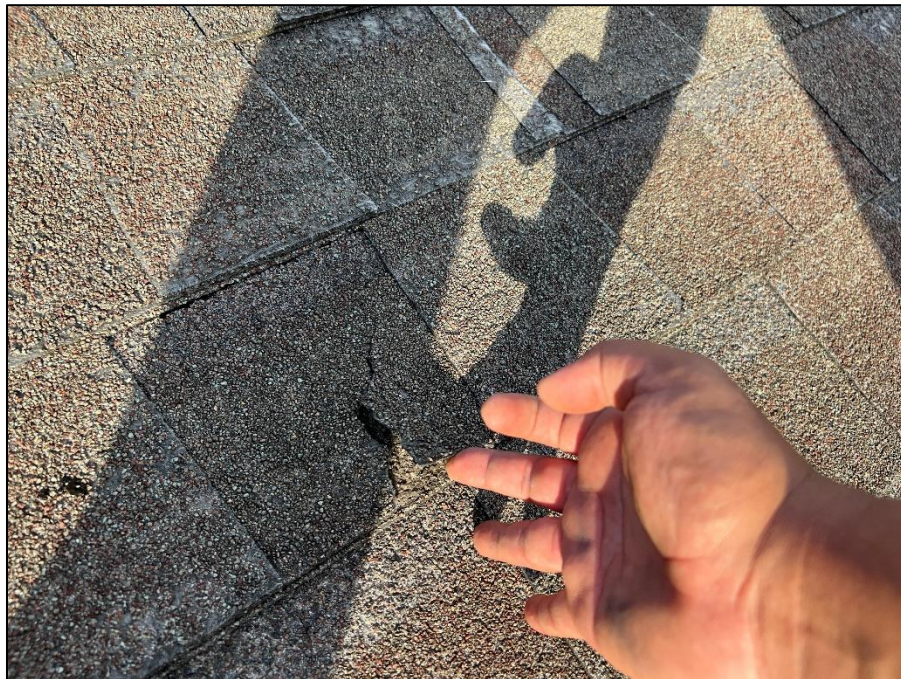
Photograph 46: Typical view of damaged, missing, and/or torn asphalt shingles on roof.

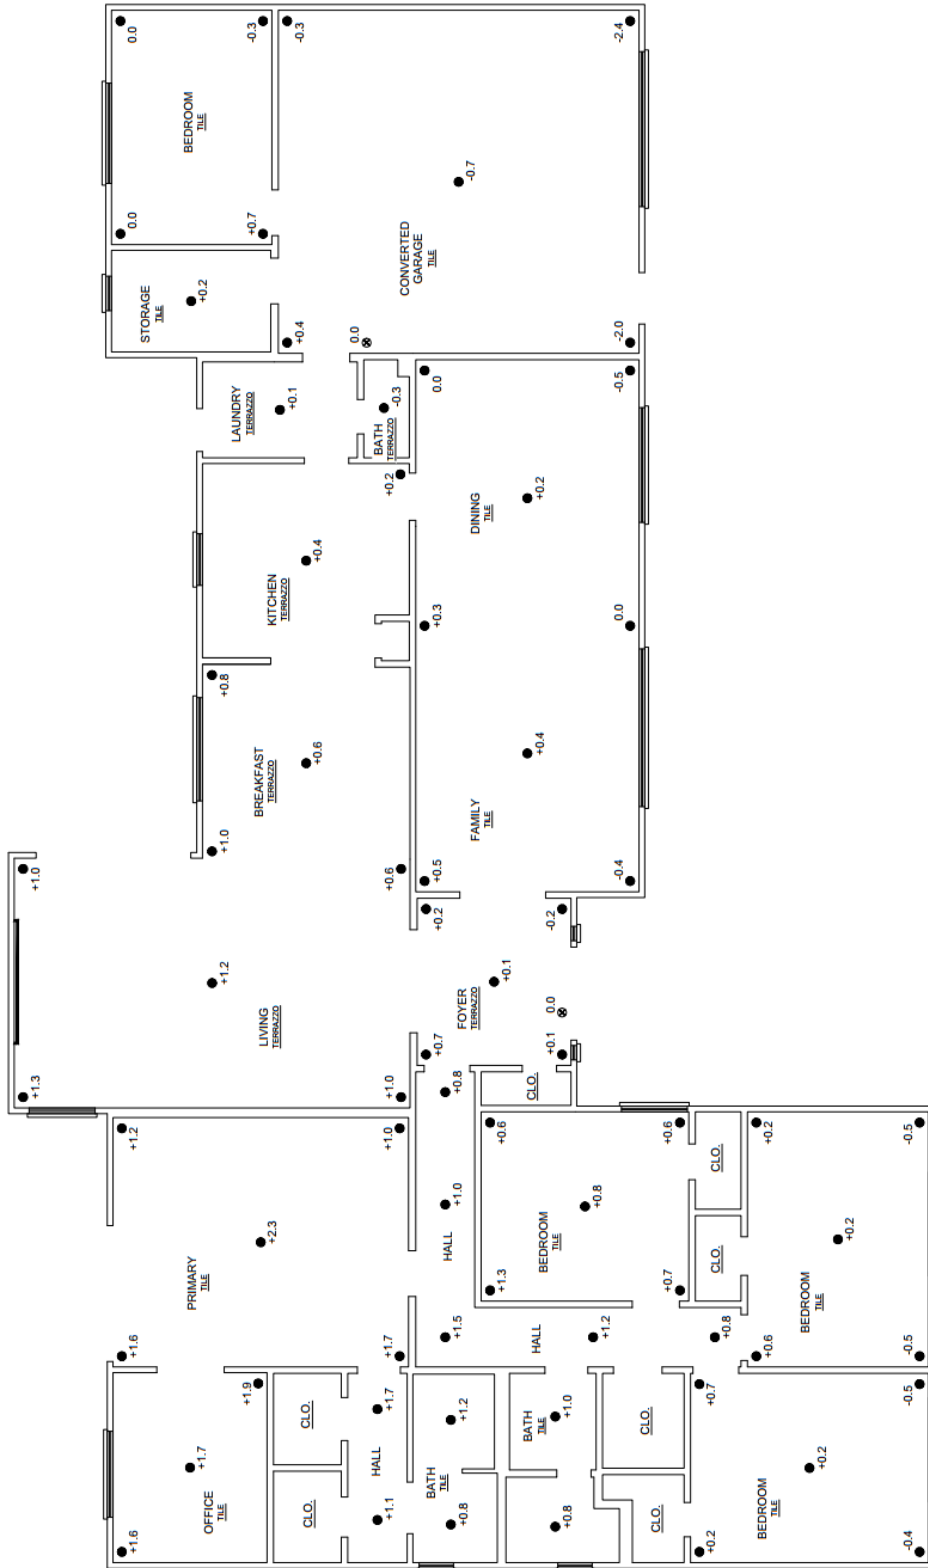
**STRUCTURAL ASSESSMENT REPORT (SAR)
Not Suitable for Rehabilitation (NSFR)**

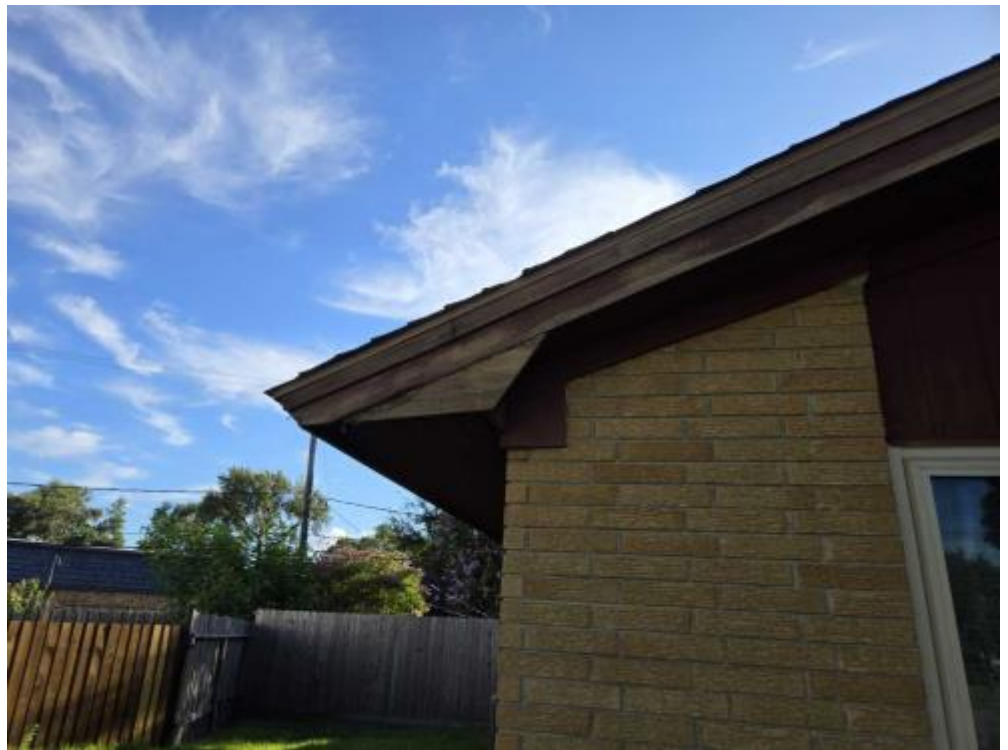
Estimated Cost of Repairs

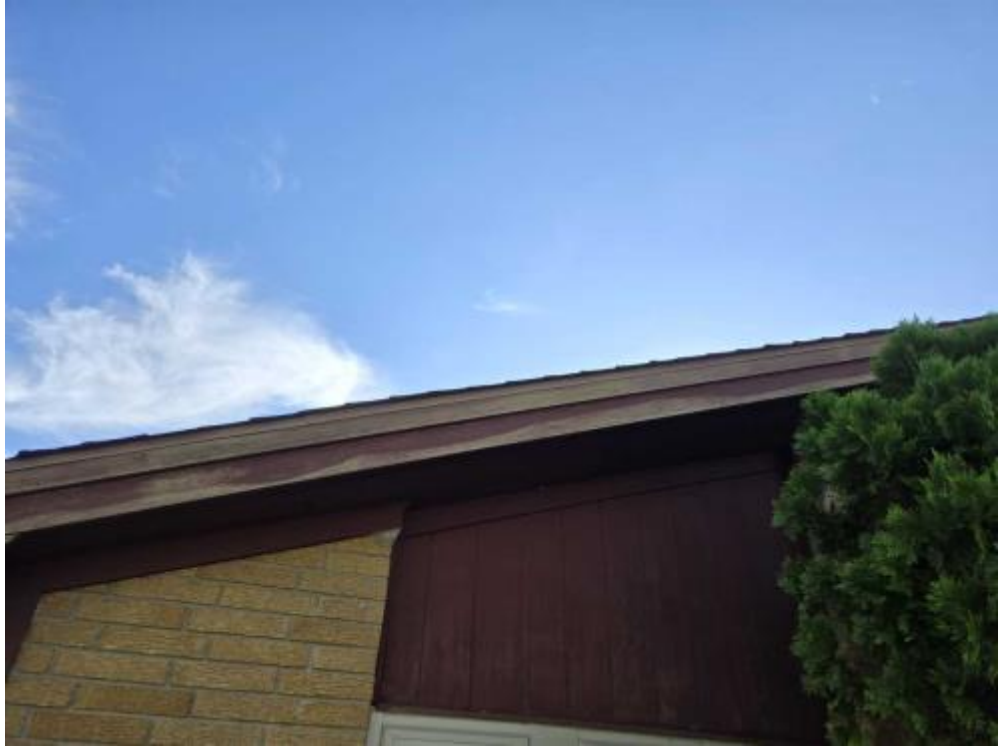
- 4 ECR-NEW - 4-Front Elevation
Date Taken: 8/16/2024
Taken By: Ducky
Moisture damage to fascia and soffit

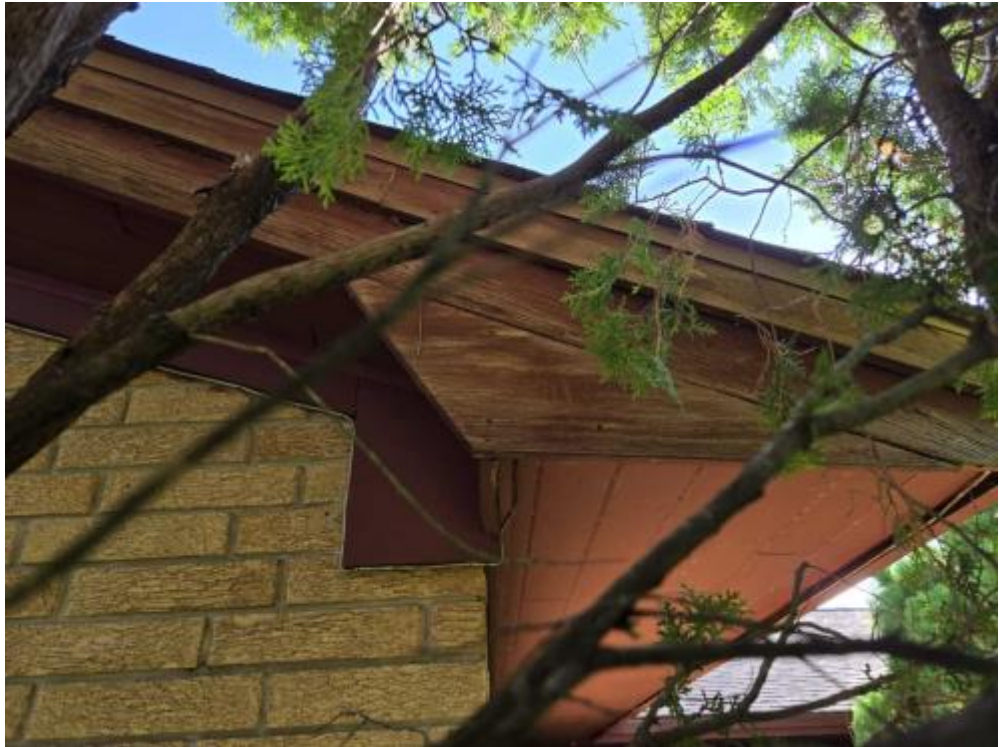
Estimated Cost of Repairs

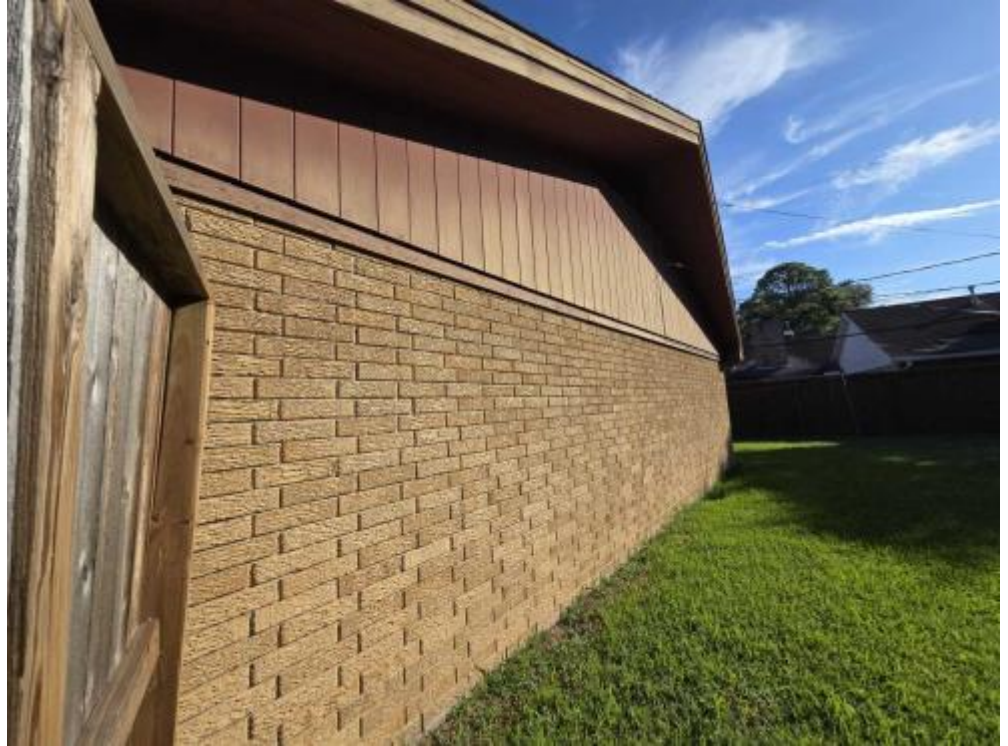
6 ECR-NEW - 6-Right Elevation

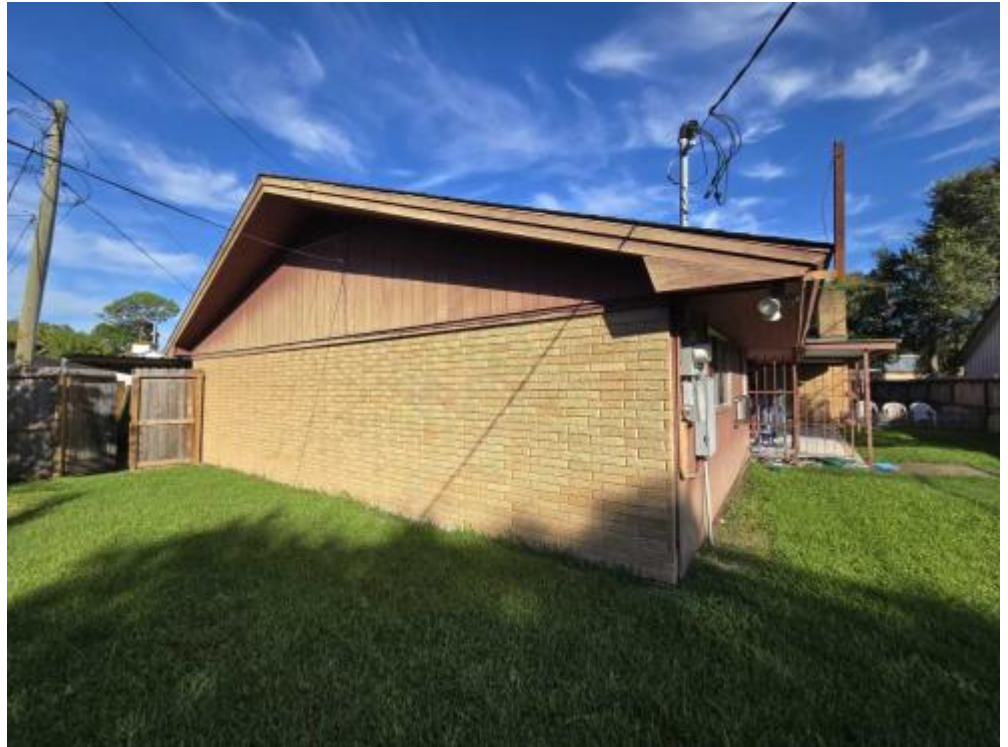
Estimated Cost of Repairs

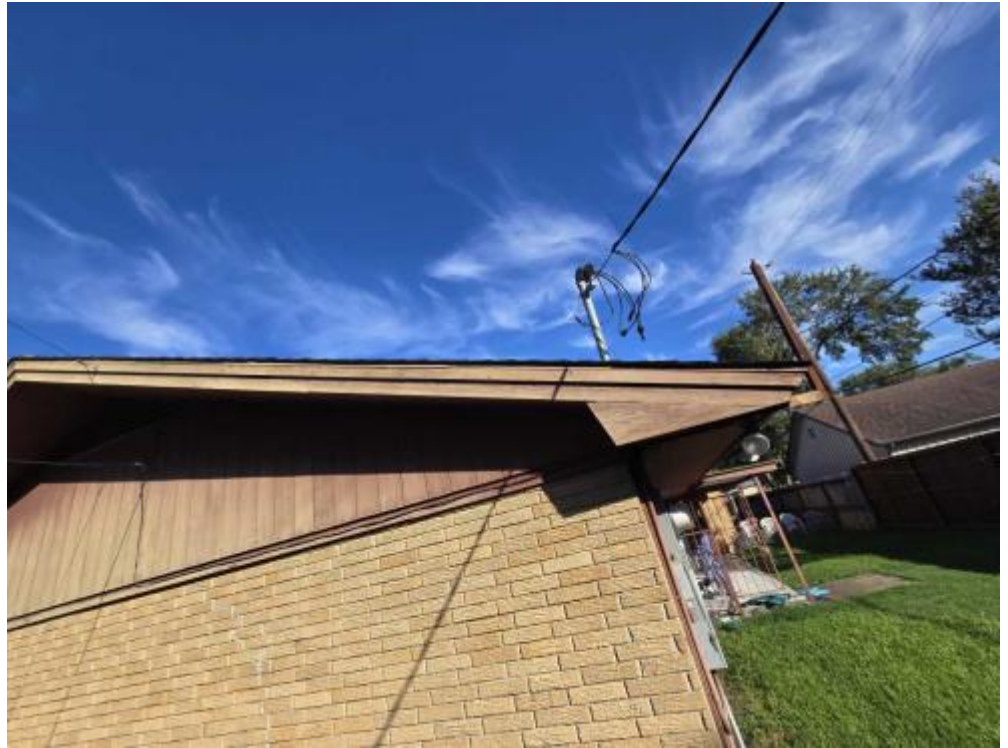
8 ECR-NEW - 8-Right Elevation

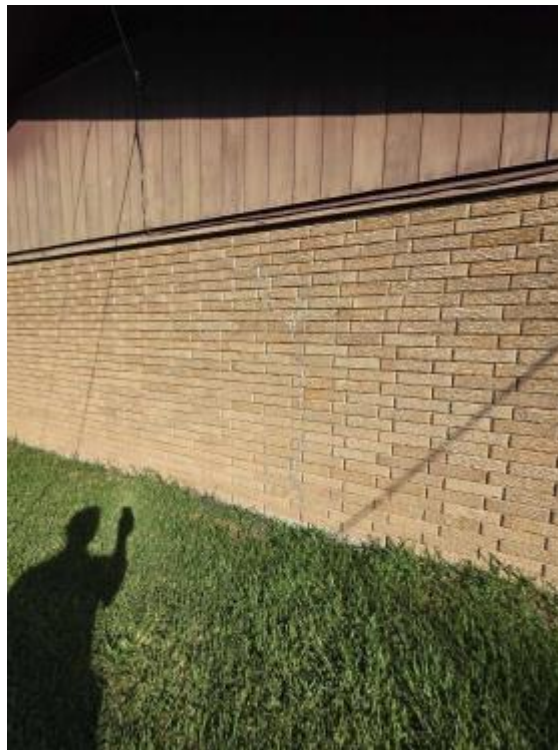
Estimated Cost of Repairs

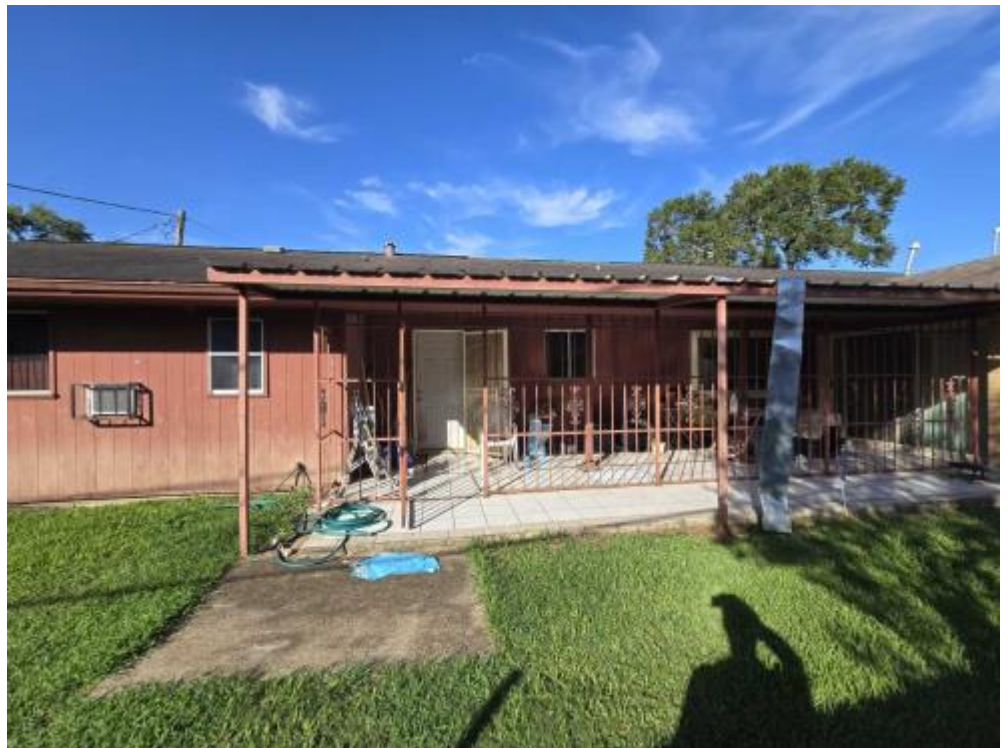
Estimated Cost of Repairs

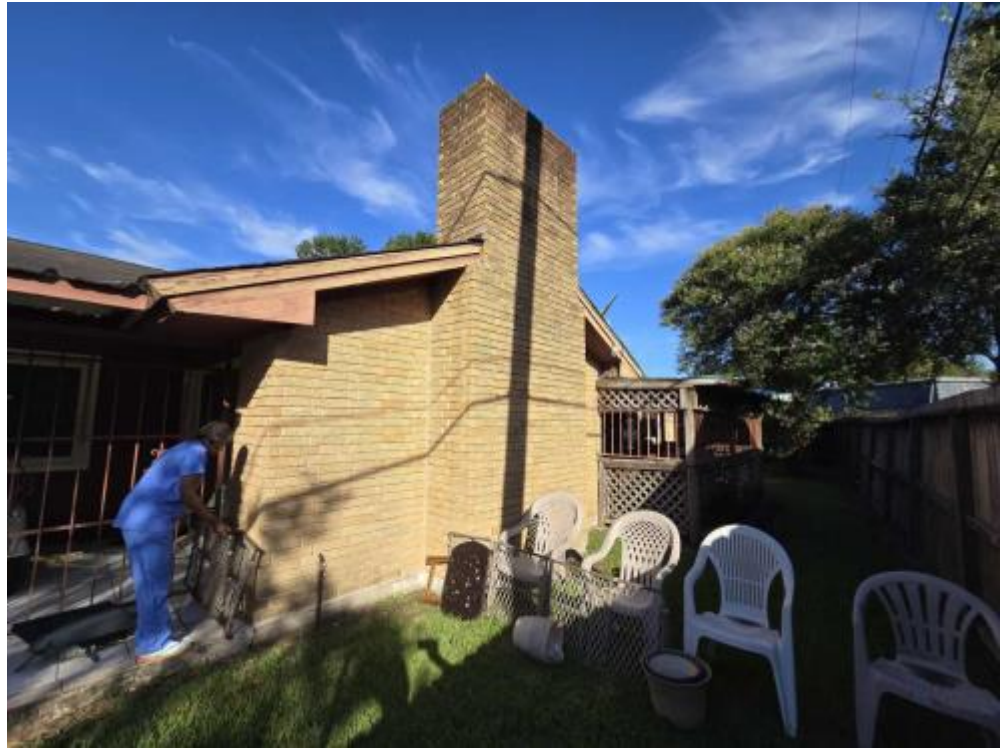
12 ECR-NEW - 12-Rear Elevation

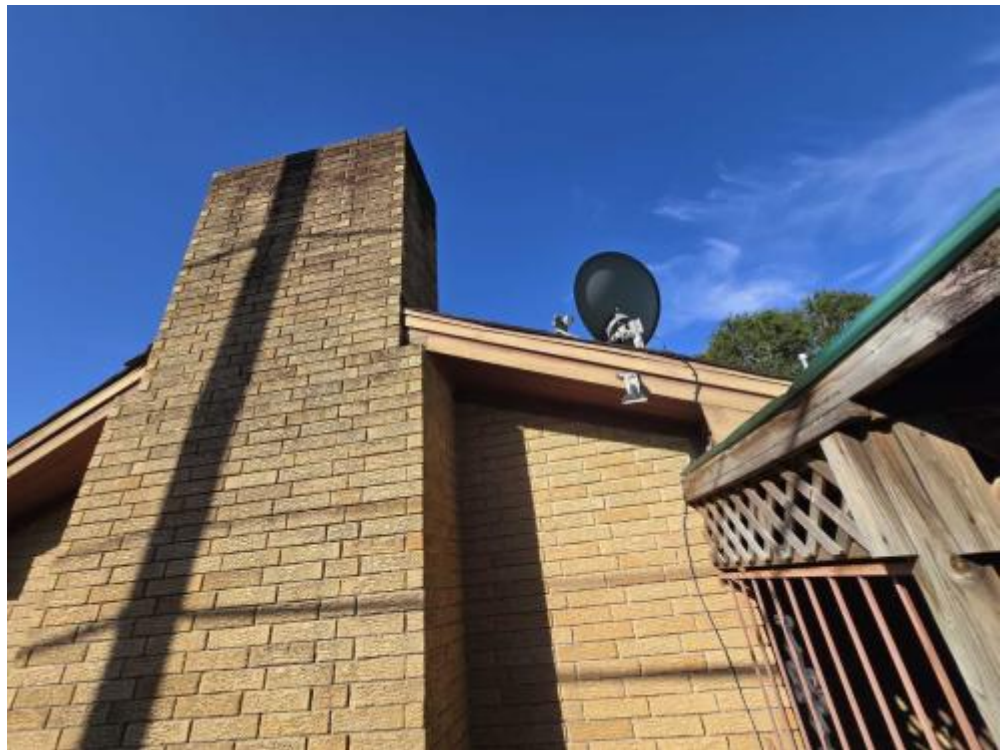
Estimated Cost of Repairs

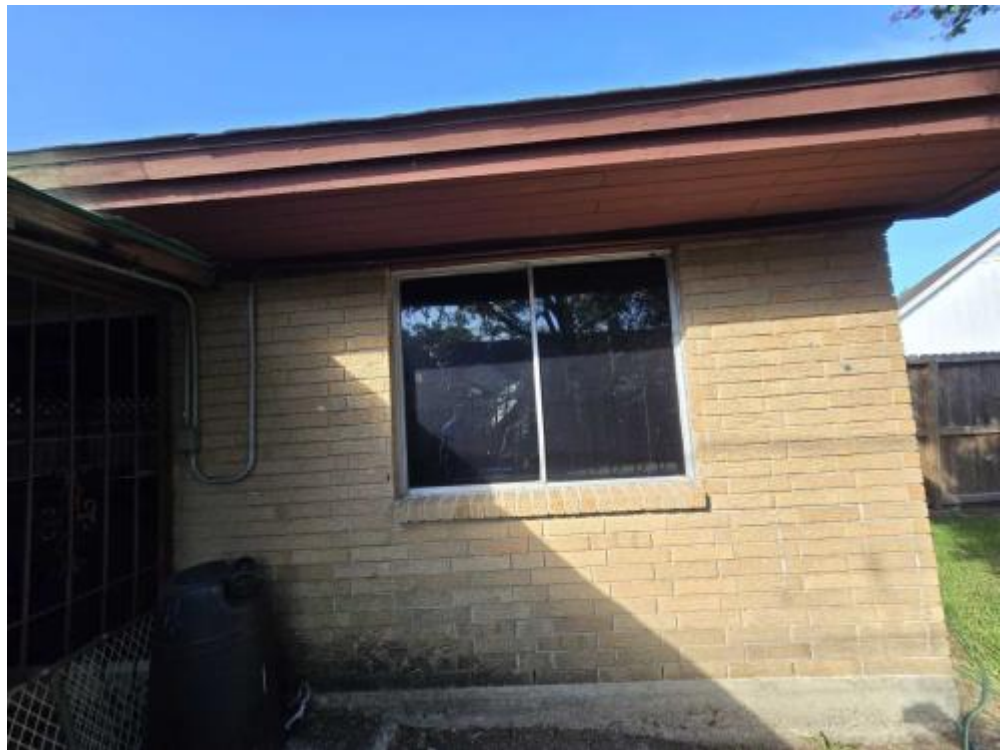
Estimated Cost of Repairs

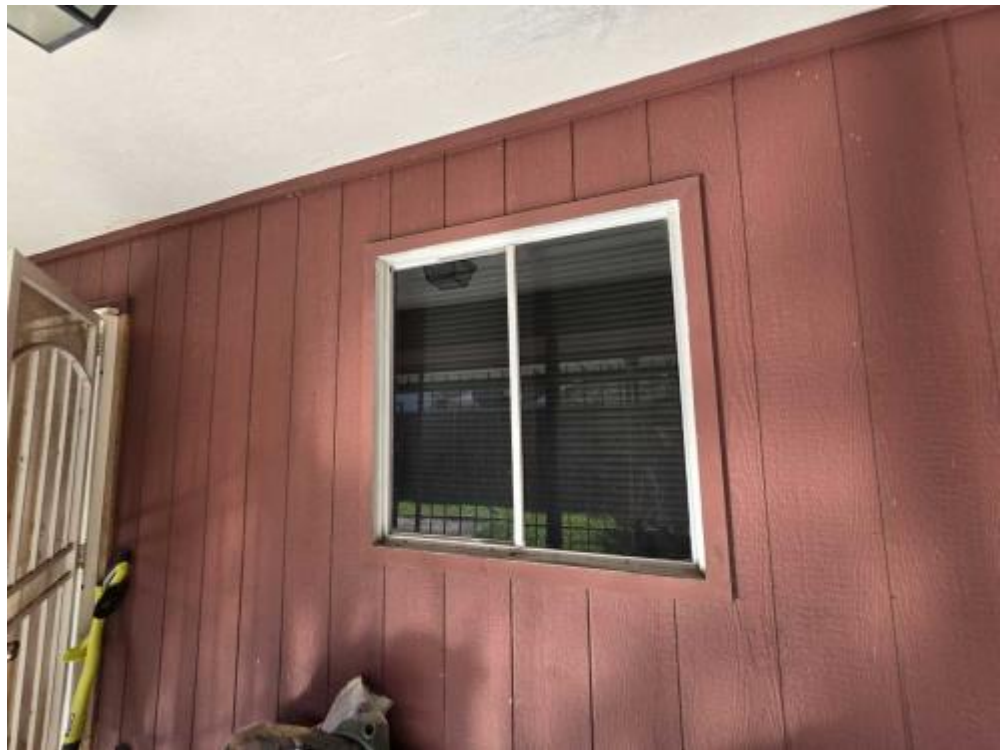
Estimated Cost of Repairs

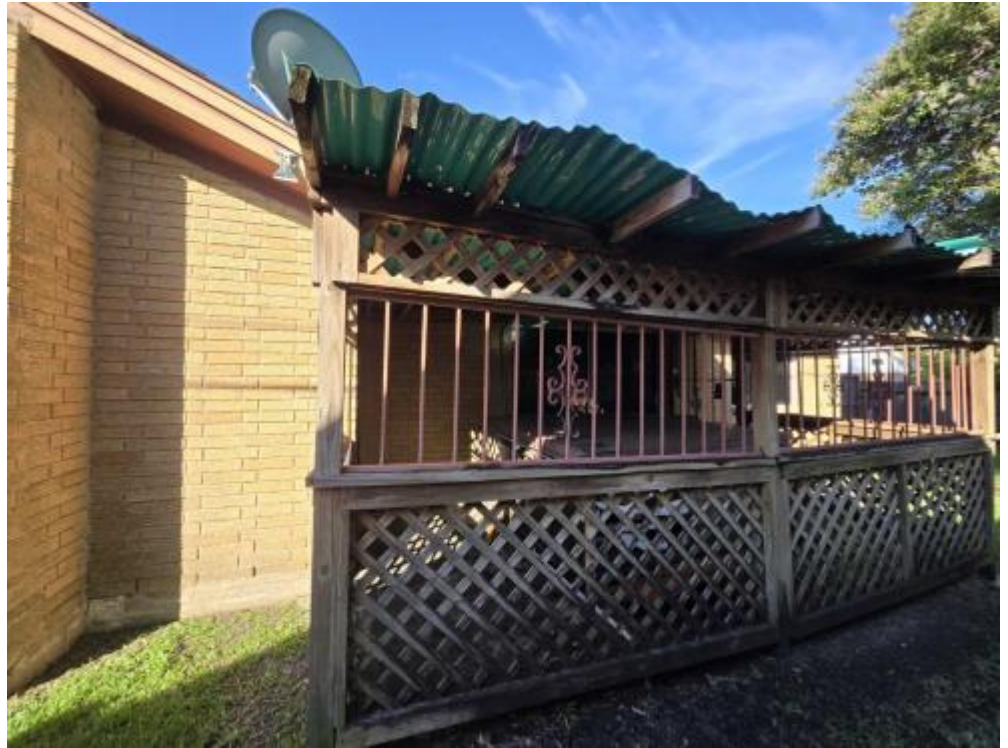
18 ECR-NEW - 18-Rear Elevation

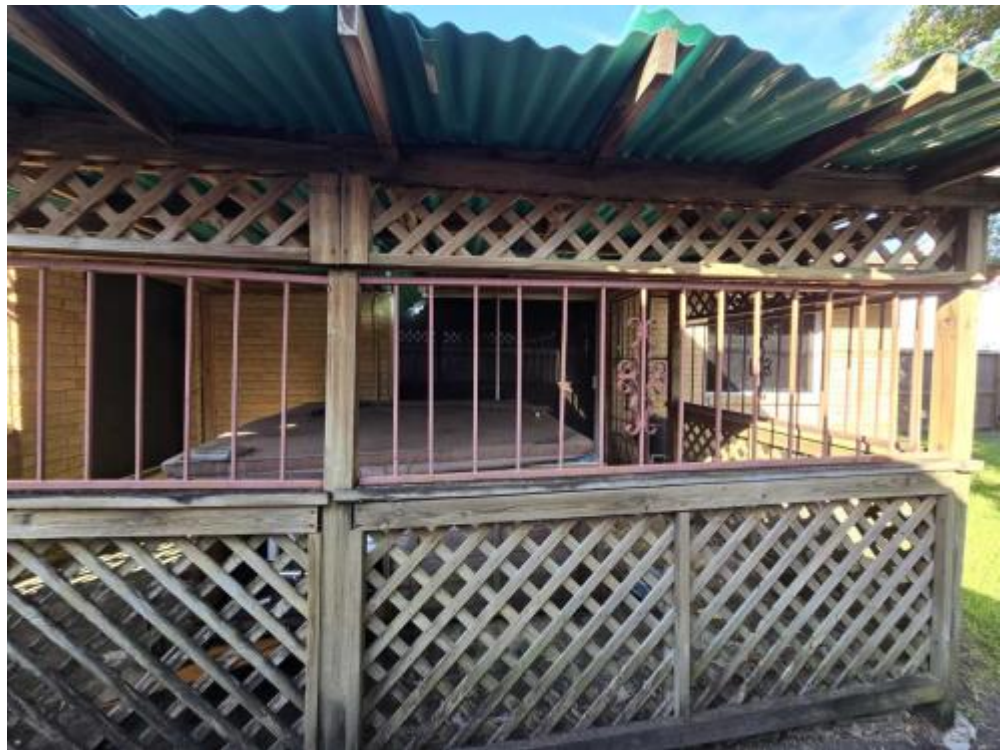
Estimated Cost of Repairs

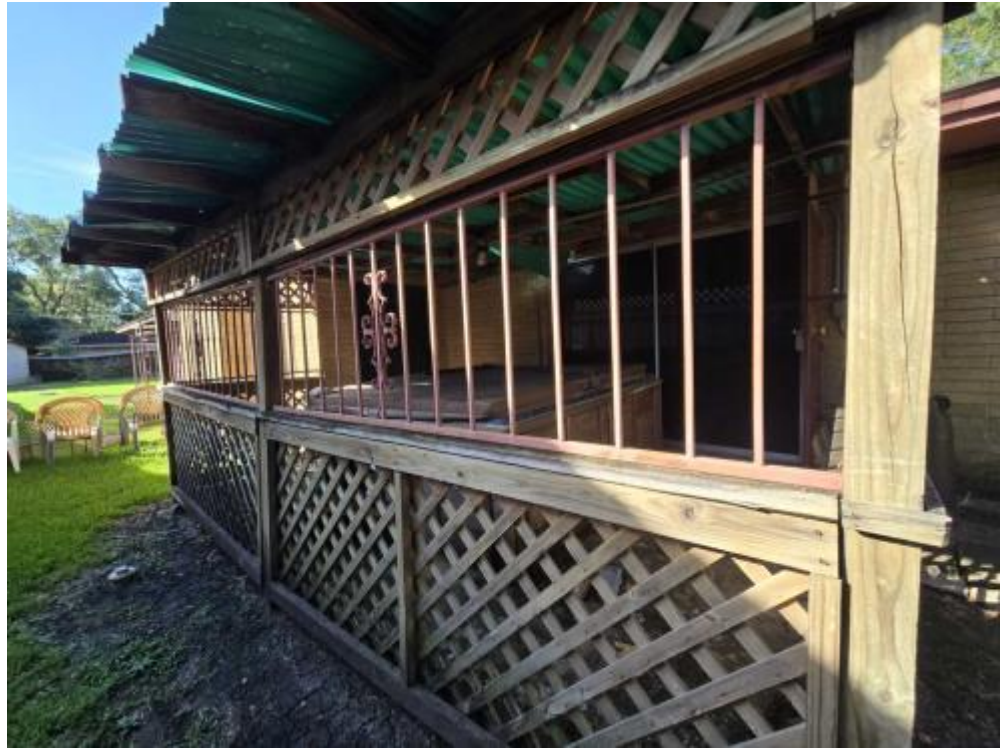
20 ECR-NEW - 20-Rear Elevation

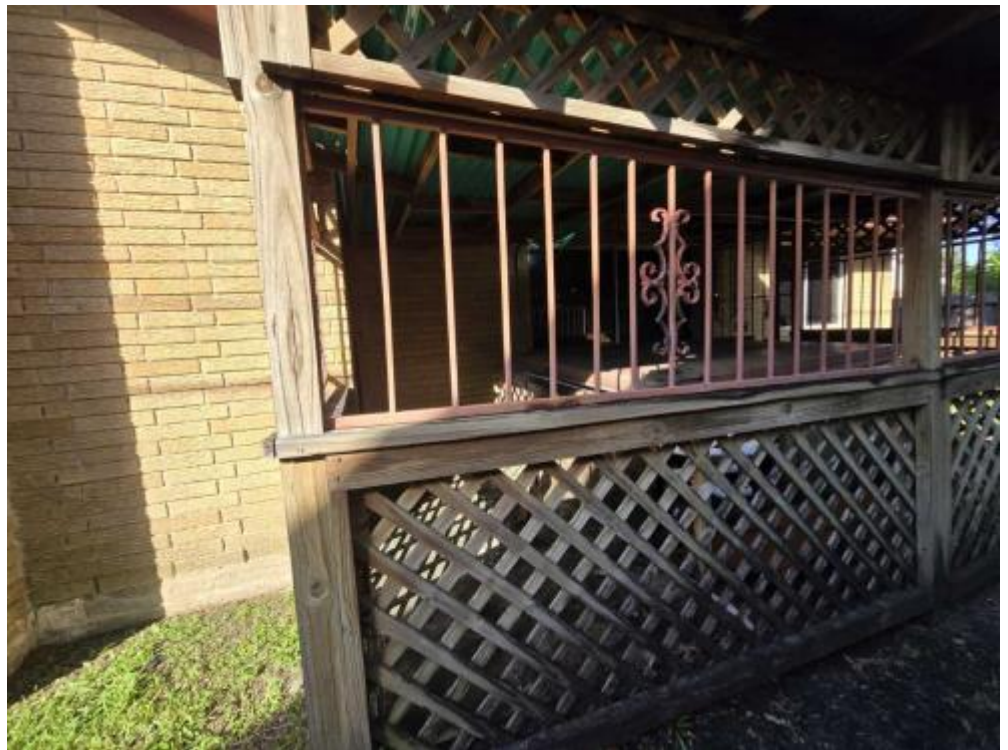
Estimated Cost of Repairs

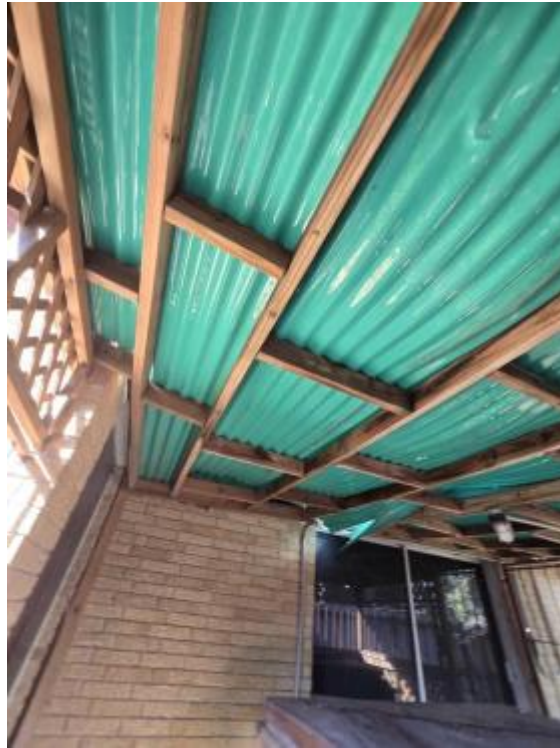
22 ECR-NEW - 22-Rear Elevation

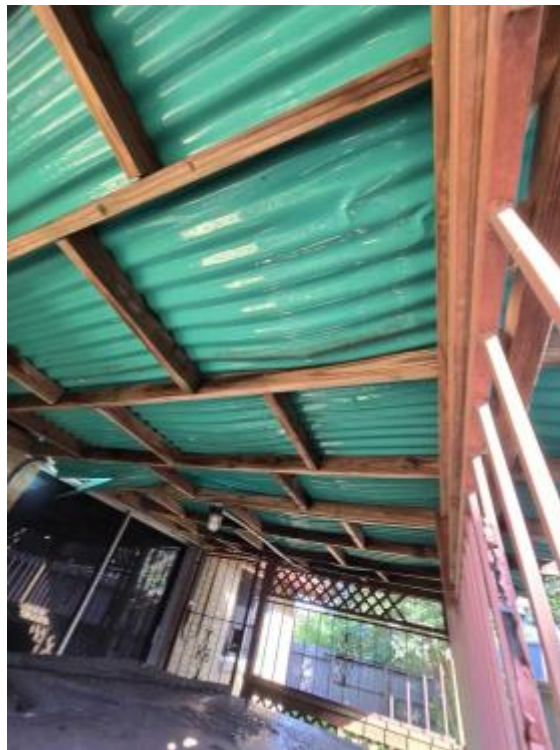
Estimated Cost of Repairs

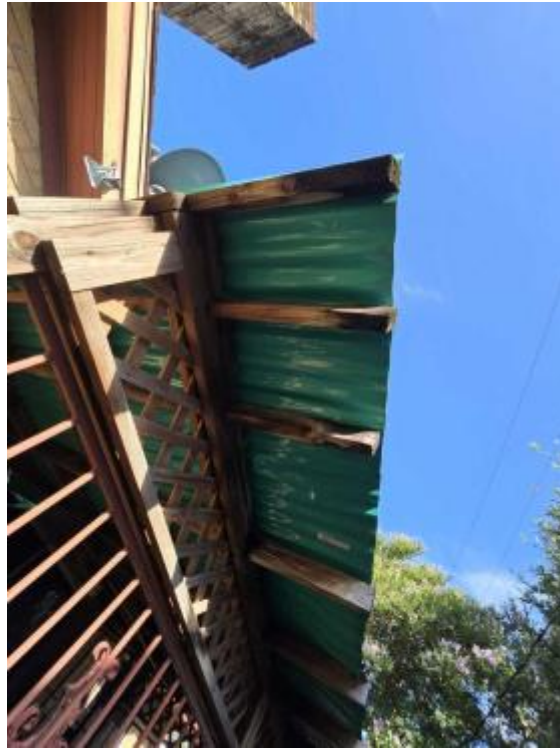
24 ECR-NEW - 24-Rear Elevation

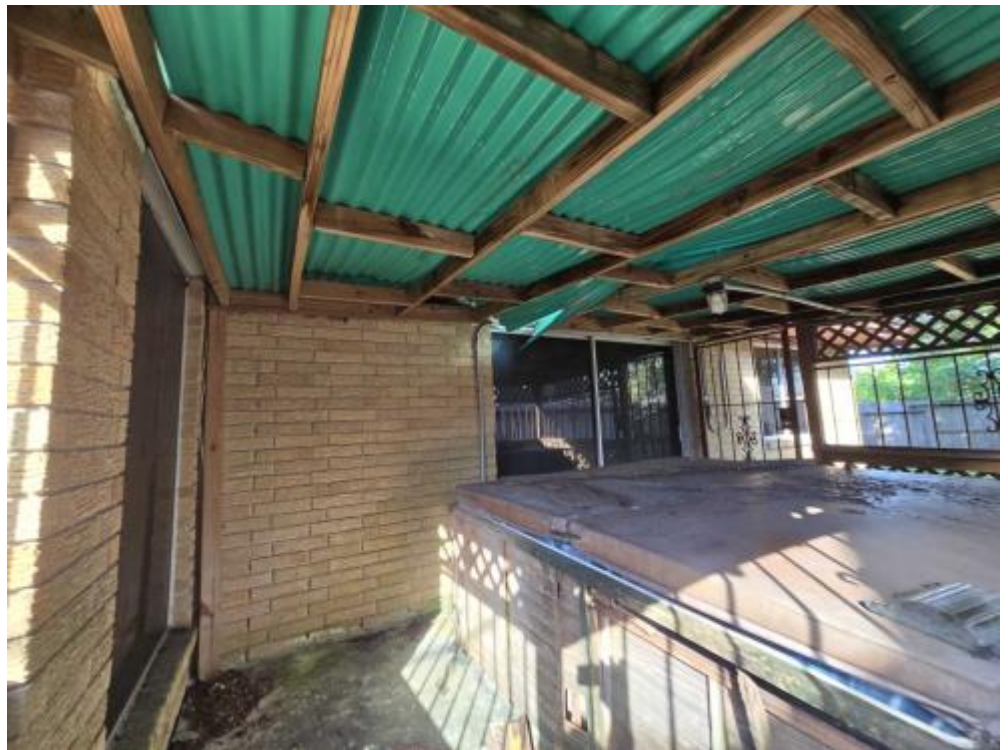
Estimated Cost of Repairs

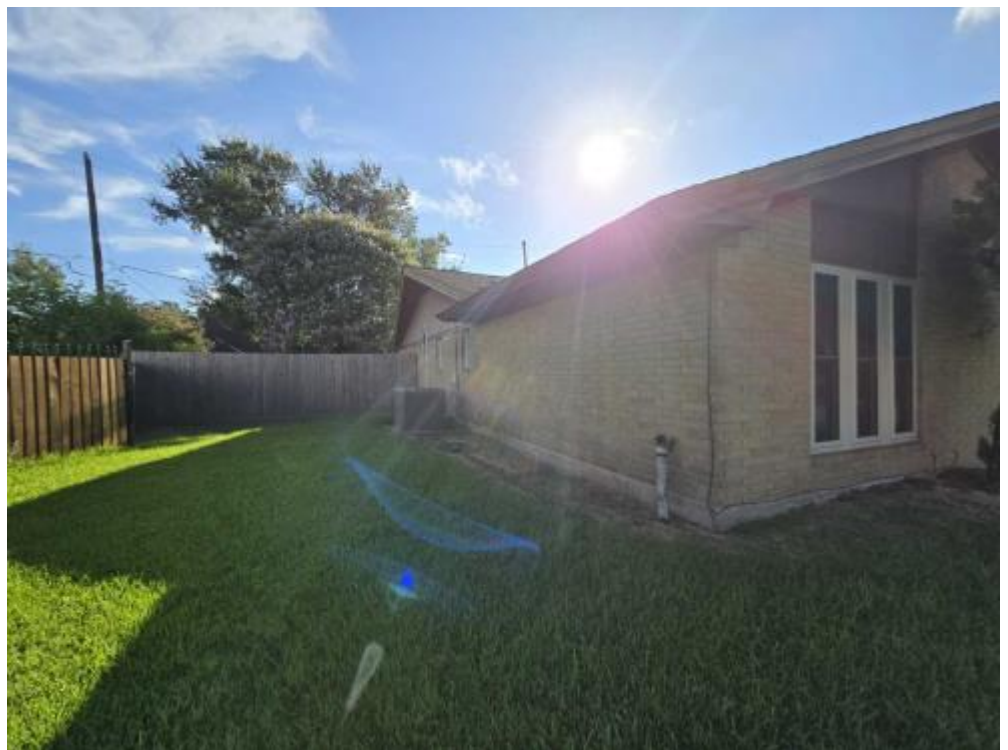
Estimated Cost of Repairs

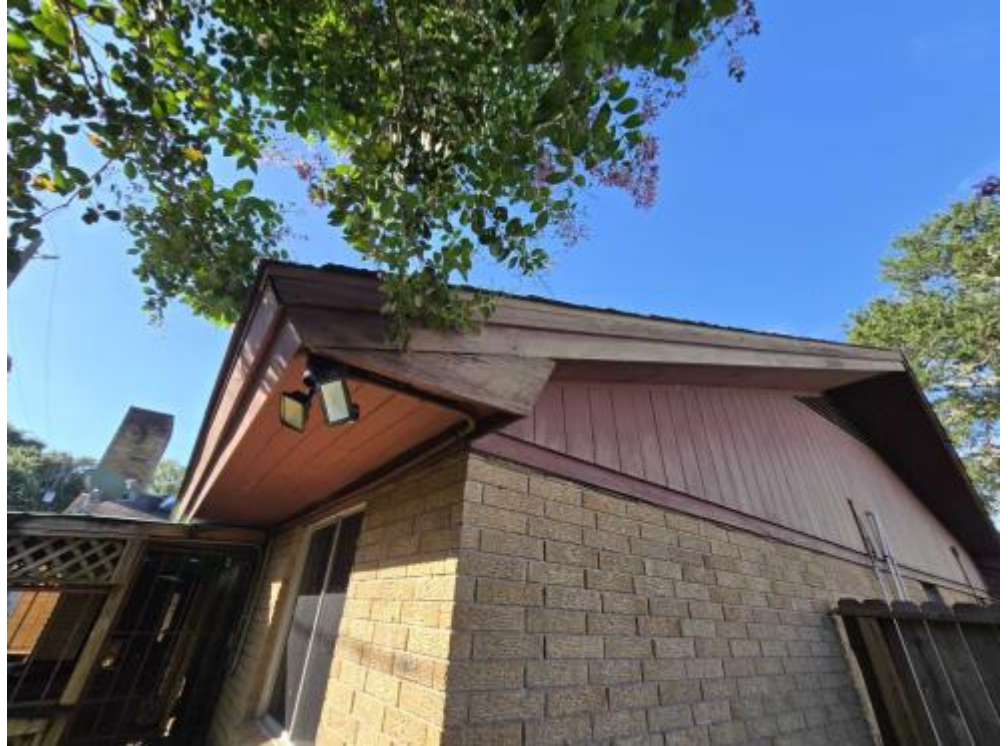
28 ECR-NEW - 28-Left Elevation

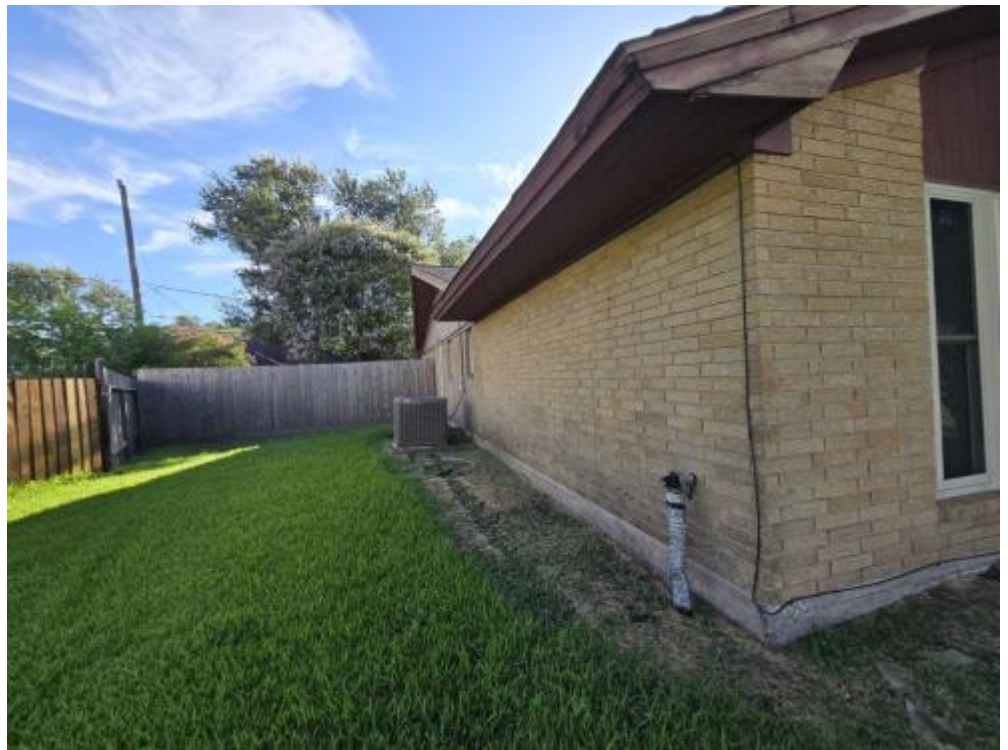
Estimated Cost of Repairs

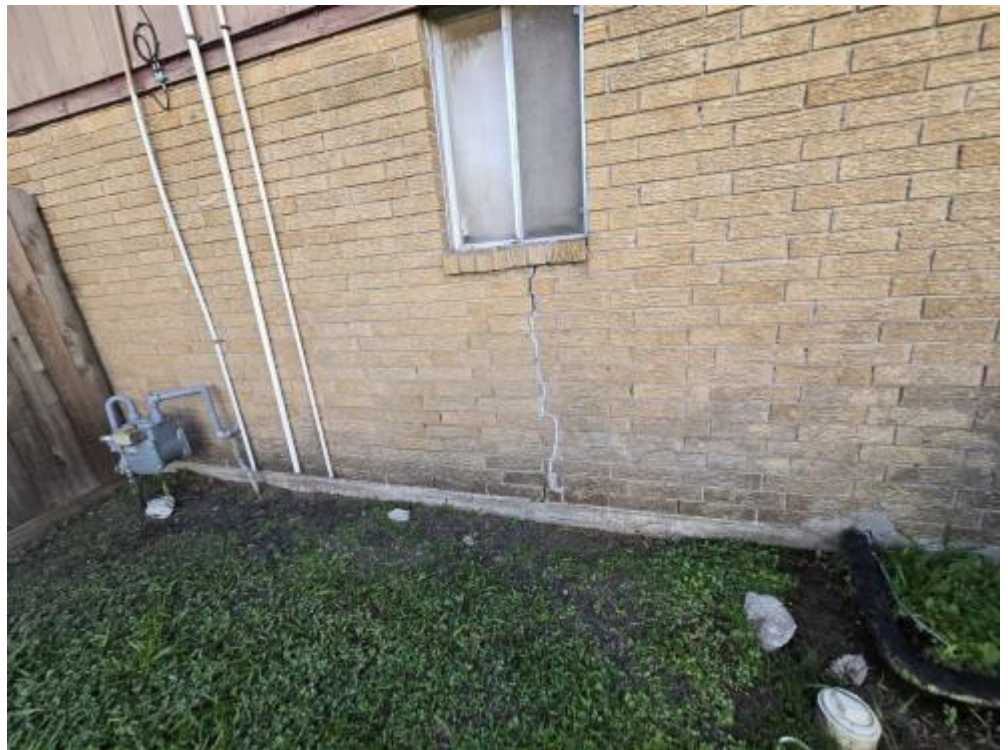
Estimated Cost of Repairs

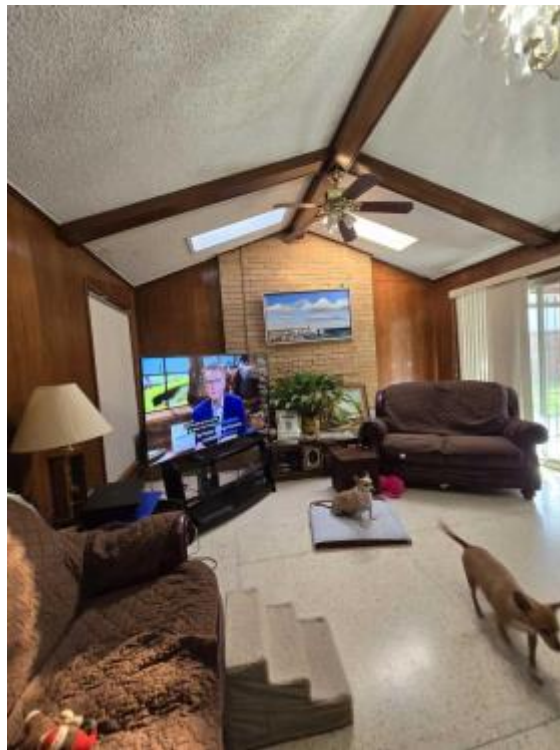
Estimated Cost of Repairs

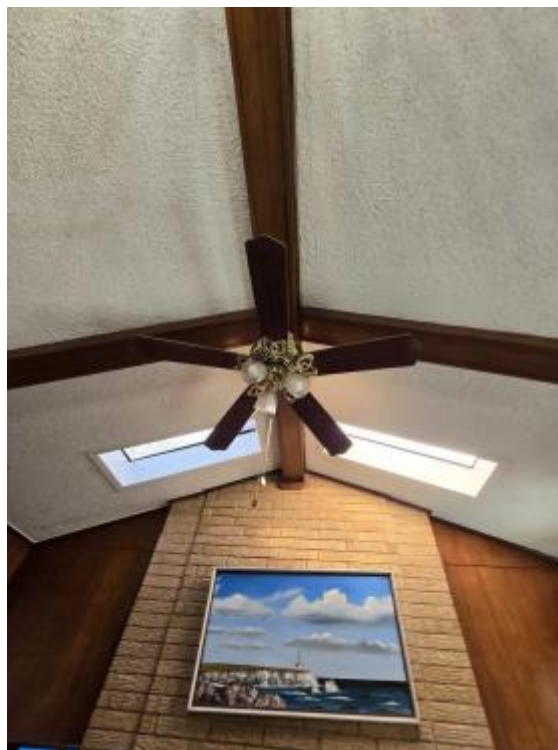
Estimated Cost of Repairs
