CERTIFICATE OF APPROPRIATENESS

Applicant: Jessie Enander, agent for, Bennie Davis, owner

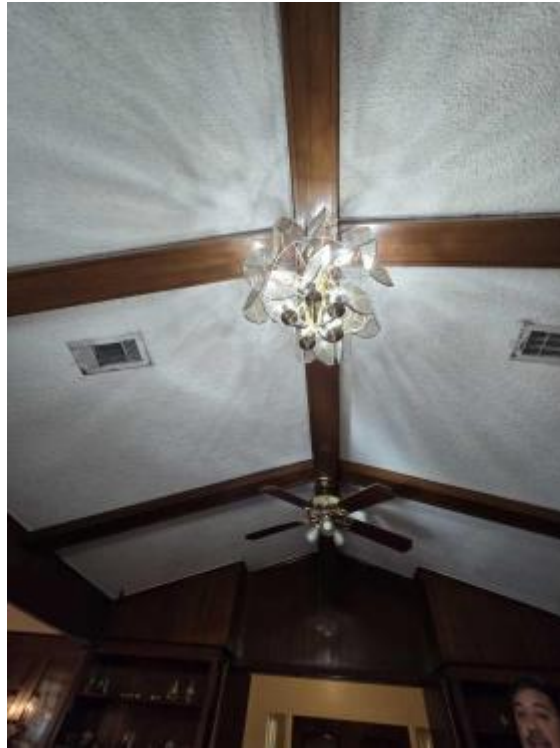
36 ECR-NEW - 36-Family

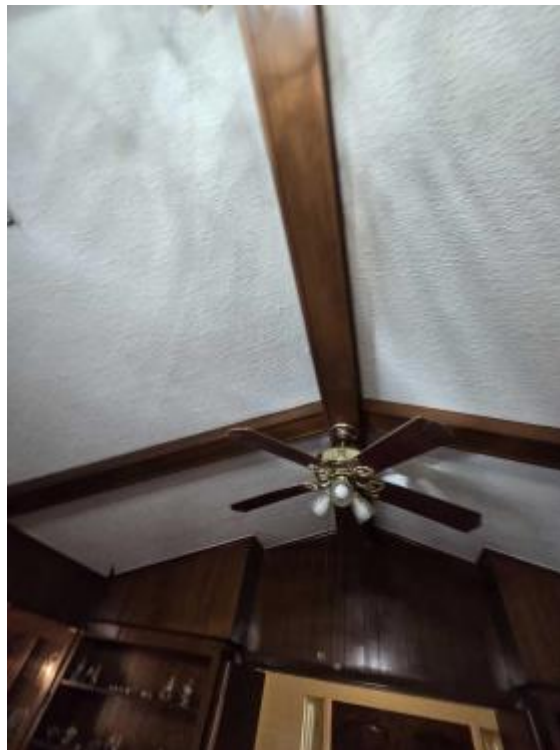
Estimated Cost of Repairs

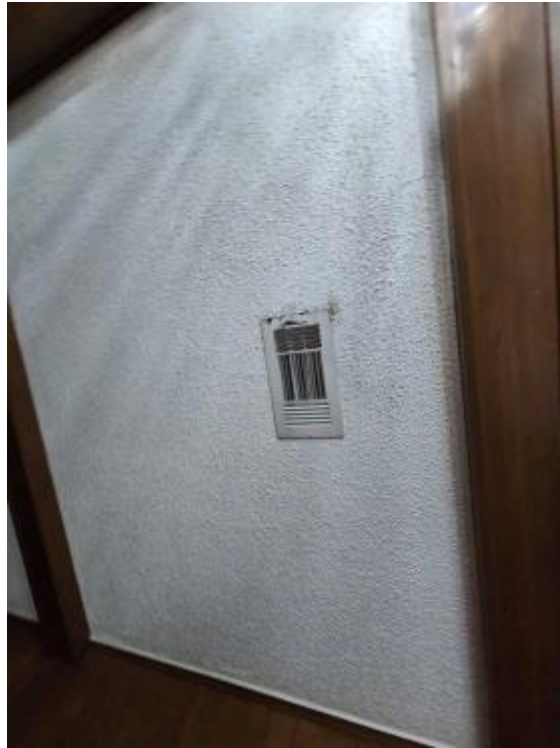
38 ECR-NEW - 38-Family

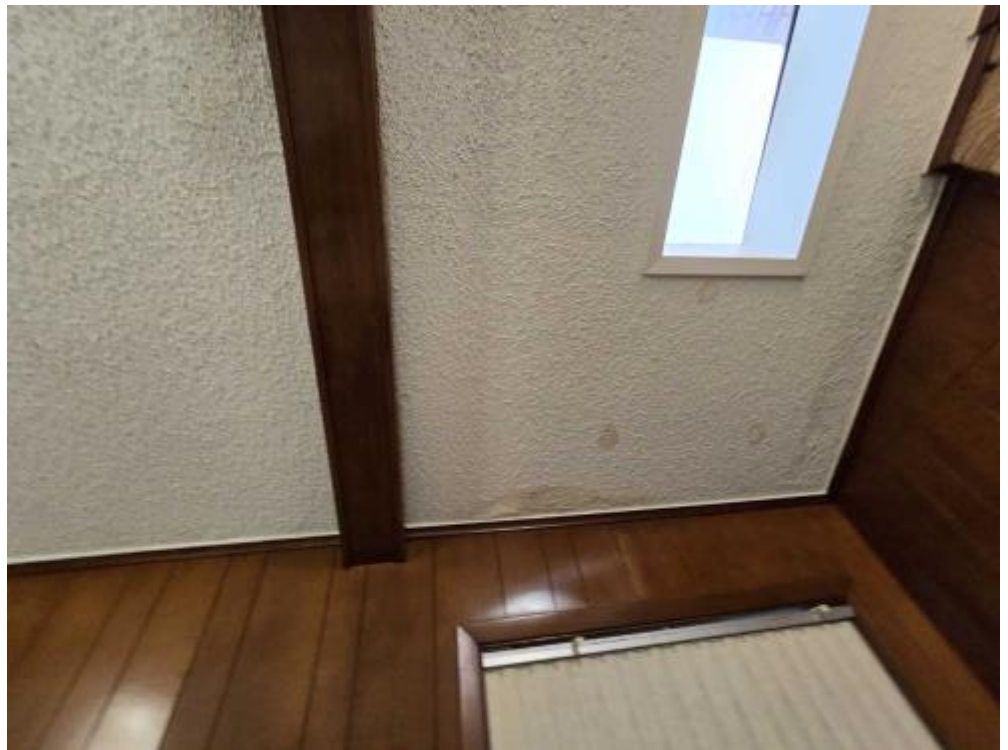
Estimated Cost of Repairs

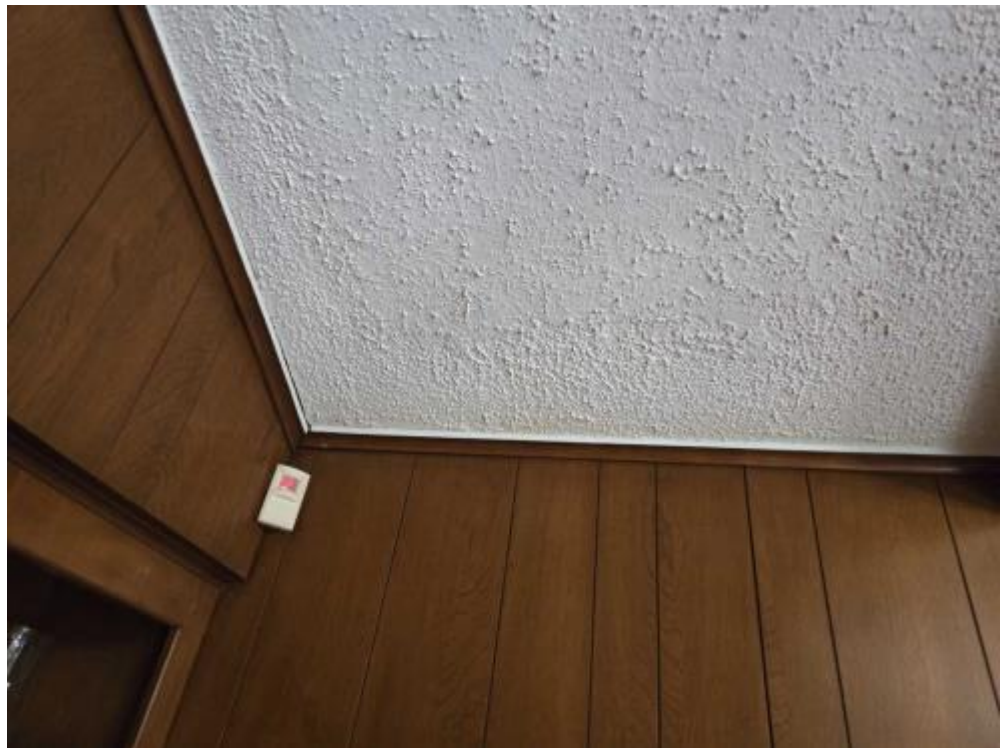
Estimated Cost of Repairs

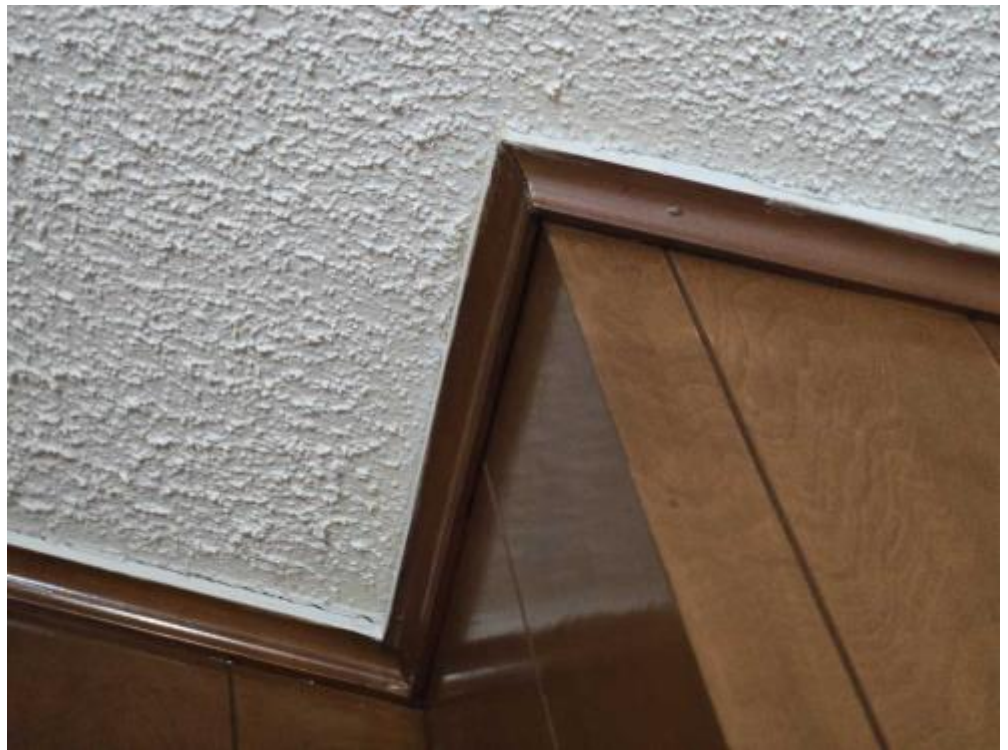
Estimated Cost of Repairs

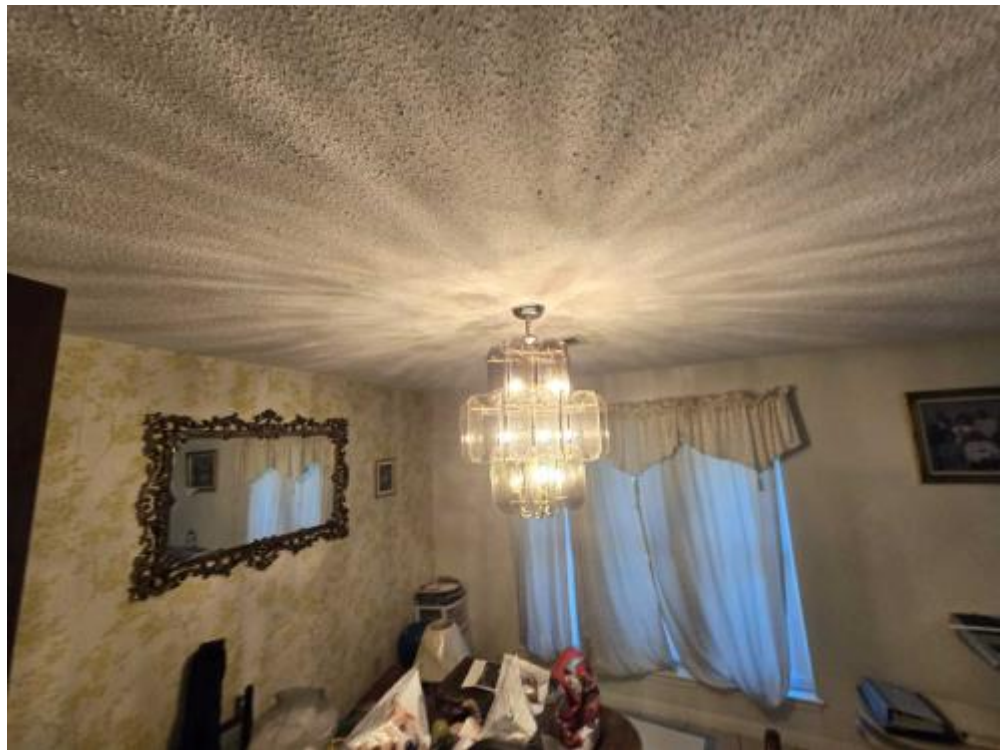
Estimated Cost of Repairs

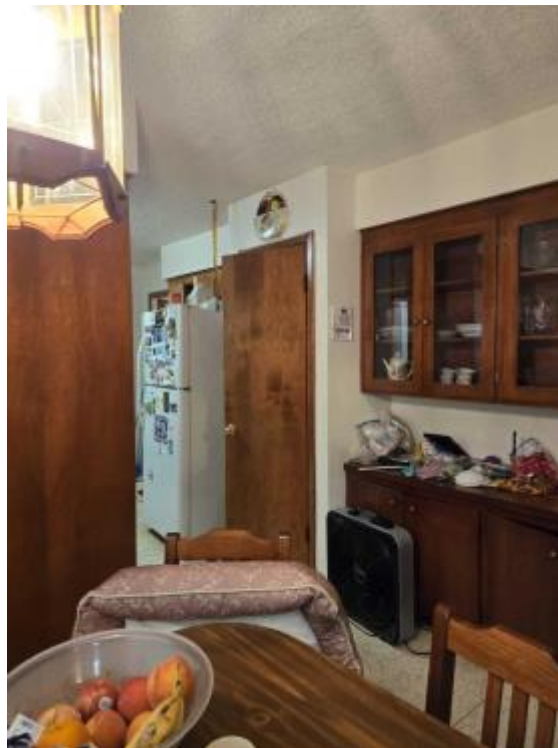
Estimated Cost of Repairs

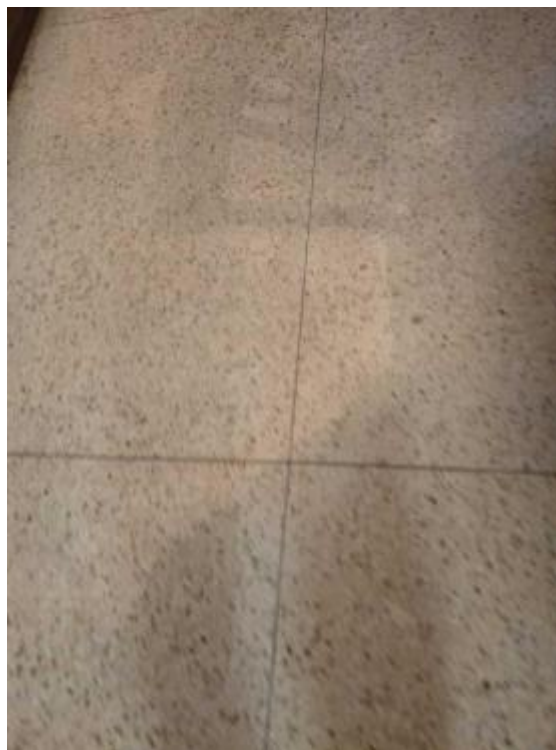
Estimated Cost of Repairs

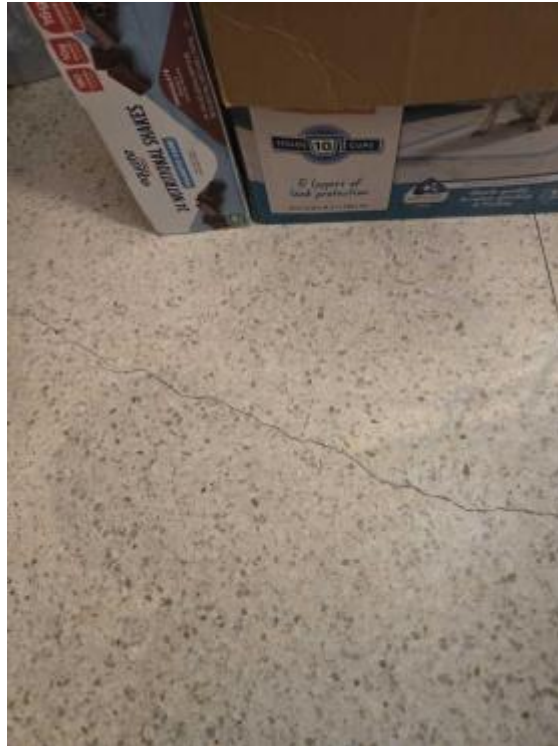
- 50 ECR-NEW - 50-Kithcen
Date Taken: 8/16/2024
Taken By: Ducky
Overview of cabinets. ECR has wron
measurements.

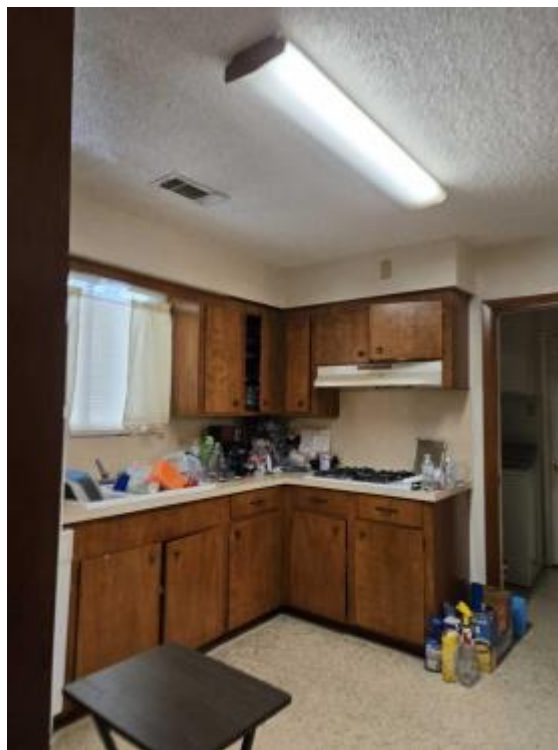
Estimated Cost of Repairs

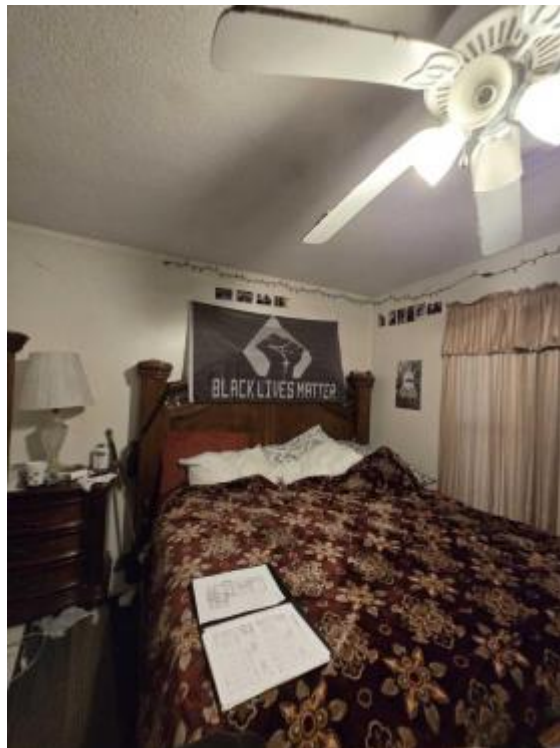
Estimated Cost of Repairs

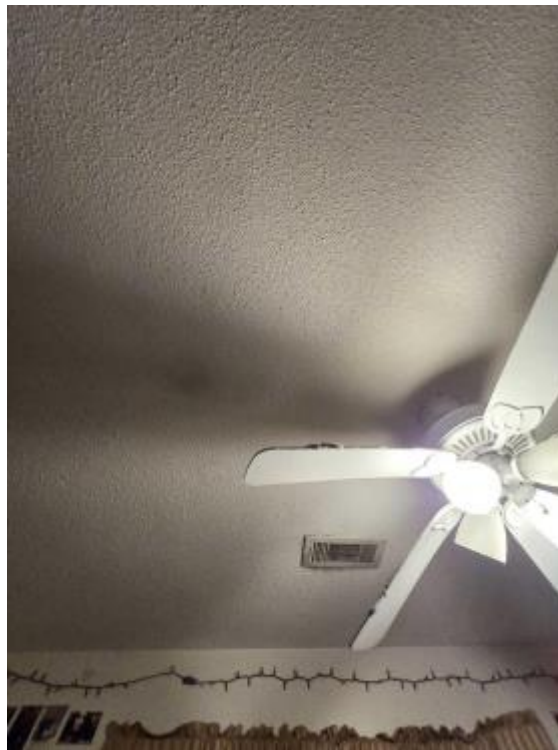
Estimated Cost of Repairs

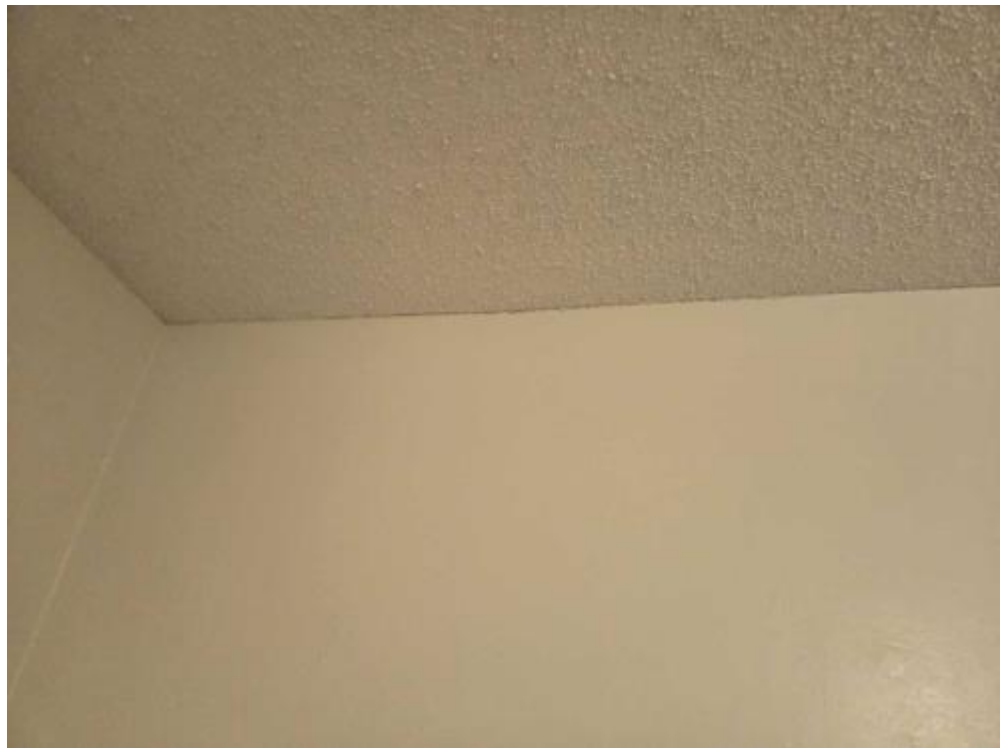
Estimated Cost of Repairs

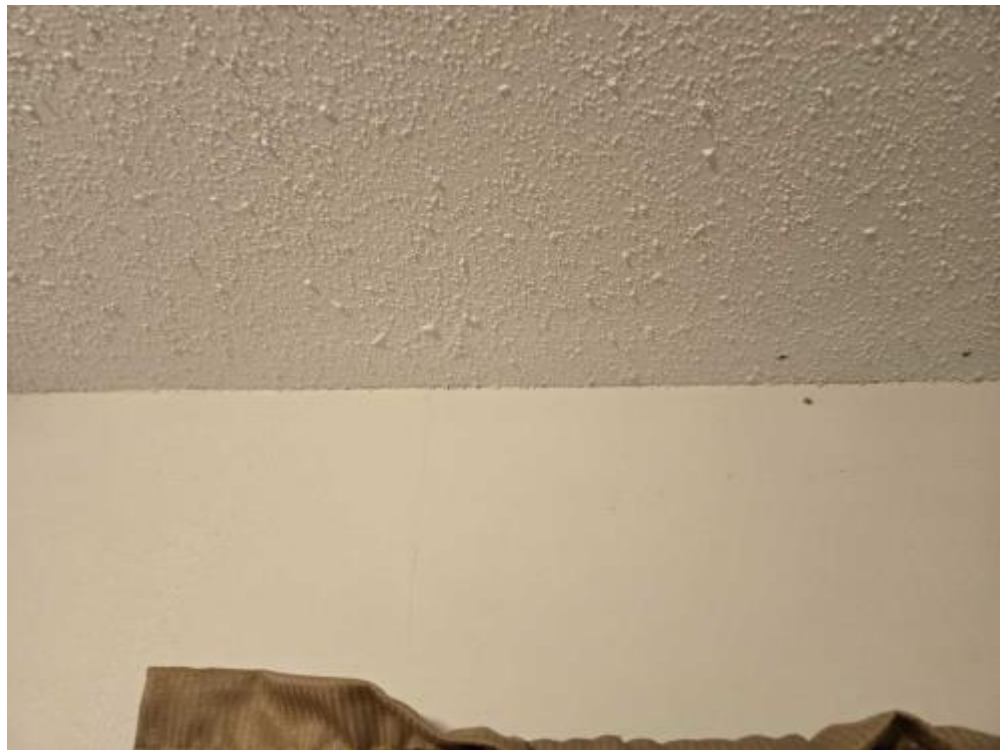
Estimated Cost of Repairs

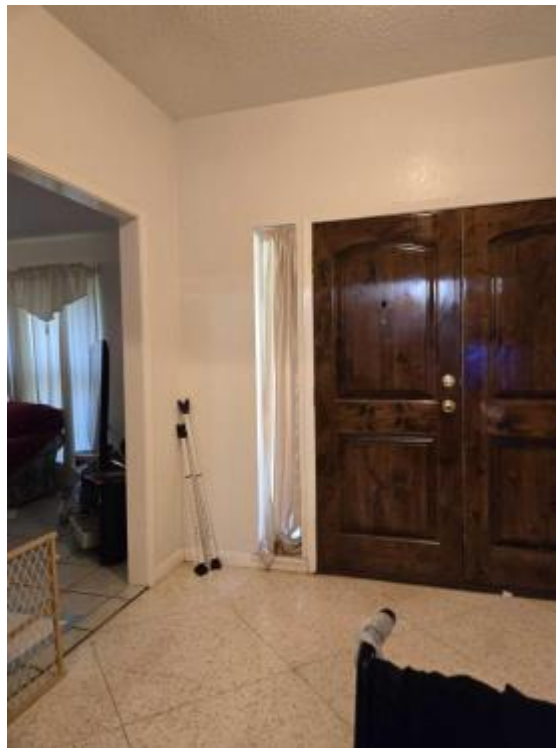
Estimated Cost of Repairs

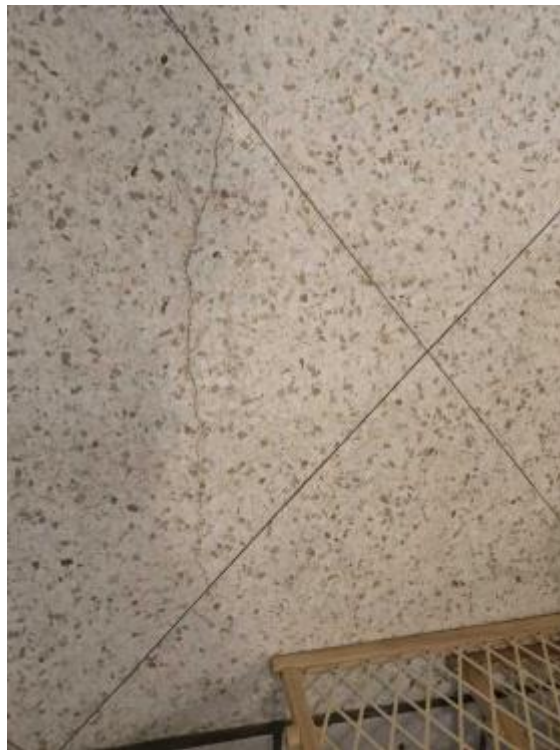
Estimated Cost of Repairs

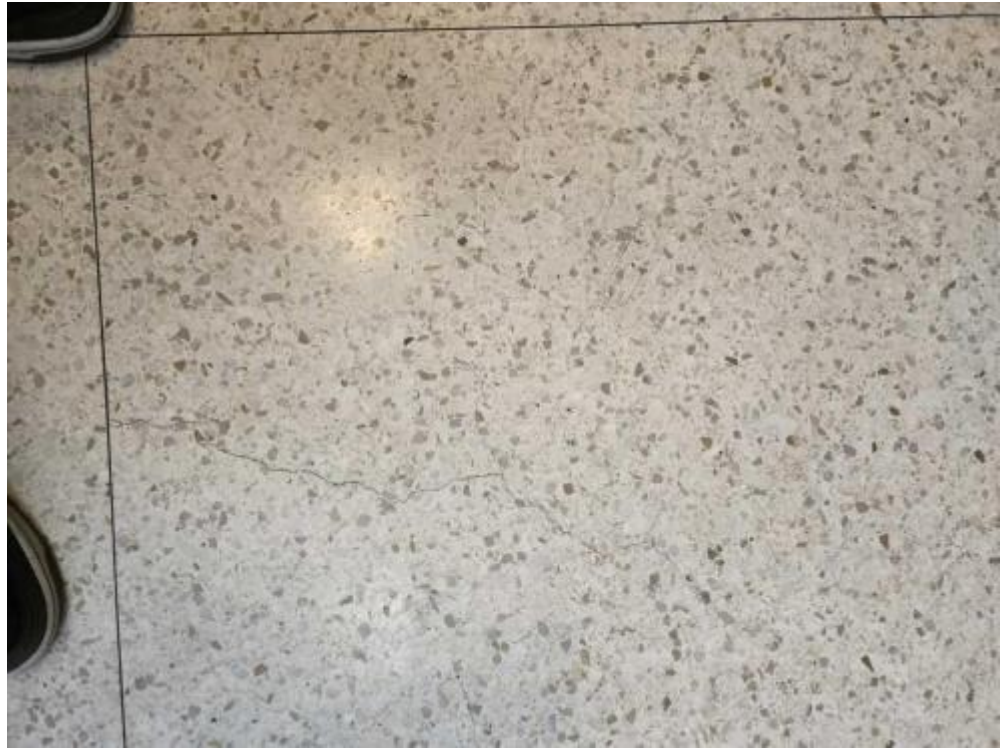
64 ECR-NEW - 64-Office

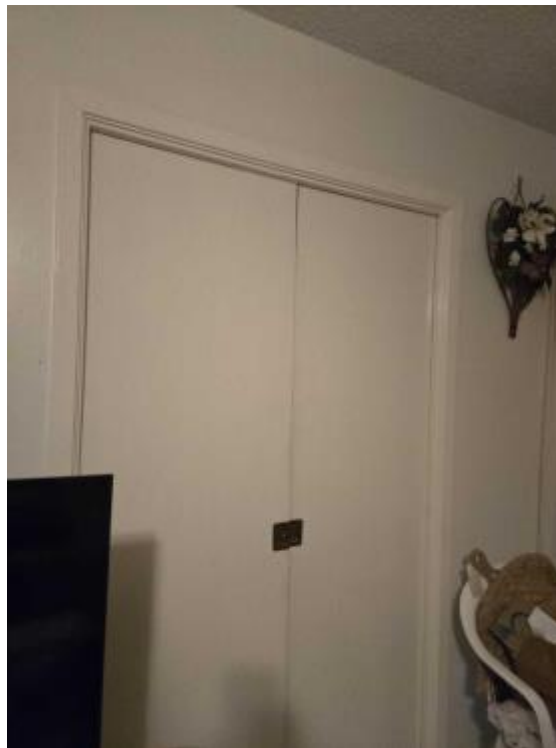
Estimated Cost of Repairs

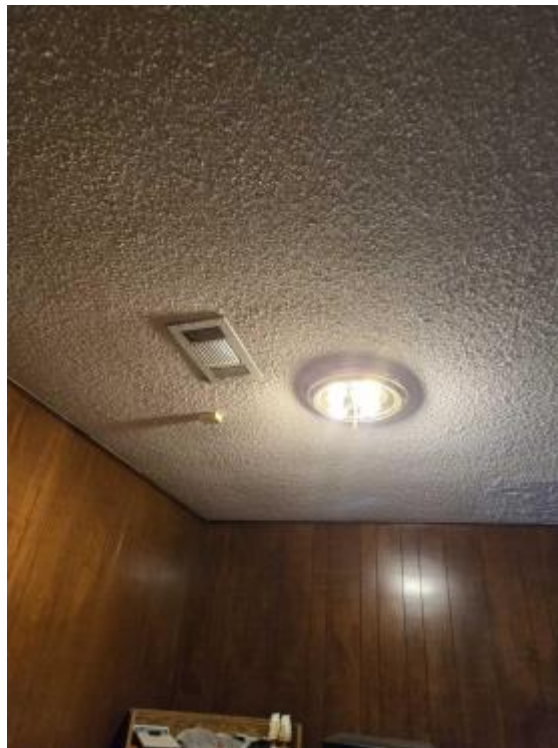
Estimated Cost of Repairs

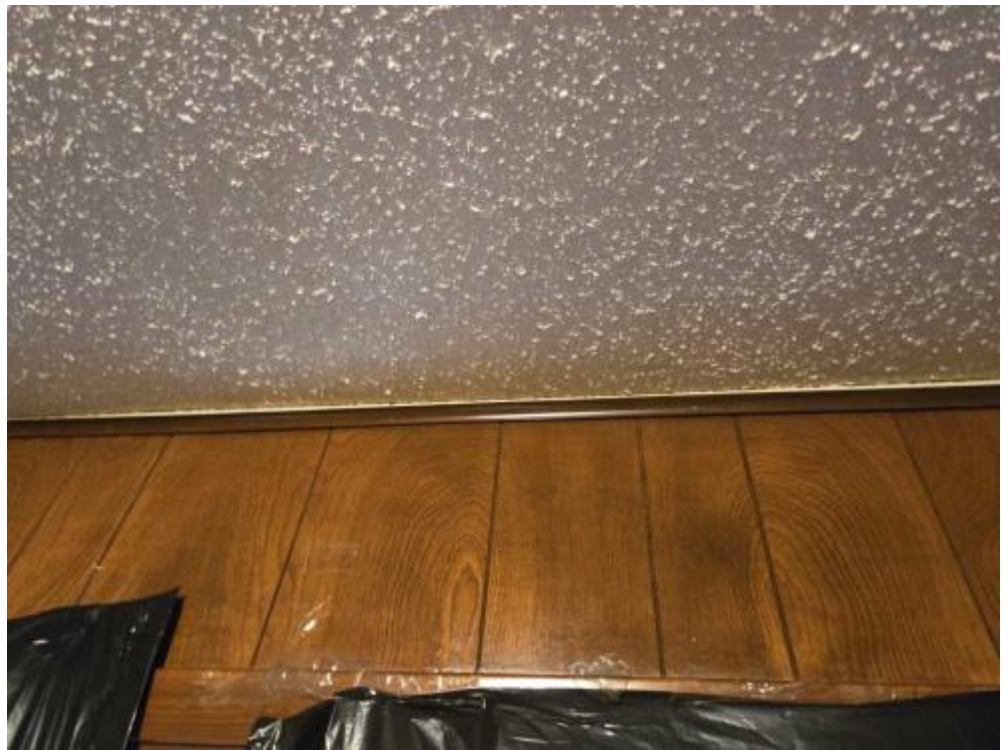
Estimated Cost of Repairs

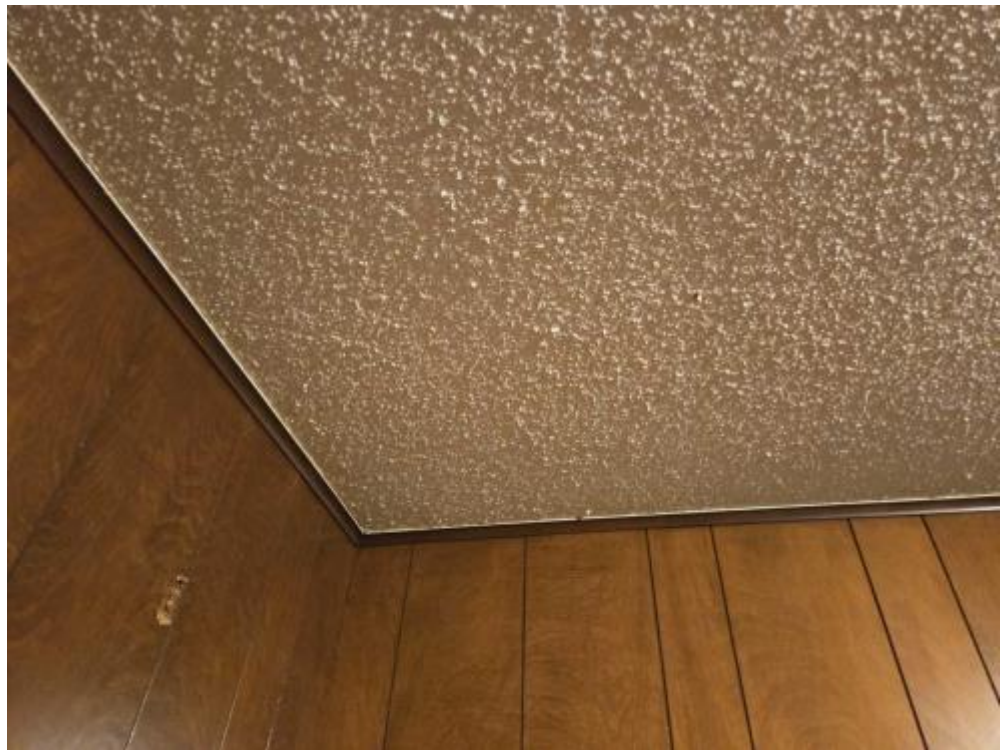
Estimated Cost of Repairs

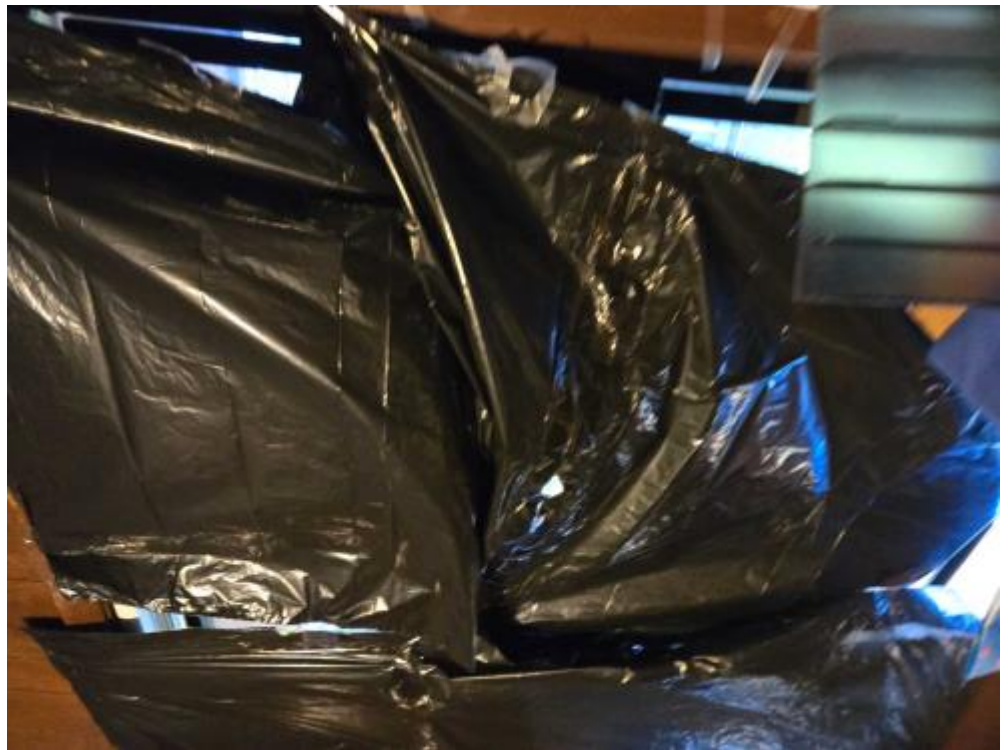
Estimated Cost of Repairs

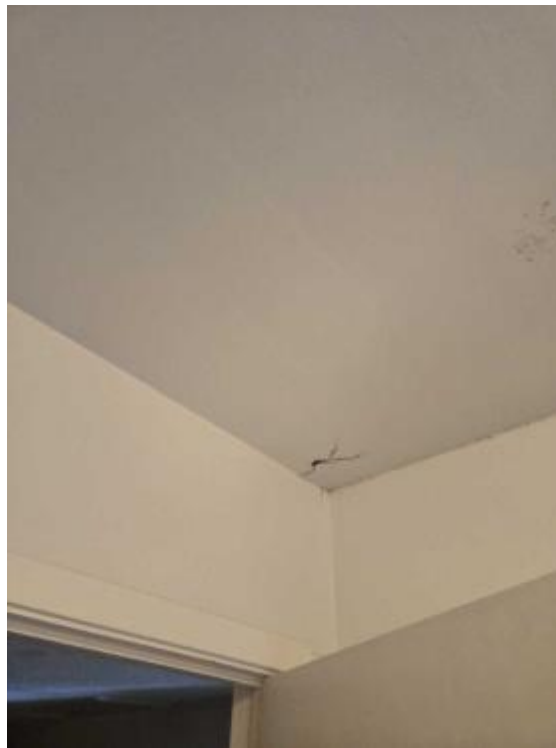
Estimated Cost of Repairs

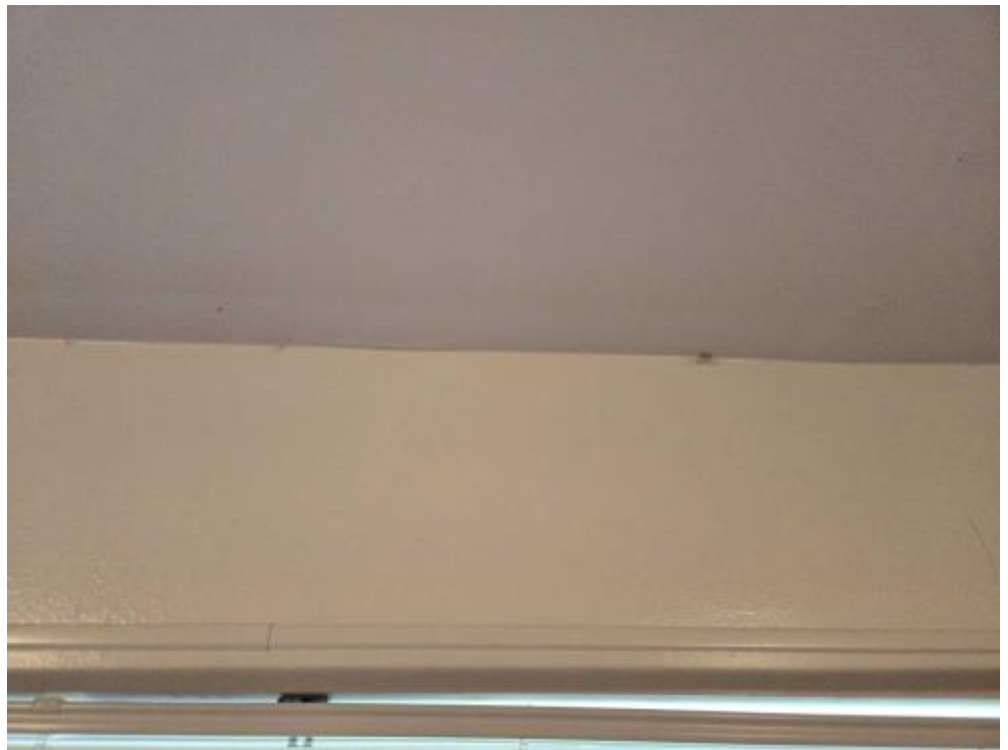
Estimated Cost of Repairs

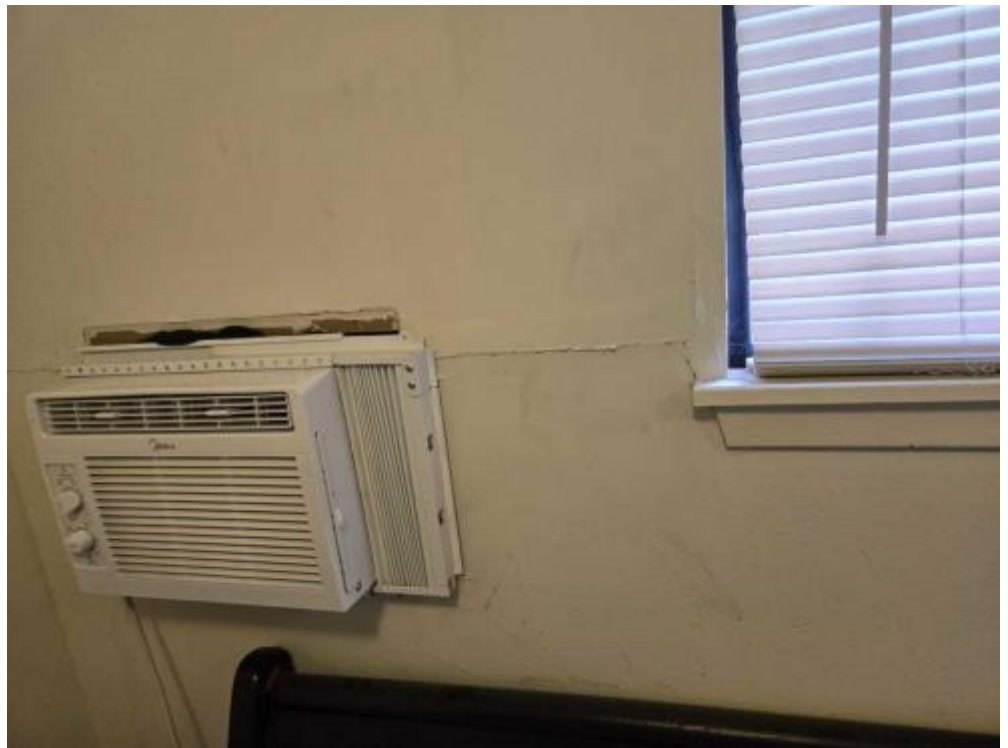
Estimated Cost of Repairs

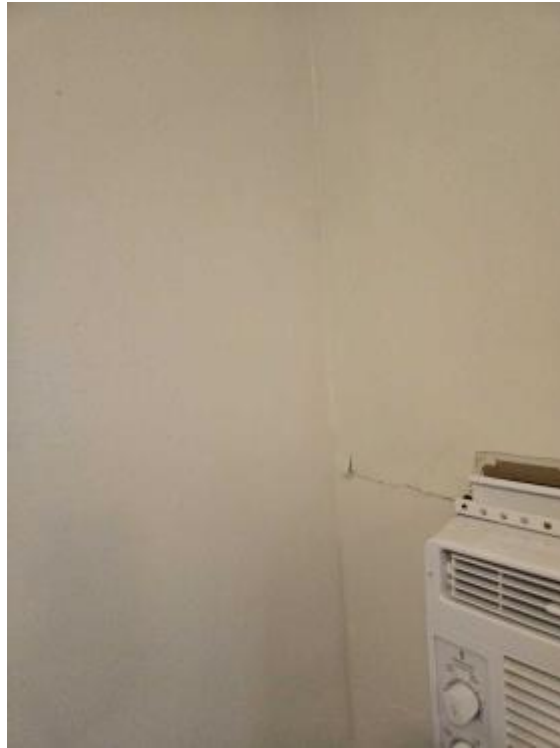
80 ECR-NEW - 80-Prayer Room

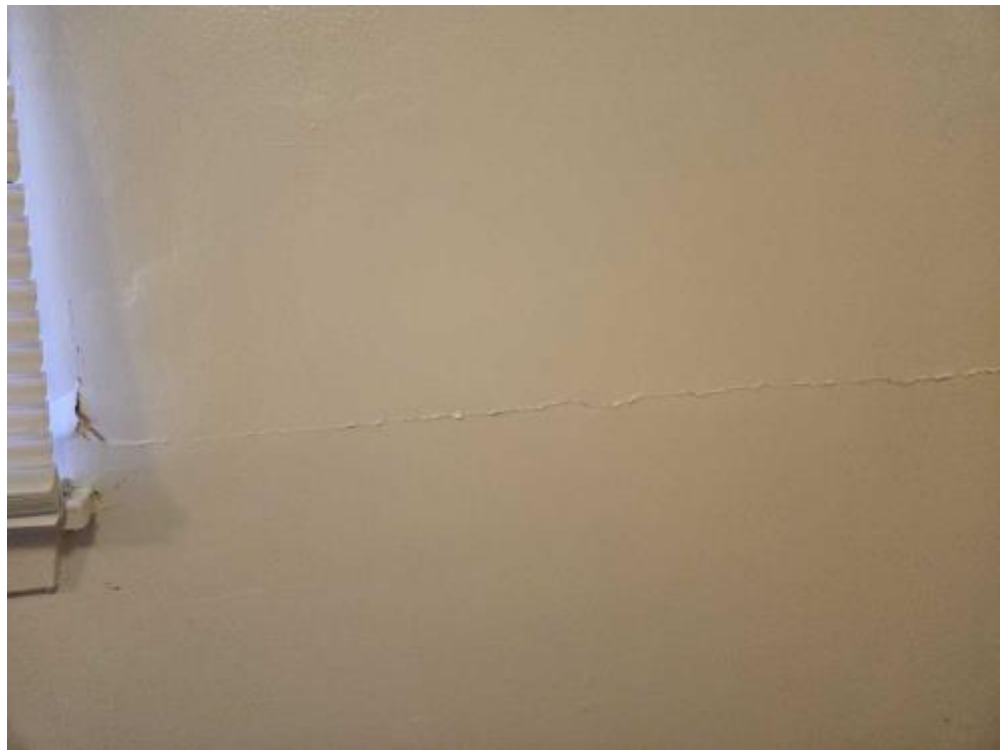
Estimated Cost of Repairs

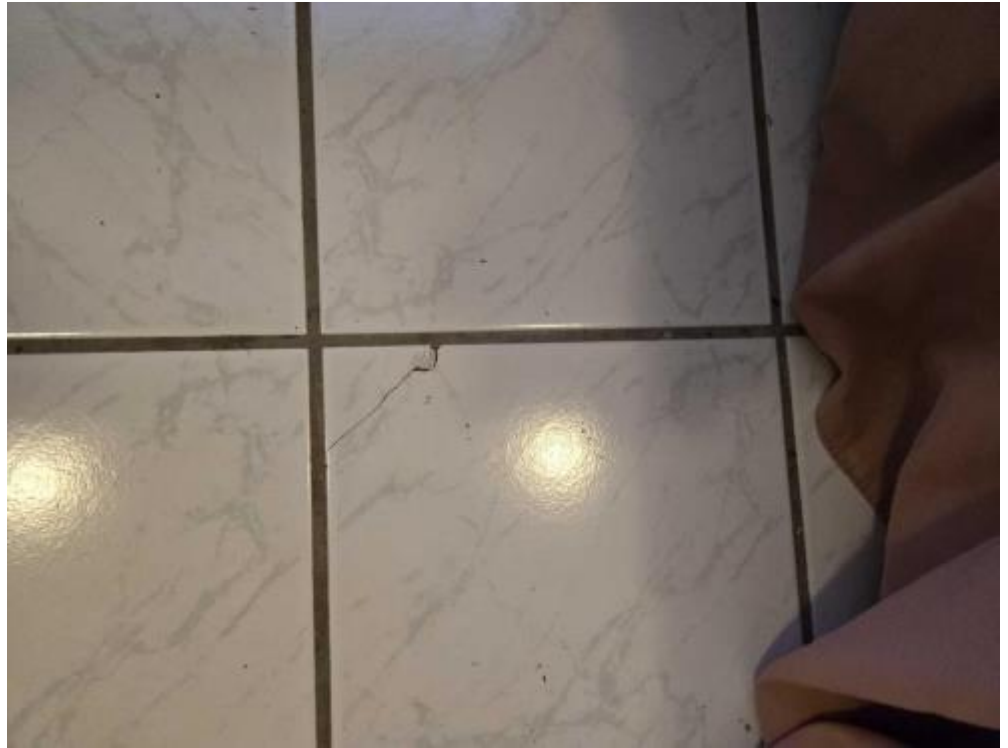
82 ECR-NEW - 82-HVAC

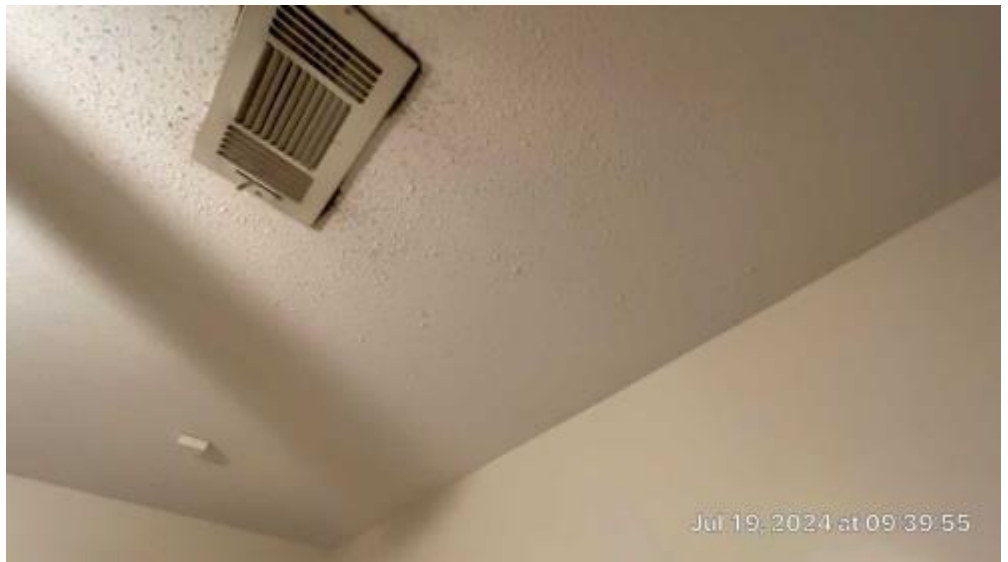
Estimated Cost of Repairs

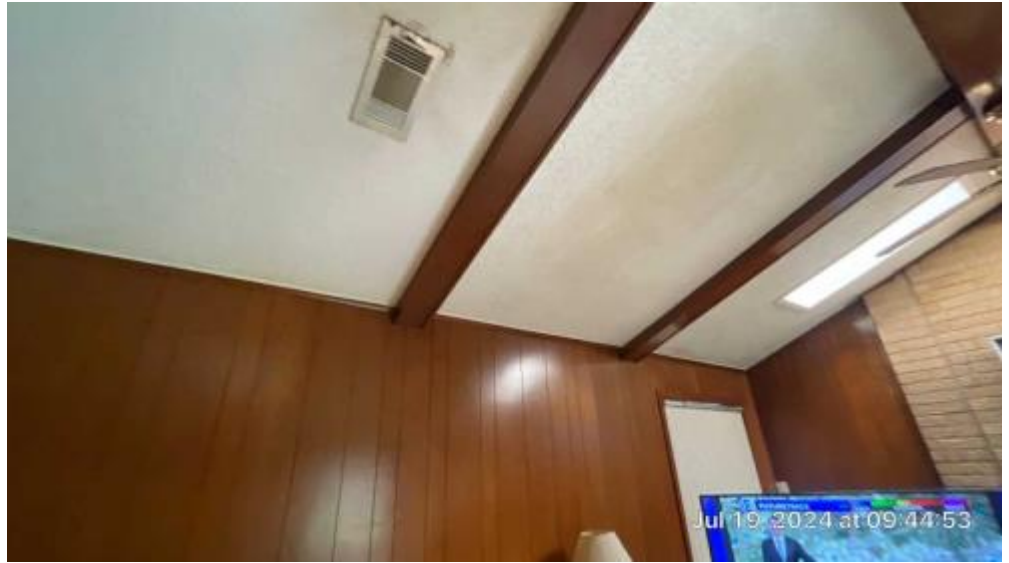
84 ECR-NEW - 84-HVAC

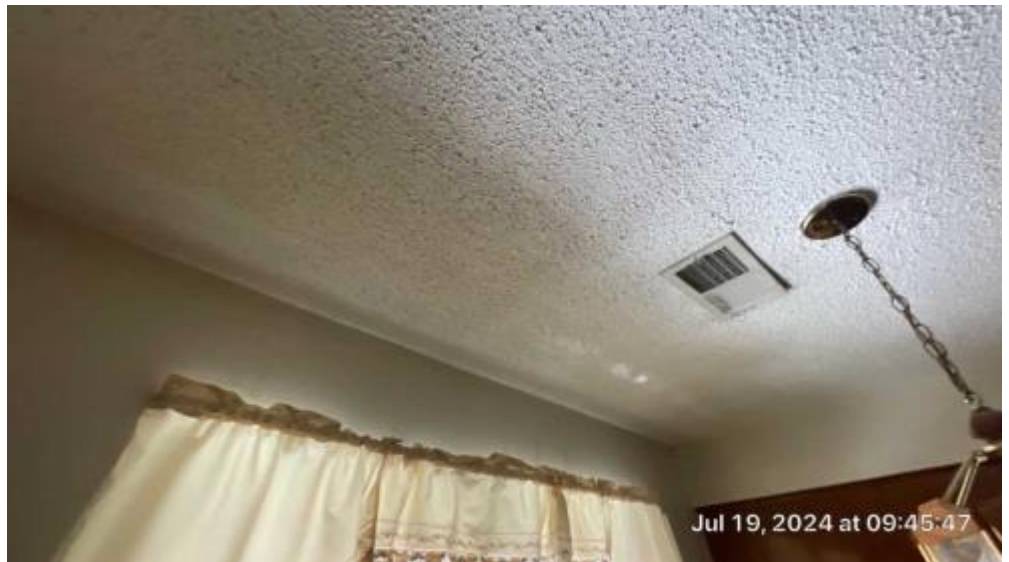
Estimated Cost of Repairs

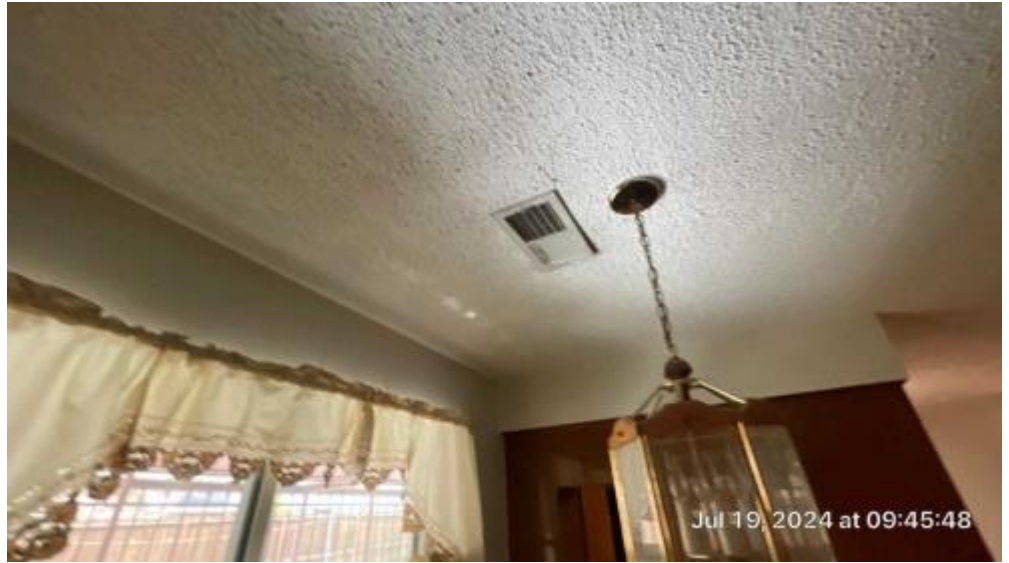
86 ECR-NEW - 86-HVAC

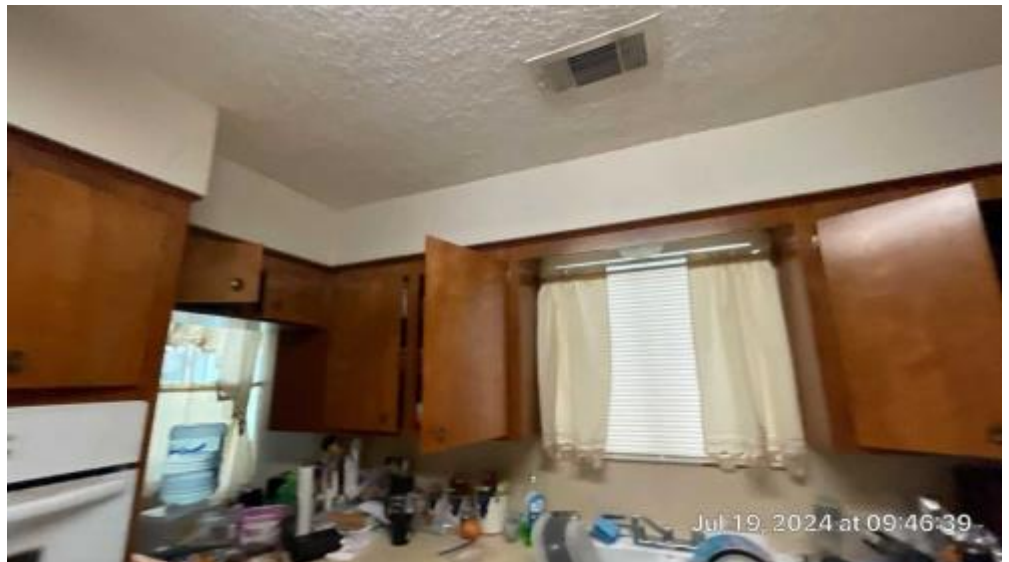
Estimated Cost of Repairs

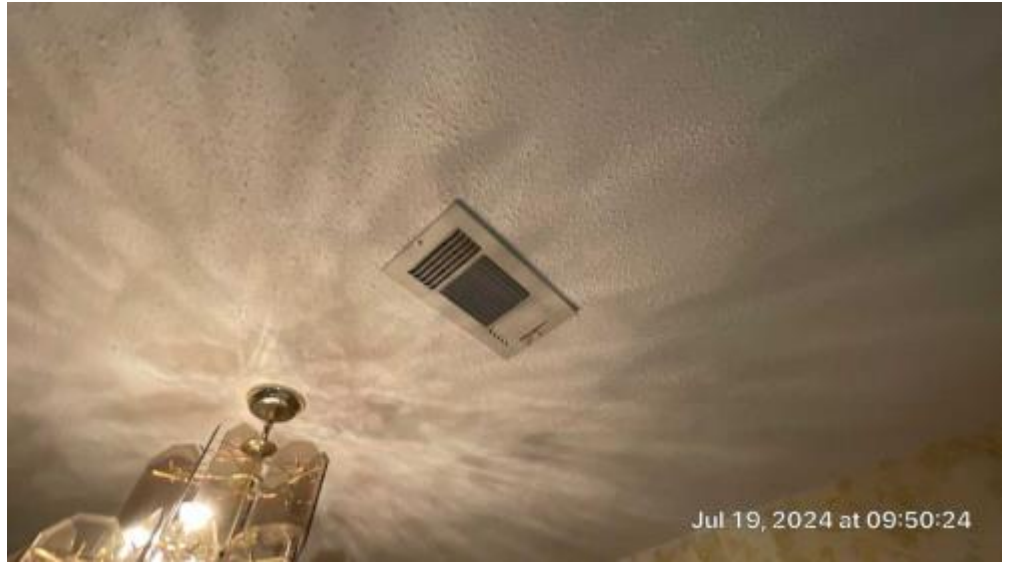
88 ECR-NEW - 88-HVAC

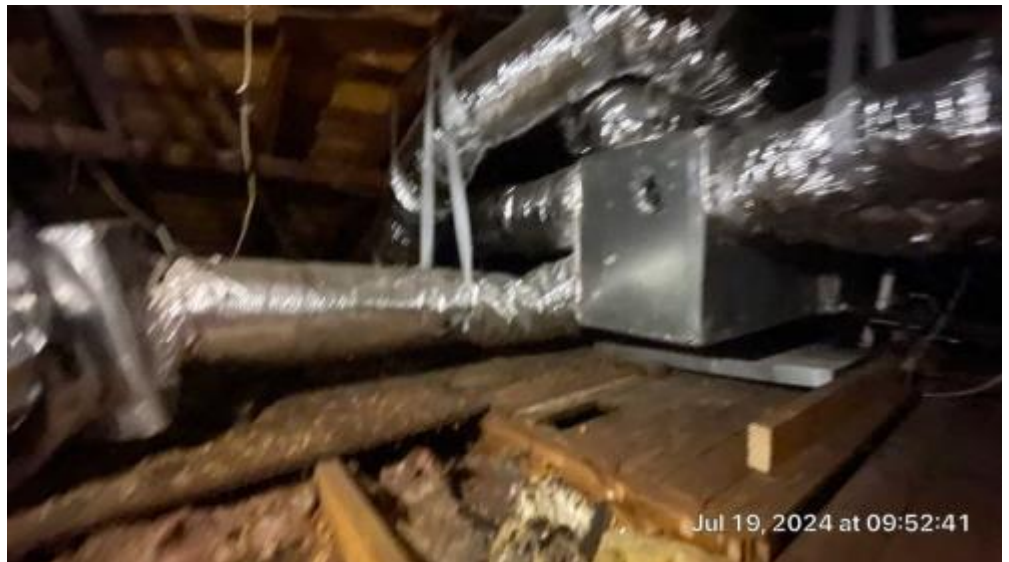
Estimated Cost of Repairs

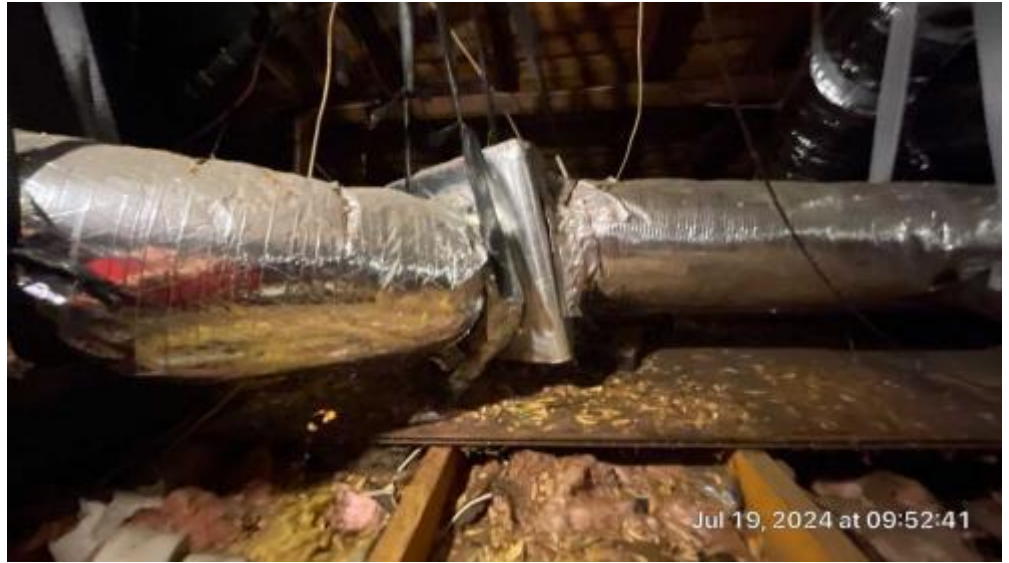
90 ECR-NEW - 90-Bathroom 2

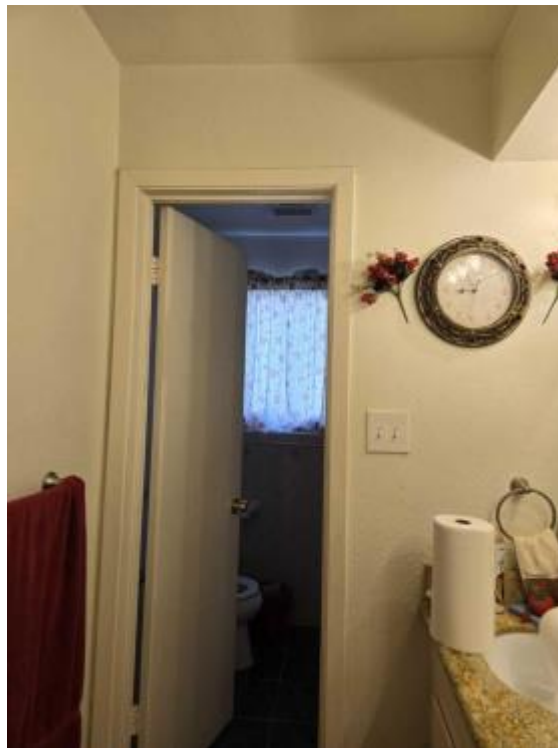
Estimated Cost of Repairs

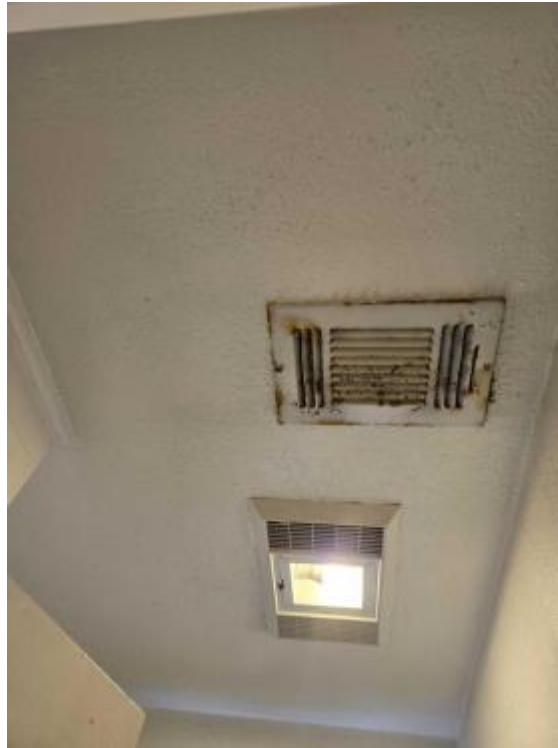
92 ECR-NEW - 92-Bathroom 2

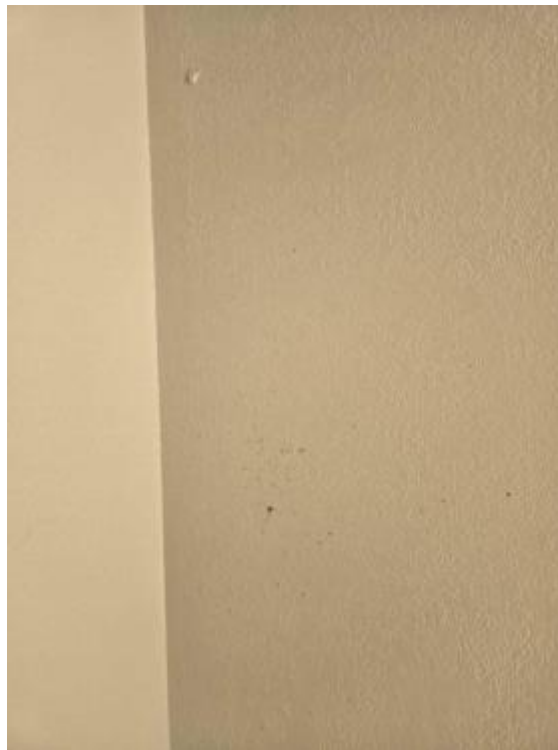
Estimated Cost of Repairs

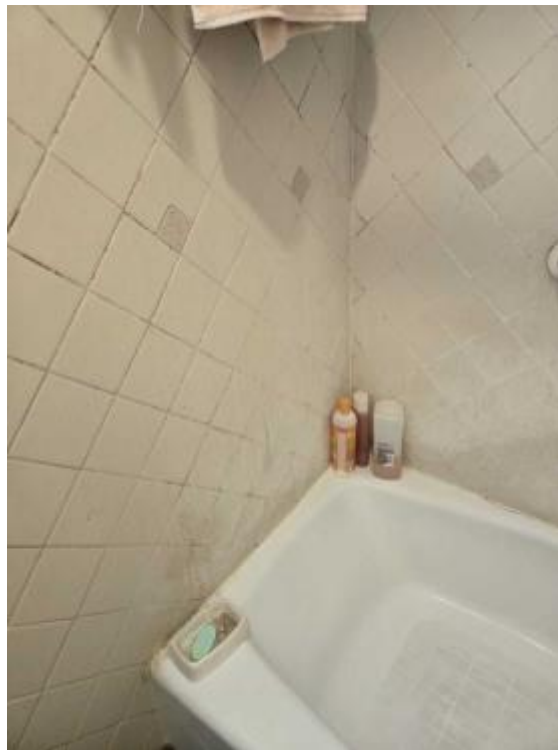
Estimated Cost of Repairs
