CERTIFICATE OF APPROPRIATENESS

Applicant: Jessie Enander, agent for, Bennie Davis, owner

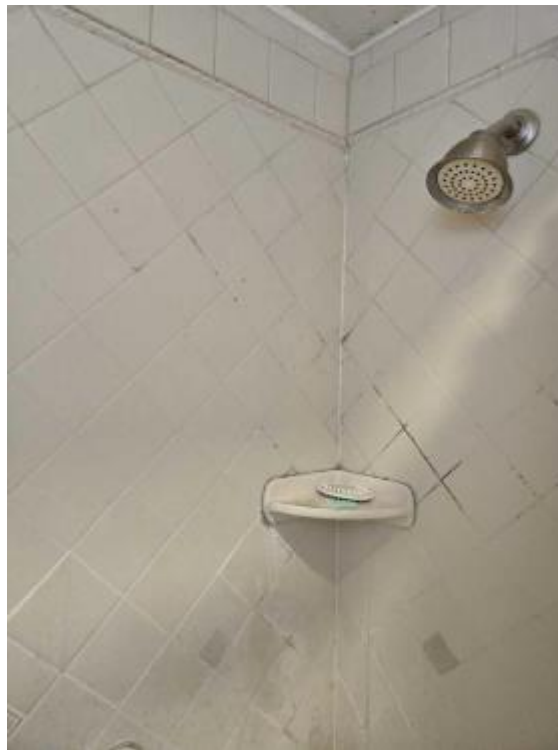
Estimated Cost of Repairs

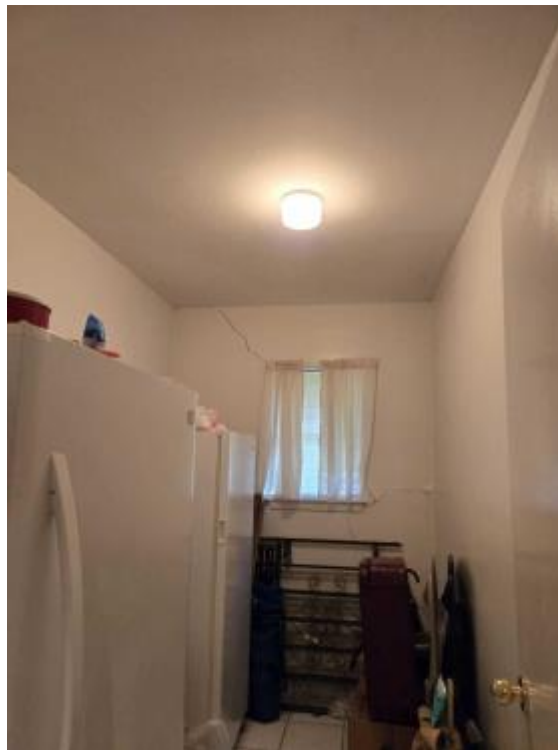
Estimated Cost of Repairs

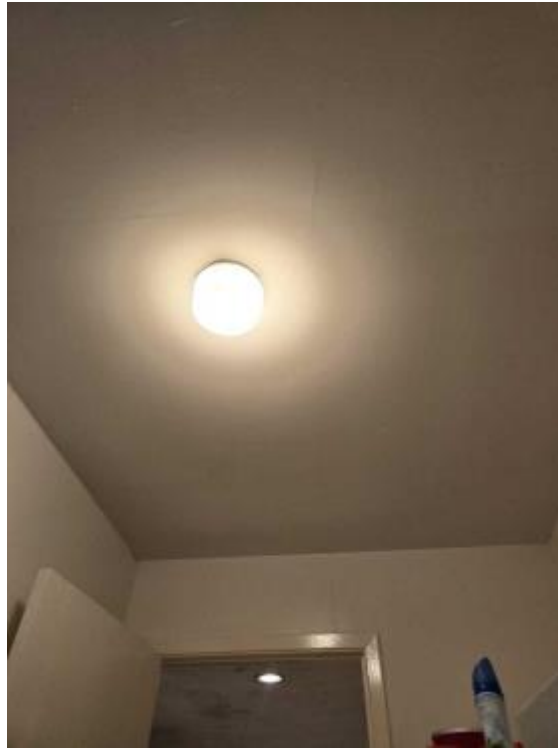
100 ECR-NEW - 100-Freezer Room

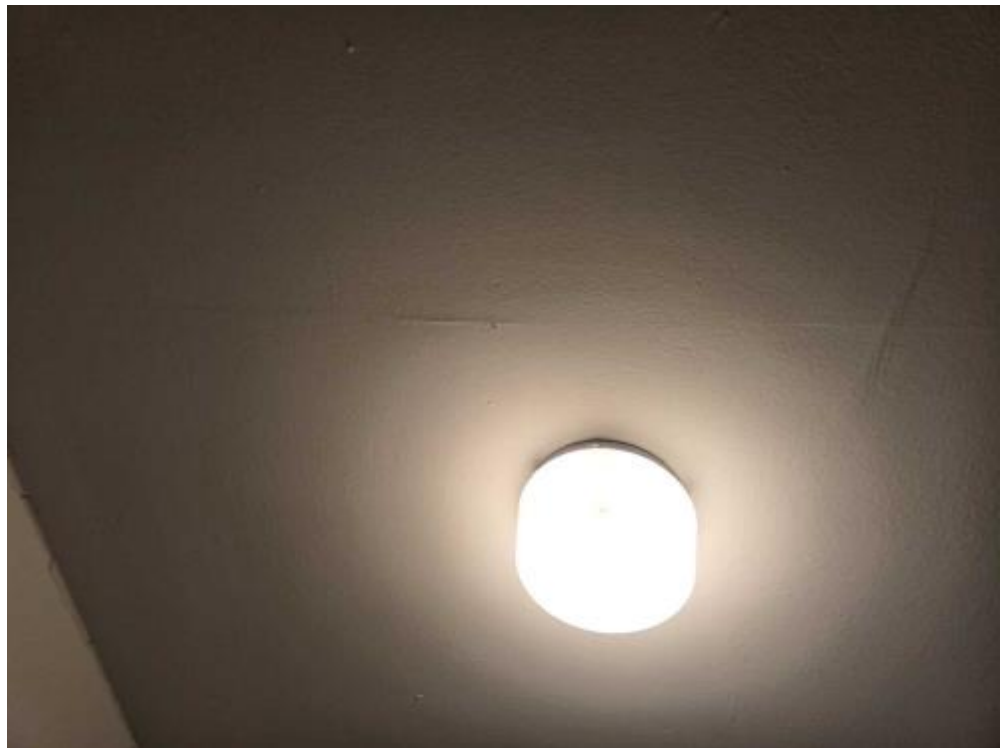
Estimated Cost of Repairs

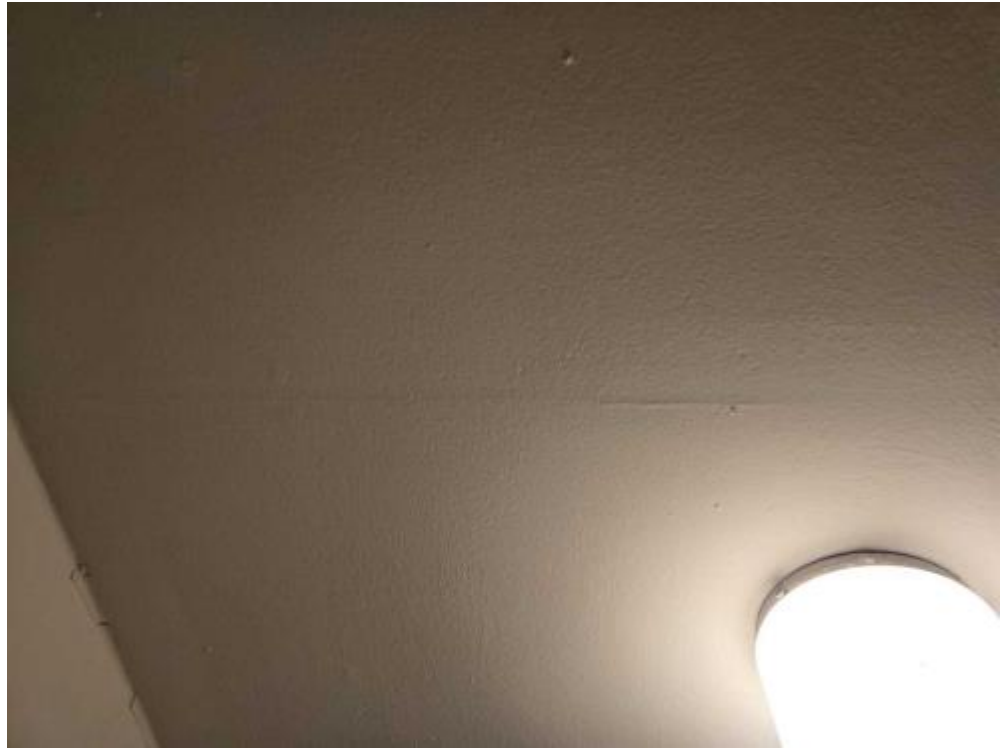
102 ECR-NEW - 102-Freezer Room

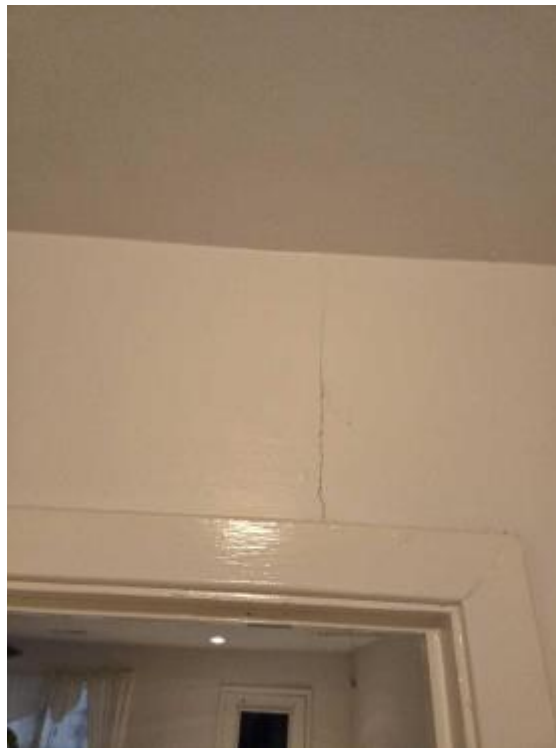
Estimated Cost of Repairs

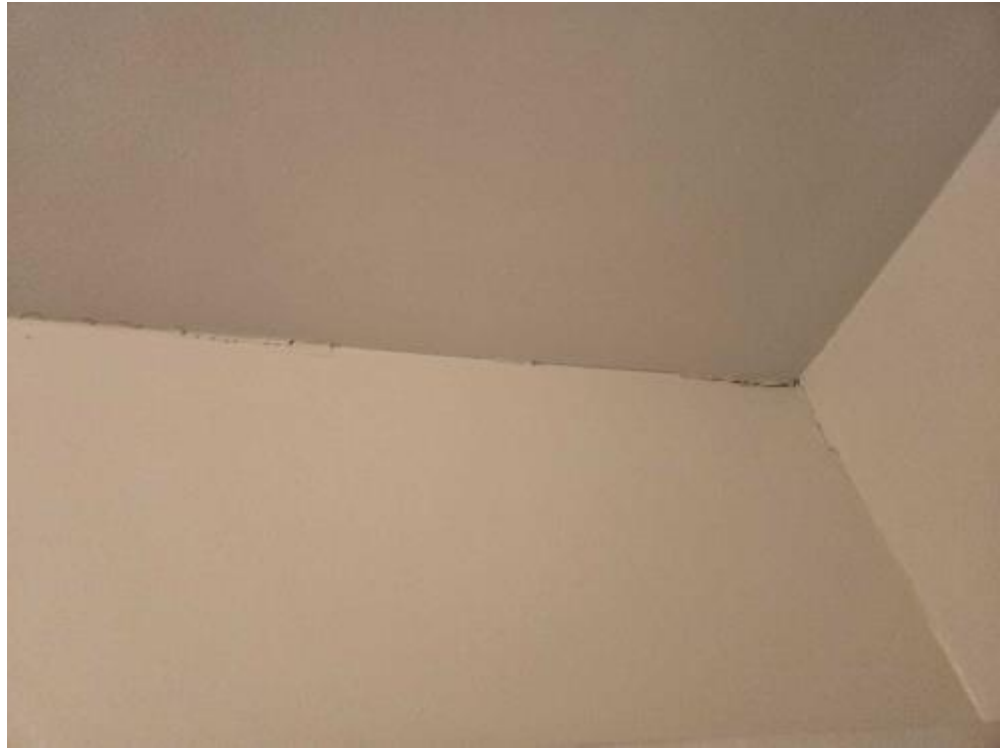
104 ECR-NEW - 104-Freezer Room

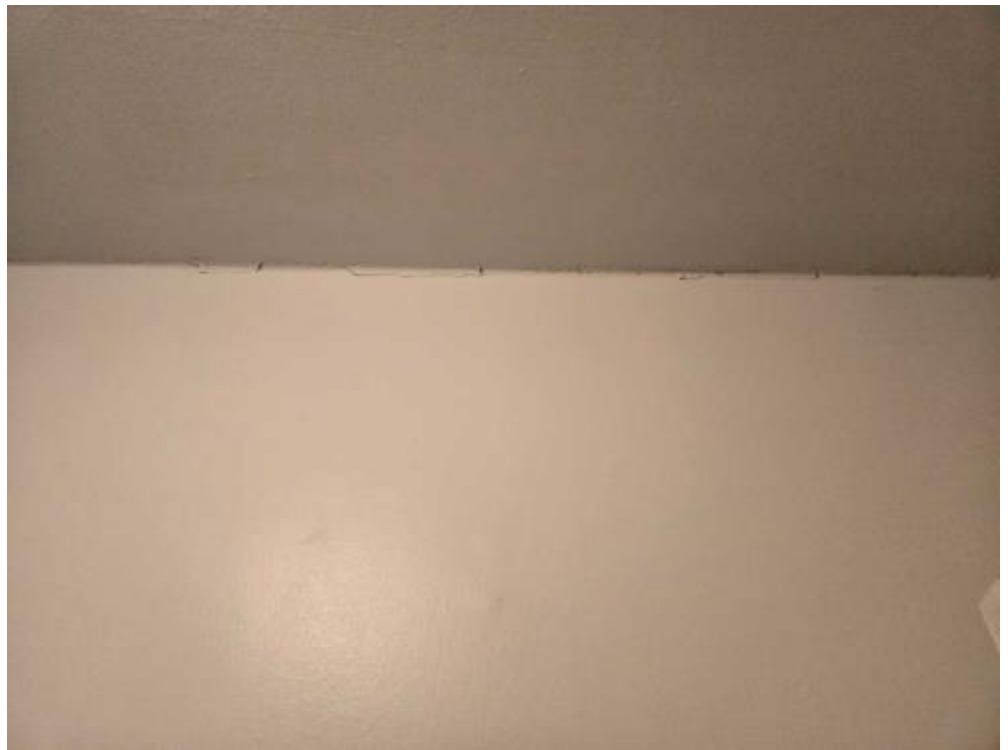
Estimated Cost of Repairs

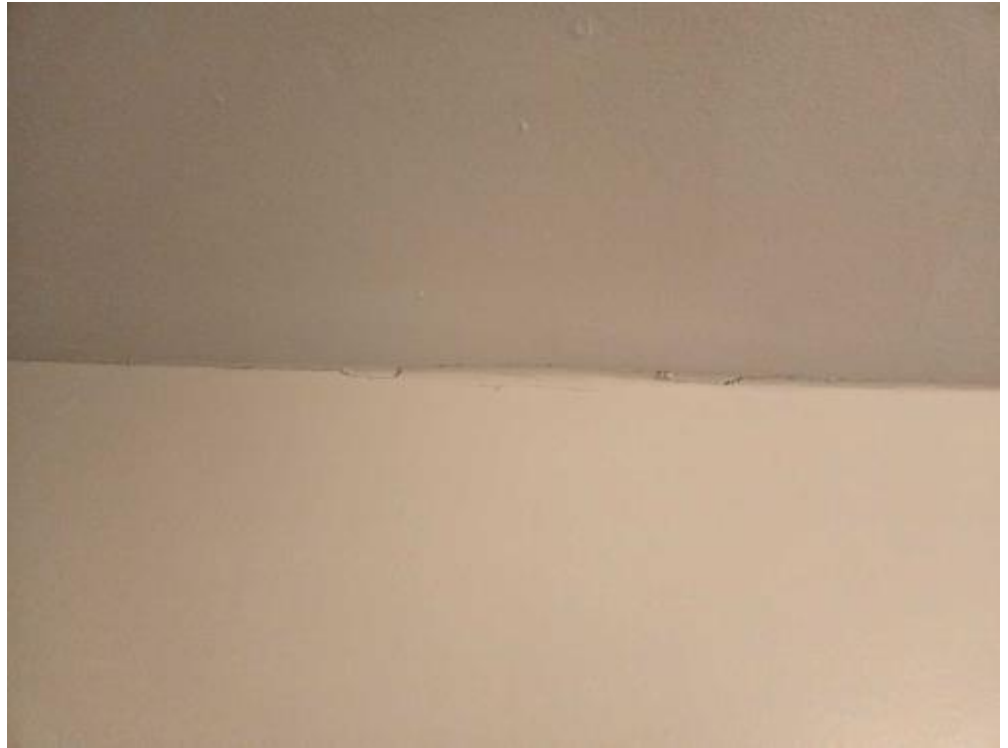
106 ECR-NEW - 106-Freezer Room

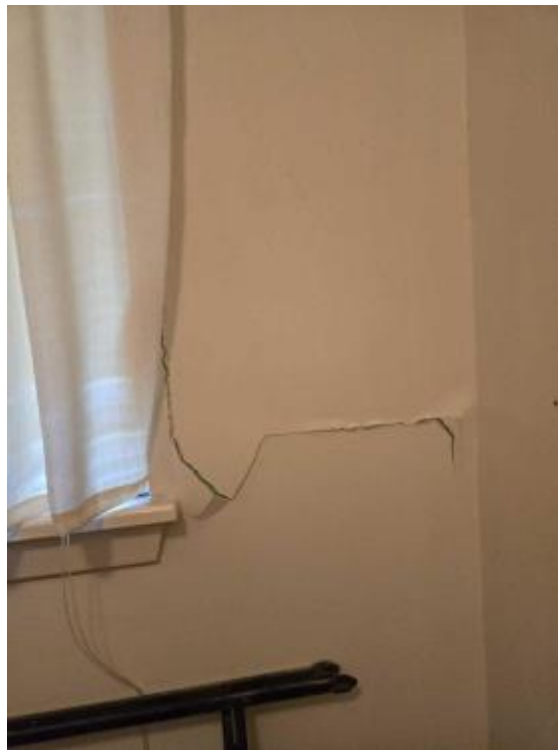
Estimated Cost of Repairs

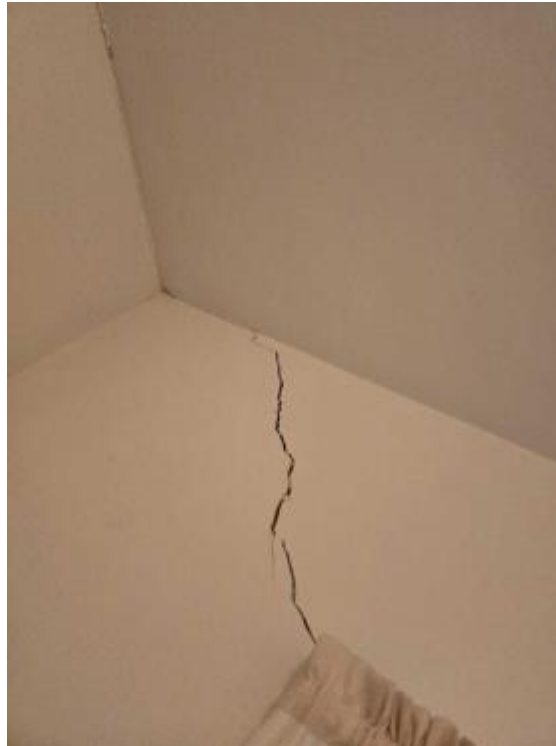
108 ECR-NEW - 108-Gym

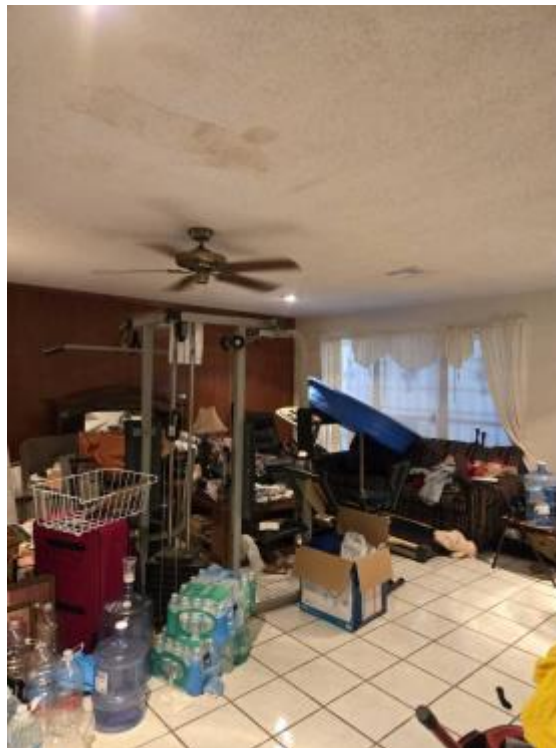
Estimated Cost of Repairs

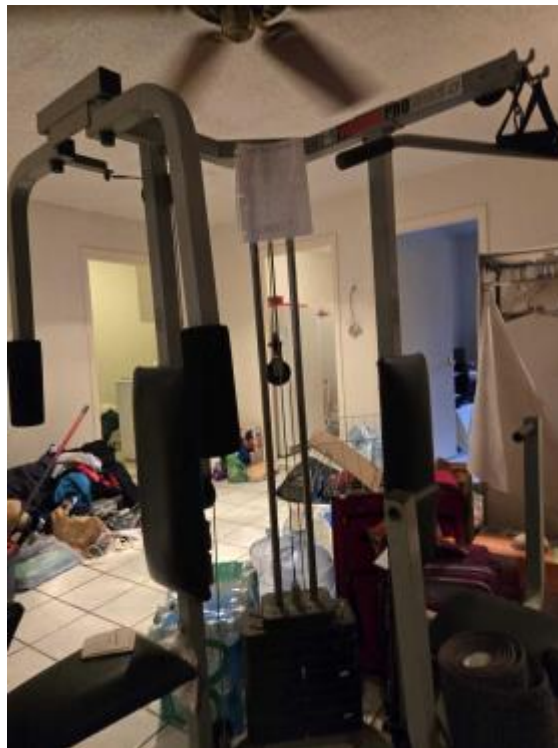
Estimated Cost of Repairs

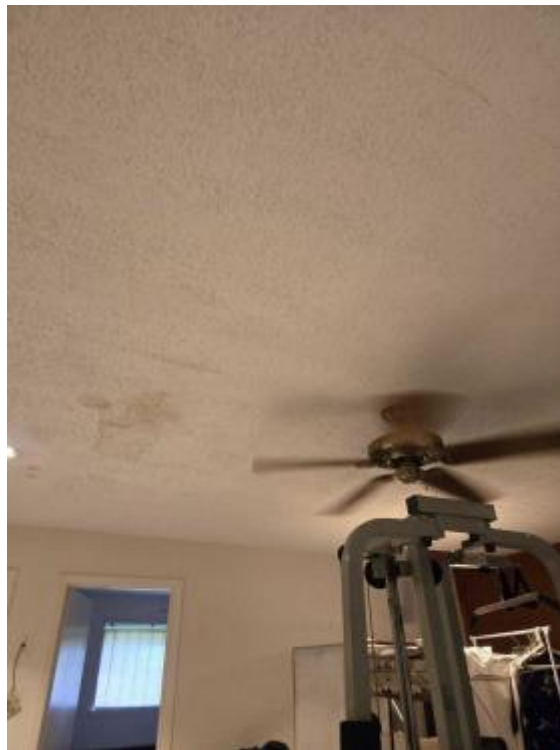
Estimated Cost of Repairs

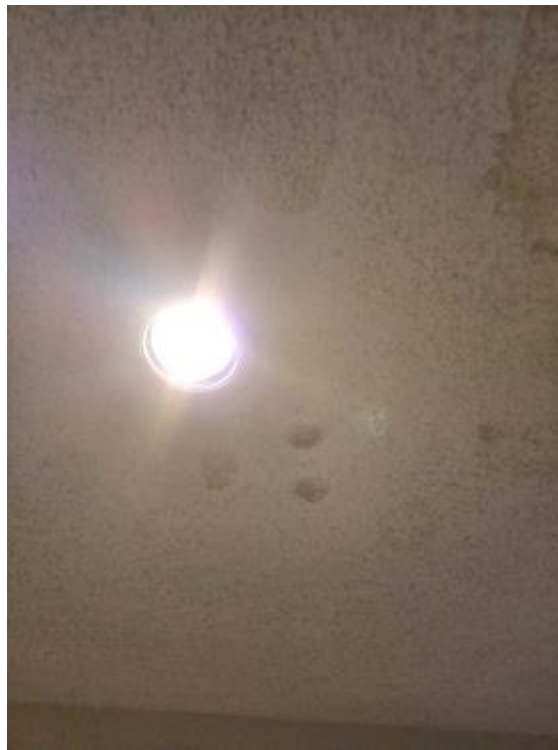
Estimated Cost of Repairs
