**CERTIFICATE OF APPROPRIATENESS**

**Property:** 405 Main Street, Lot 10, Tracts 9 & 11A, Block 45, SSBB Subdivision. The property includes a historic 89,712 square foot commercial building situated on an 8,687 square foot corner lot.

**Proposal:** Alteration – Remove fire escape and repair masonry

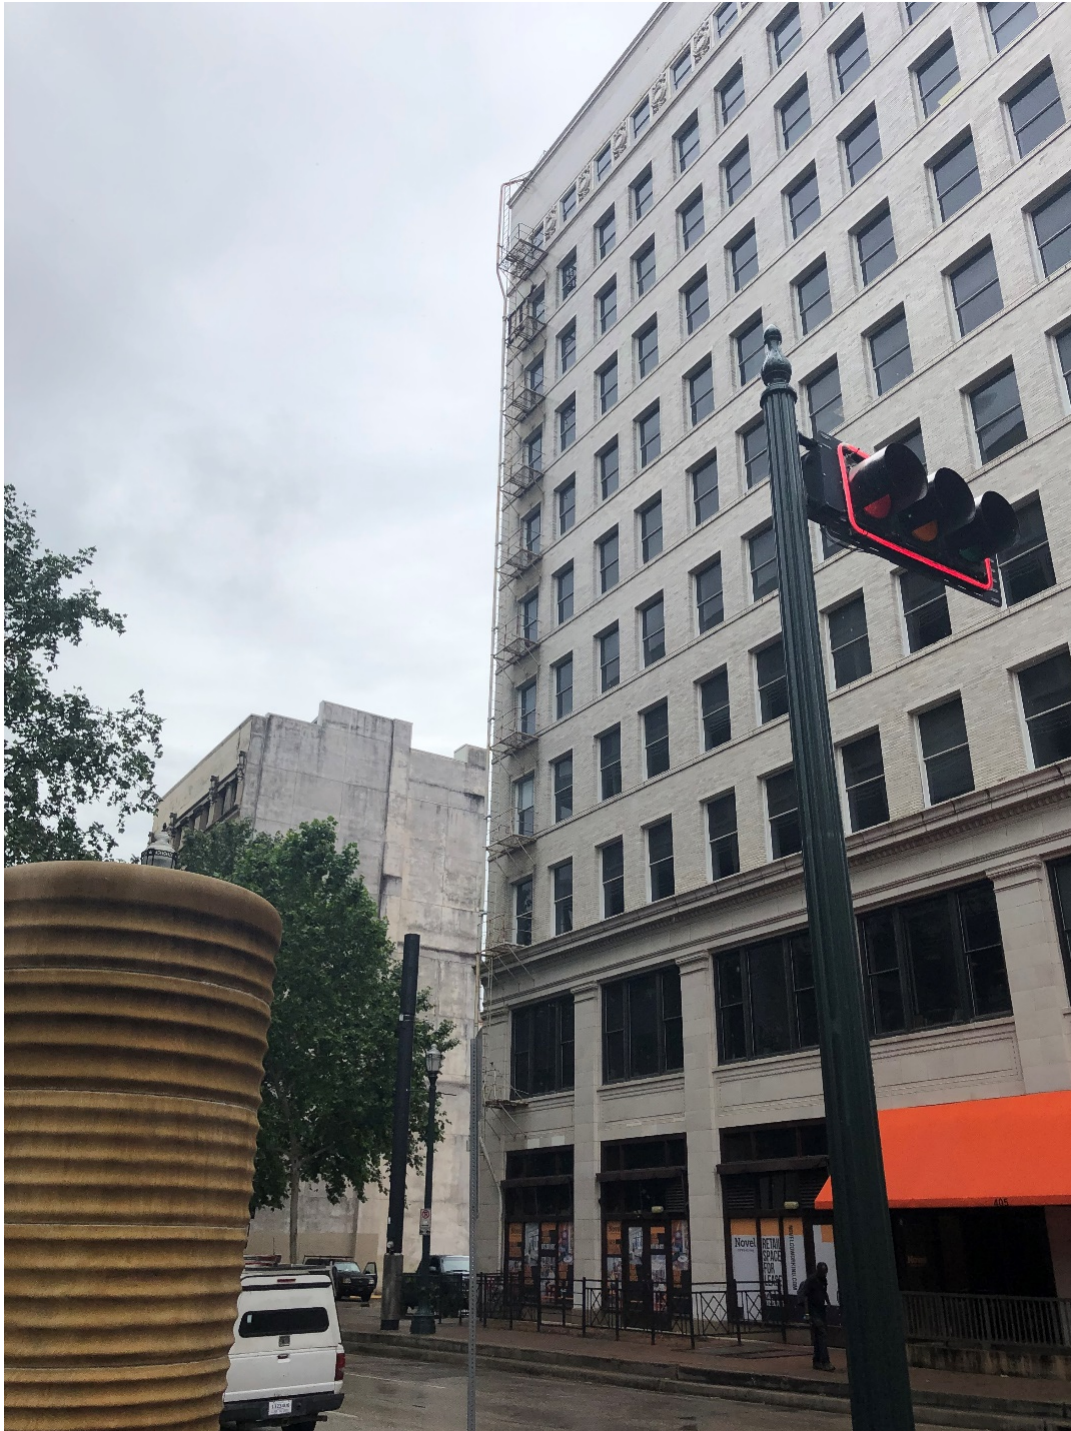
Photo 1: Far view of fire escape.

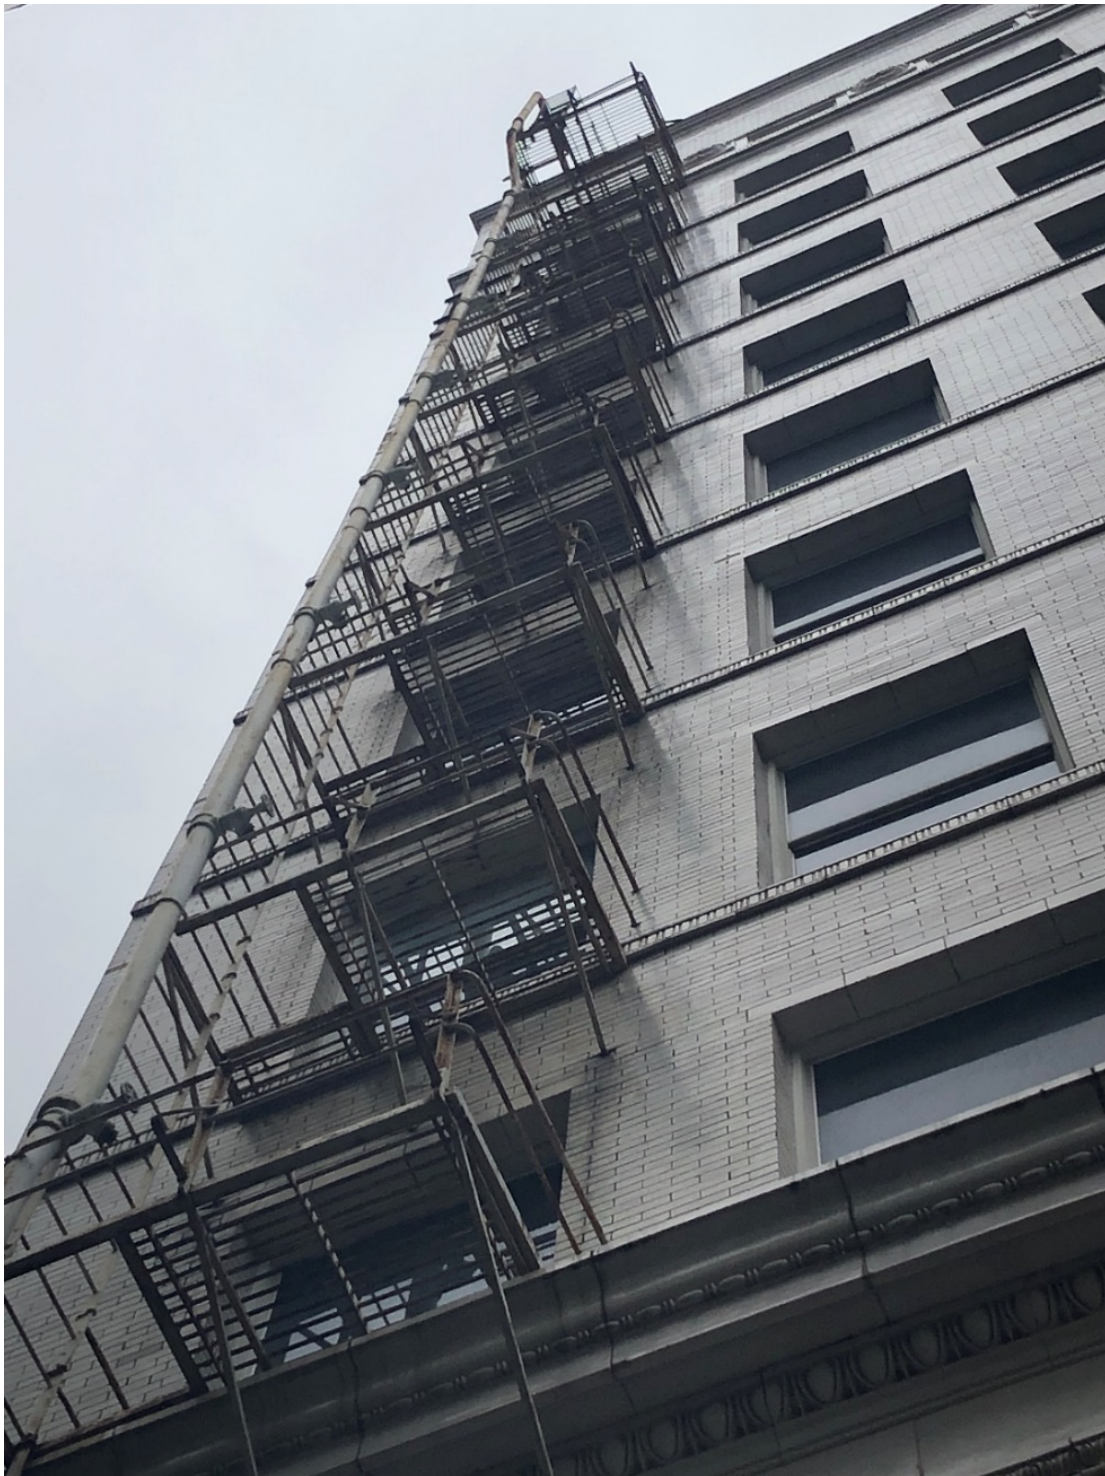
Photo 2: Closer view of fire escape to be removed.

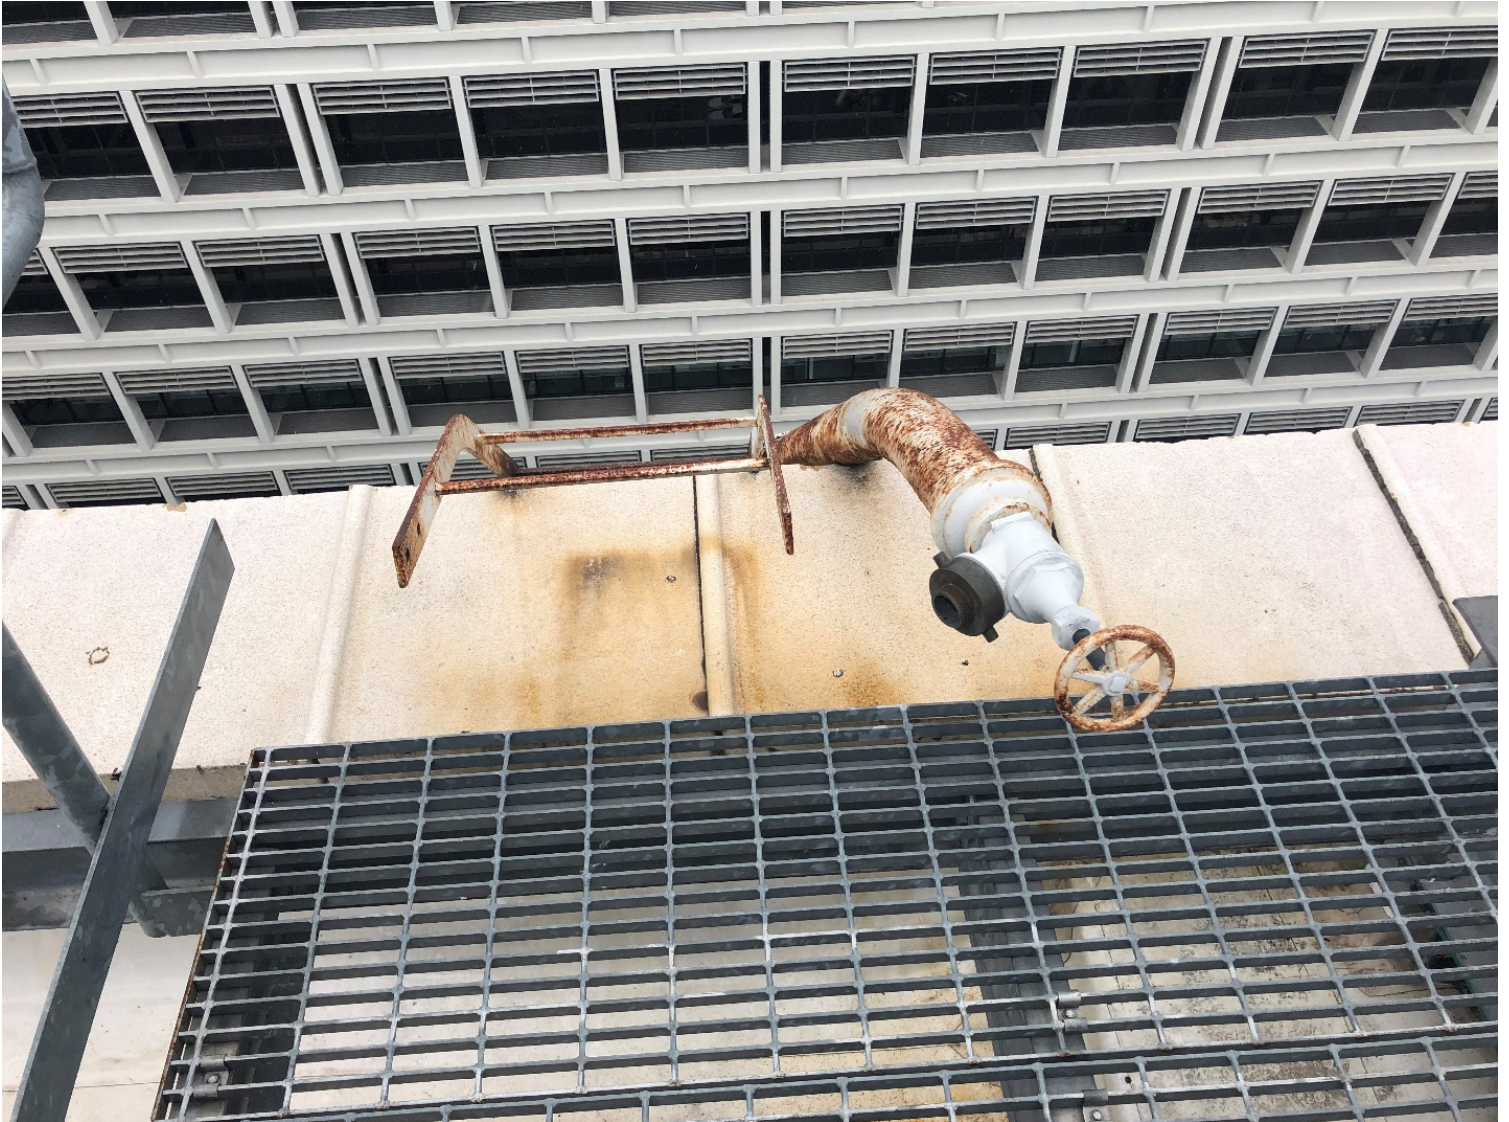
Photo 3: Top view of inoperable fire escape.

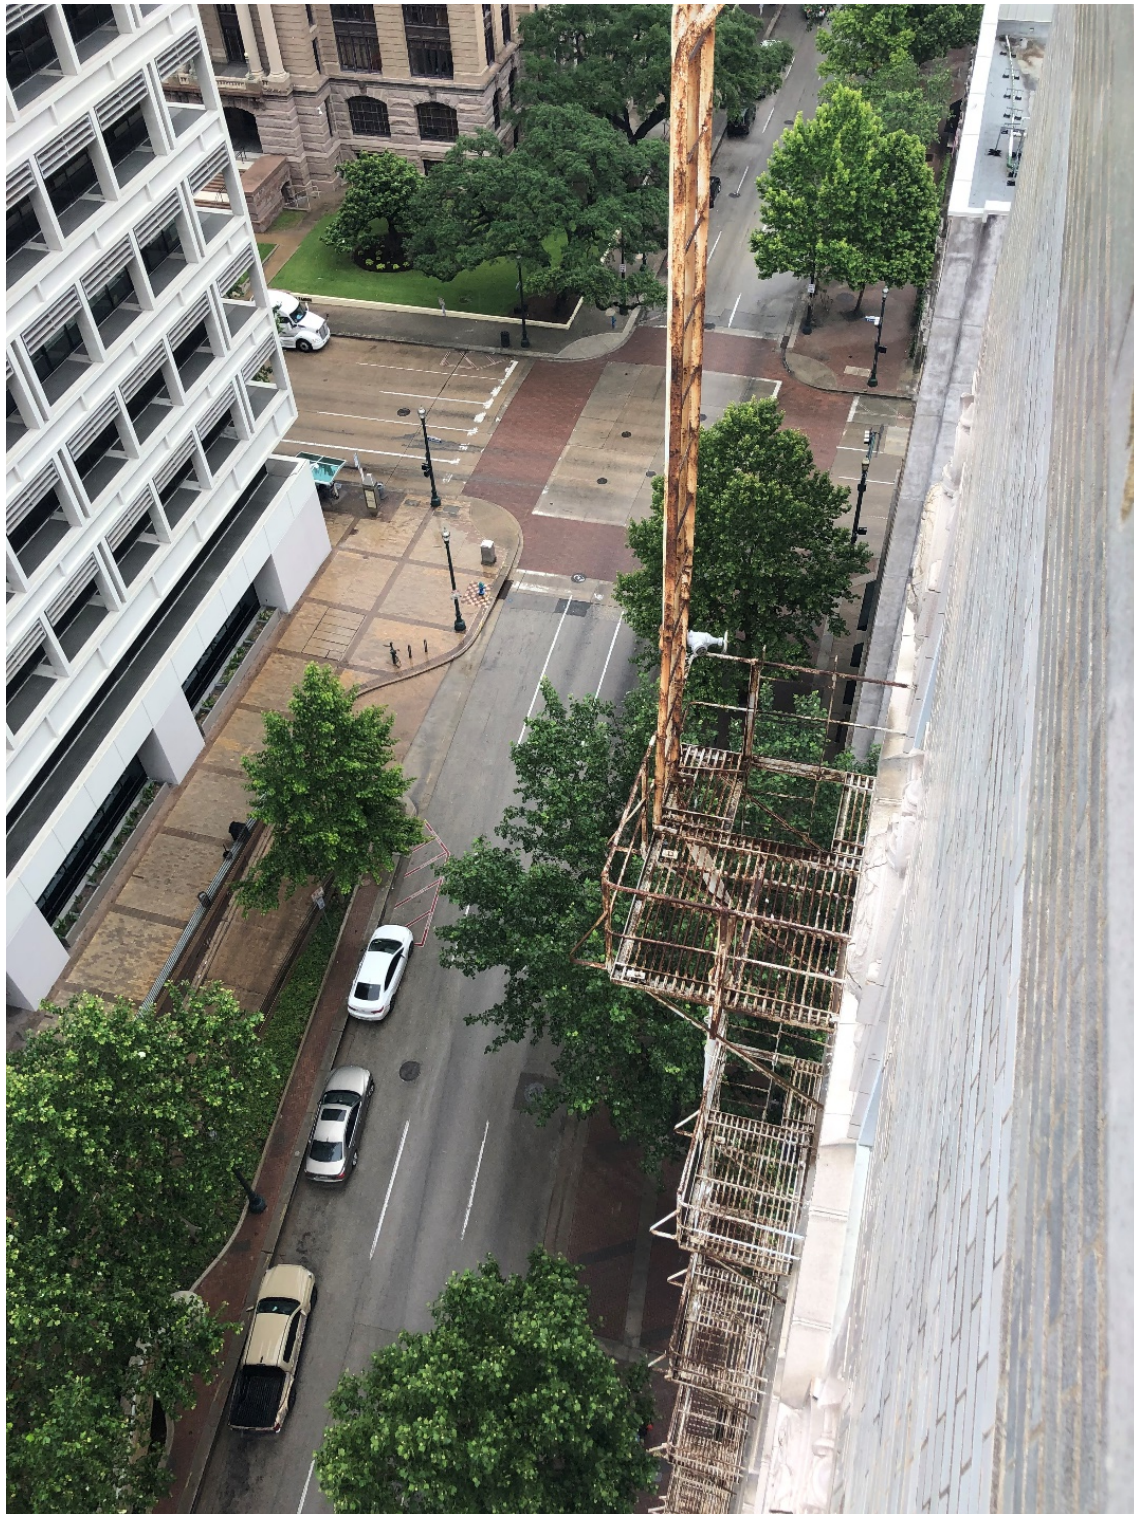
Photo 4: Another view of the fire escape.

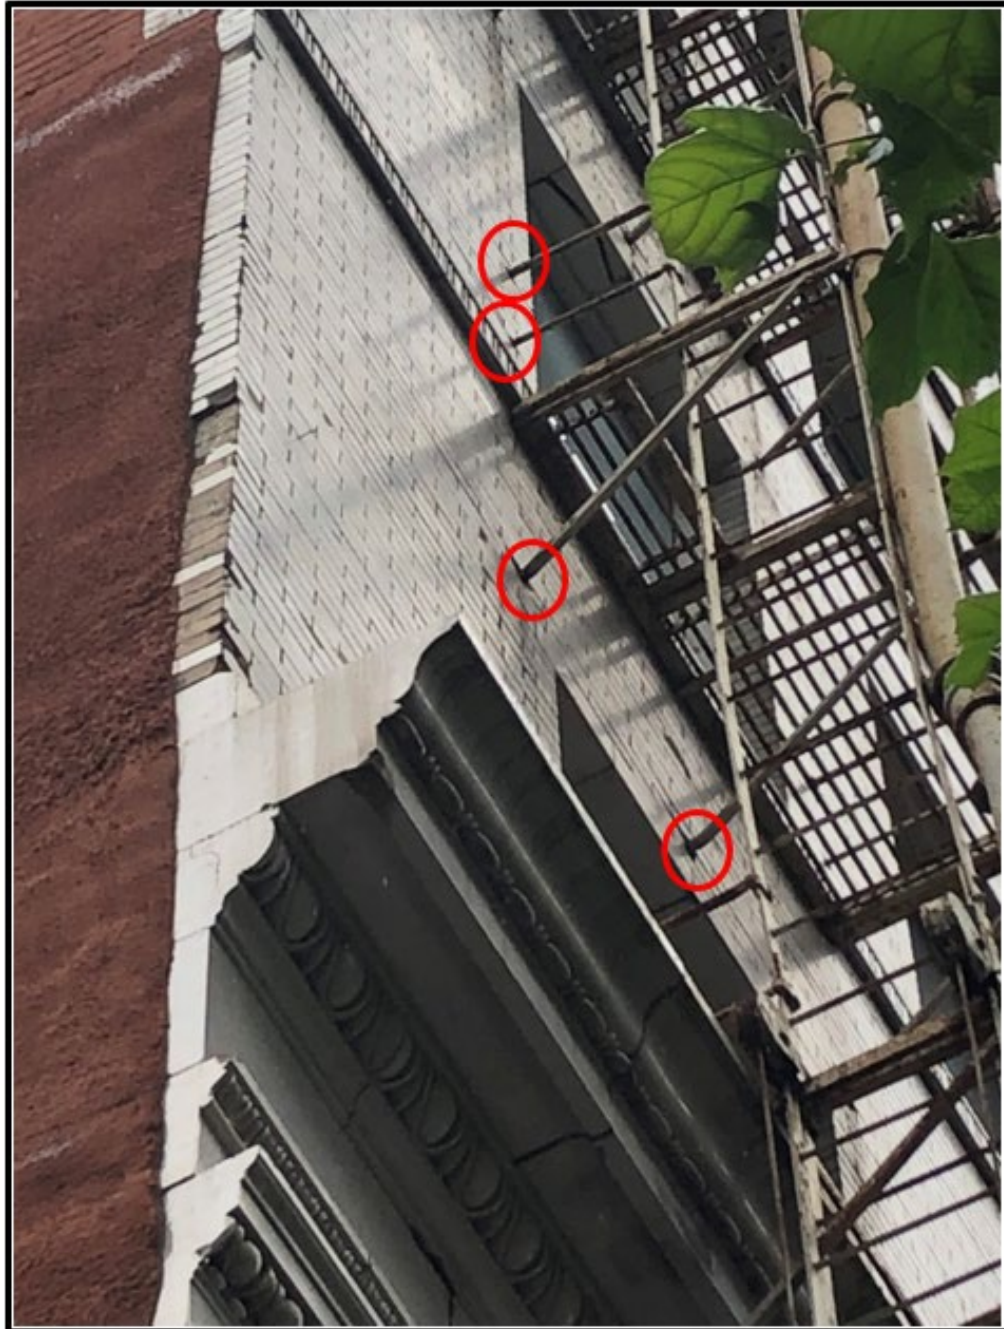
Photo 5: Representation of areas where the brick will be removed and replaced with a matching brick unit. A mortar sample will be sent in to match the existing mortar.

1. Sending in mortar samples to determine the chemical makeup of the mortar and matching color. This will allow Western to match the existing mortar restoring it to its original condition.
2. Removing and disposing of the existing fire escape.
3. Remove and replace masonry units with holes in them with matching units.
4. Tuckpoint back missing mortar.
