**CERTIFICATE OF APPROPRIATENESS**

**Property:** 602 Highland Street Lot 1, Block 29, Woodland Heights Subdivision. The property includes a historic 1,243 square foot one story single-family residence situated on a 5,000 square foot (50' x 100') corner lot.

**Significance:** Contributing Bungalow residence, constructed circa 1920, located in the Woodland Heights Historic District.

**Proposal:** Alteration – Repair, Replace, Relocate windows/doors/openings with Rear Addition

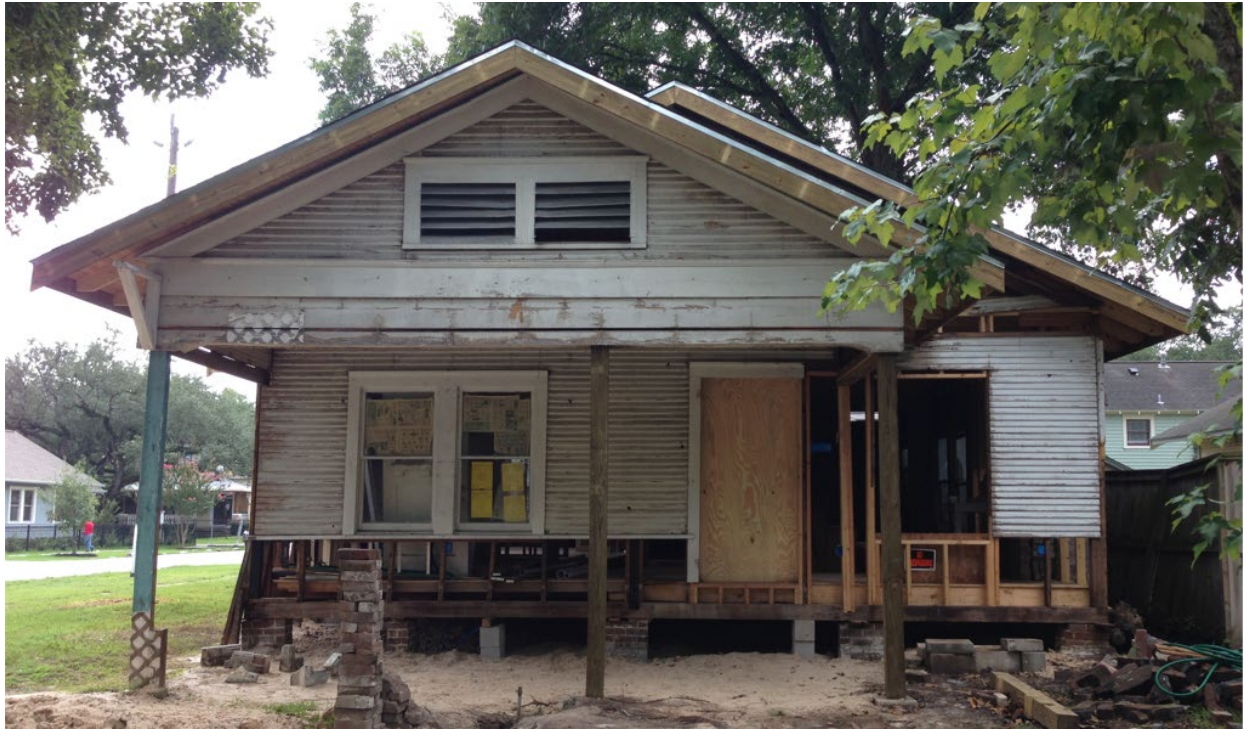
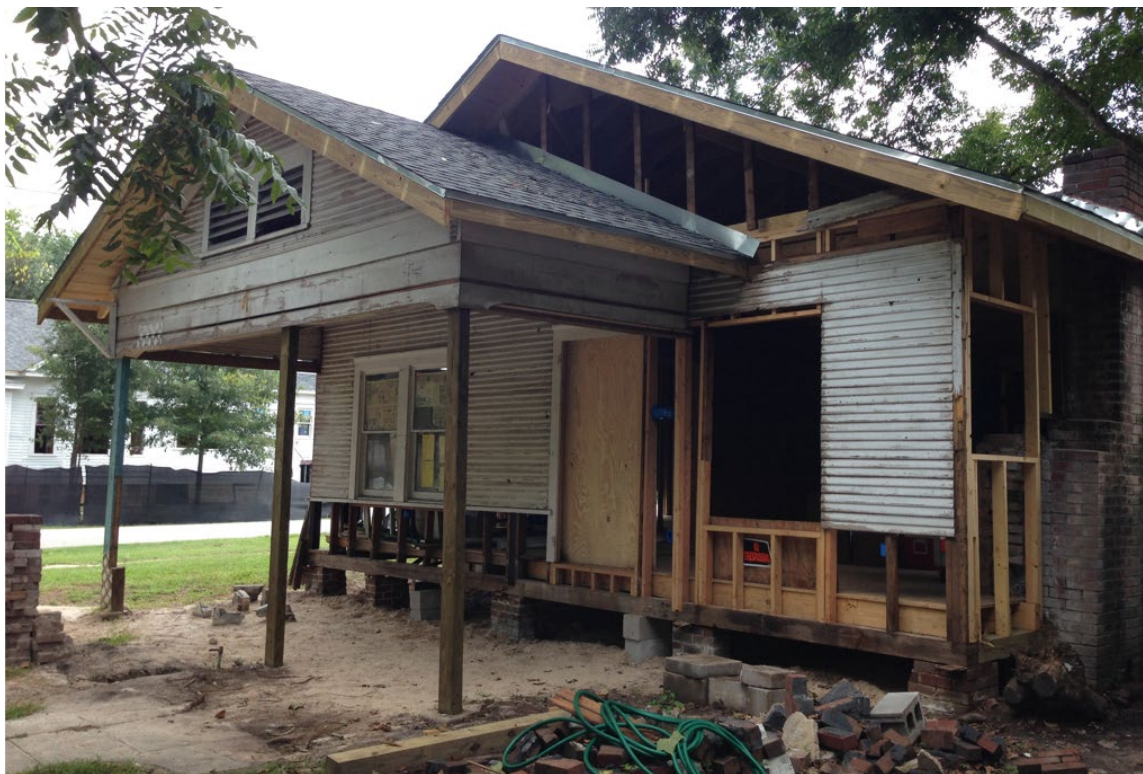
**PHOTOS OF RESTORATION/REHABILITATION C.2014**

**red tagged for exceeding structural/siding scope of work**

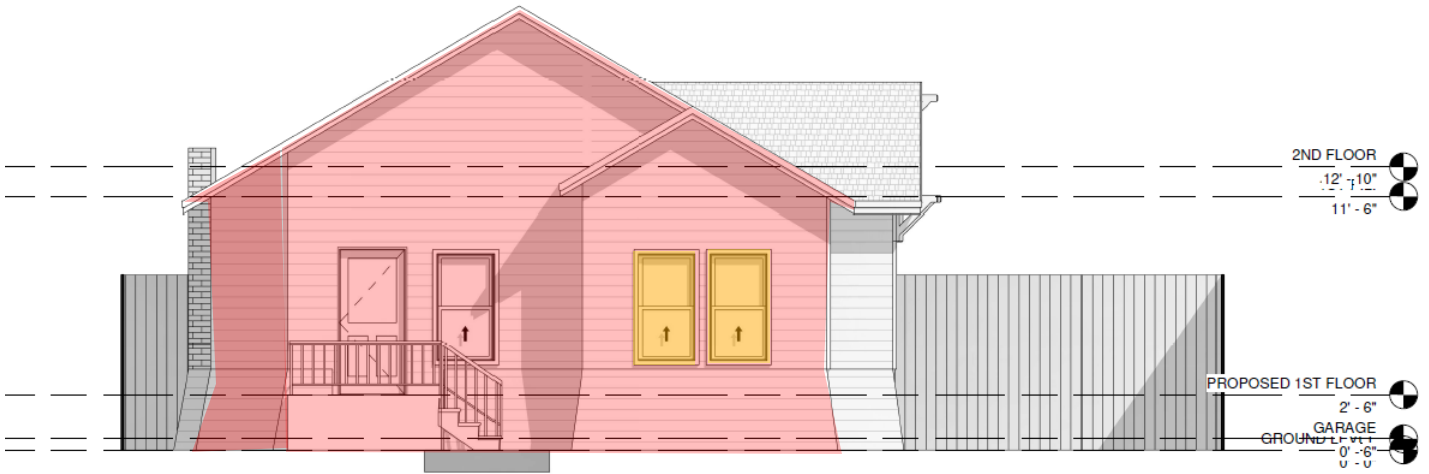
### SOUTH SIDE ELEVATION (REAR)

EXISTING \*rear windows to be relocated to side elevation bump-out (11,10)

11,10 \*RELOCATED TO EAST SIDE ELEVATION

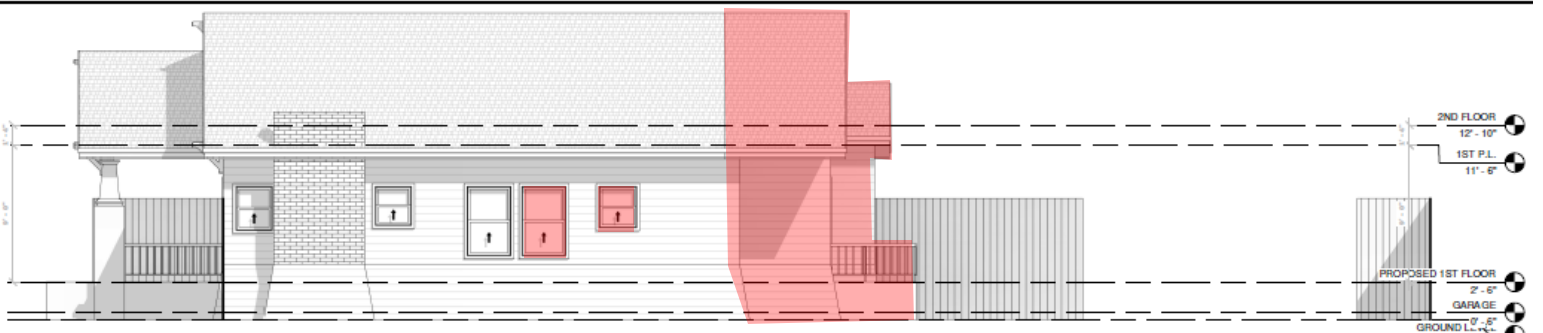
EAST SIDE ELEVATION

EXISTING – WINDOWS 14, 15 PROPOSED TO BE ENCLOSED FOR CLOSET

WINDOWS: 17, 16, 15, 14, 13 – REMOVE TWO HISTORIC WINDOWS (INTERIOR/REAR)

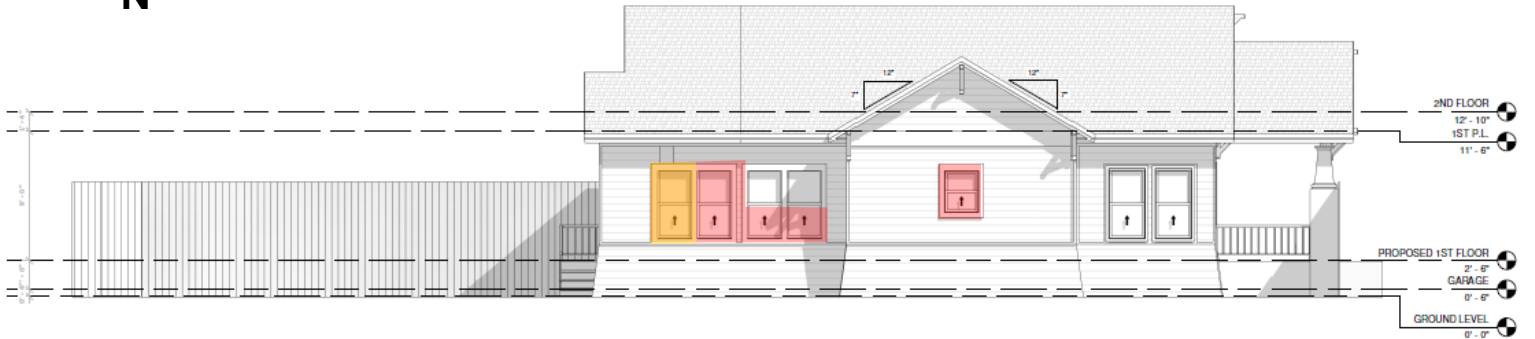
WEST SIDE ELEVATION  
EXISTING

WINDOWS: 9,8,7,6      5      4,3 (repair)

Window 9 relocated to bump out near 5, 8 removed, 7 and 6 shortened

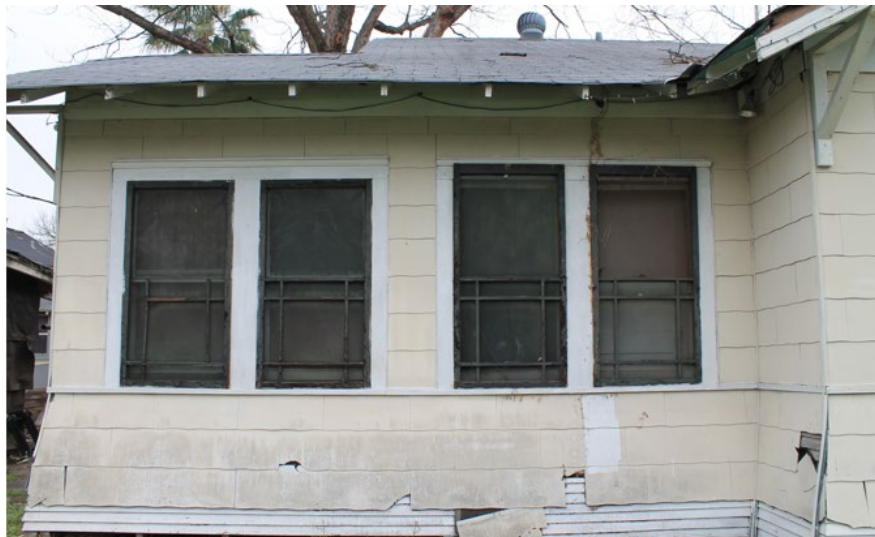
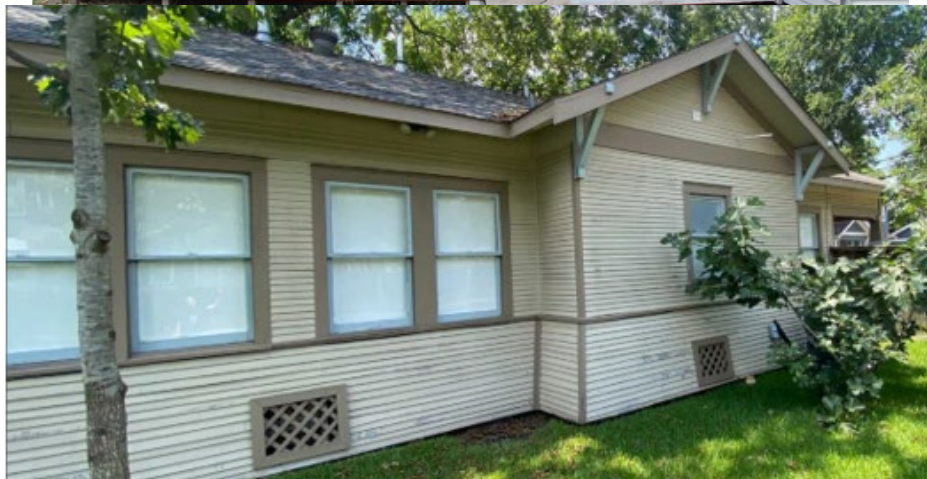
**WINDOW SCHEDULE – EAST SIDE ELVATION ALTERATIONS**

**WINDOWS: 10,9,8,7,6 PROPOSED REMOVAL & REPLACEMENT WITH 11,10,9 from side and rear**

**Historic windows restored c. 2014**

**Staff Recommends:** Repair of historic wood windows 7 and 6 on east elevation *or* relocate window 5 or 13 and find second window to match either one to relocate in openings of windows 7 and 6. Applicant to work with staff to confirm final paired windows in this location if historic materials cannot be found to match.

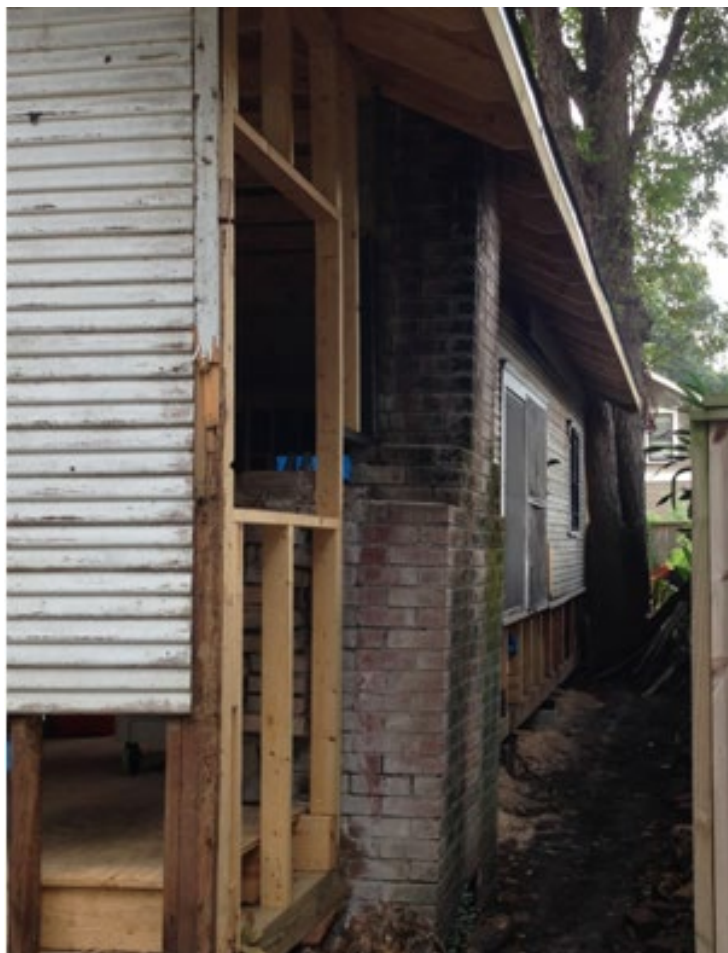
**WINDOW SCHEDULE – WEST SIDE ELVATION ALTERATIONS**

**WINDOWS: 14,13 PROPOSED REMOVAL AND CLOSED IN WITH SIDING**

Historic windows restored c. 2014

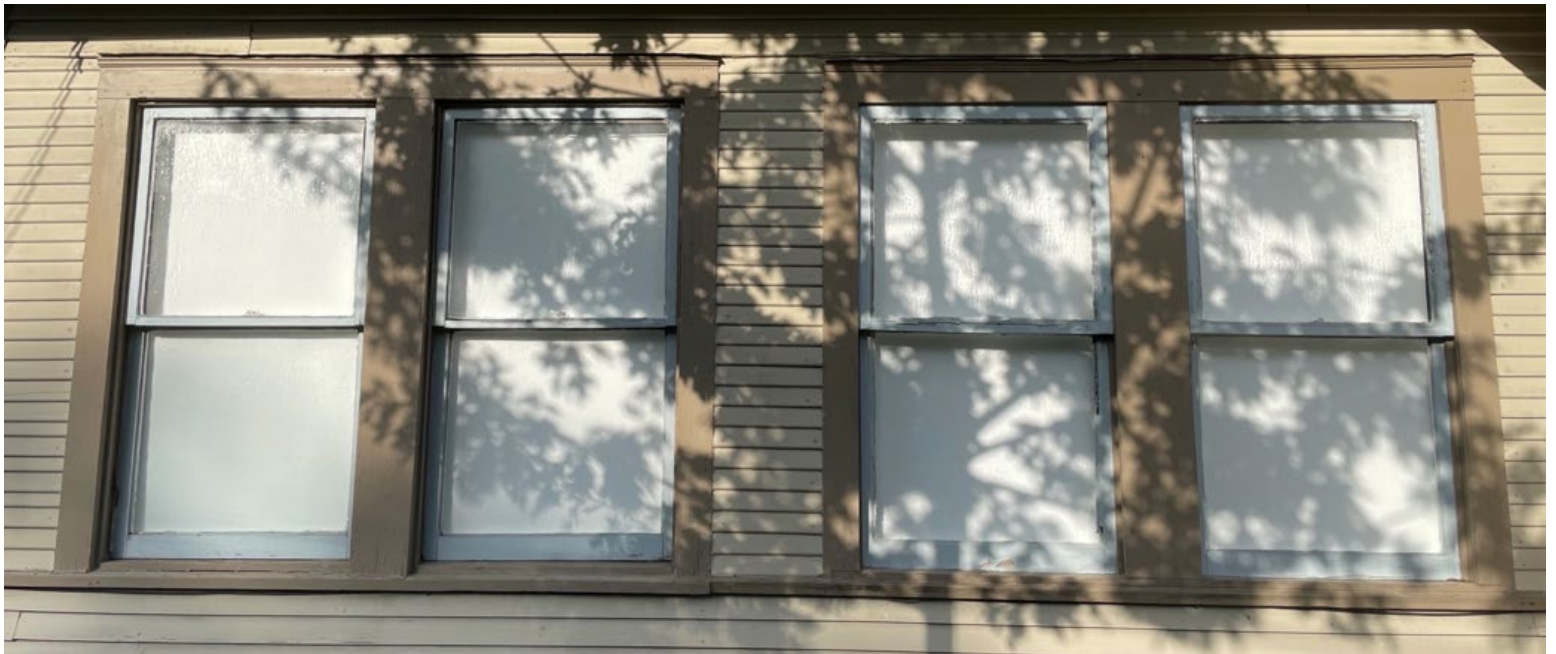
**WINDOWS 9,8,7,6**

**FAR LEFT TO BE REMOVED AND RELOCATED,  
SECOND FROM LEFT TO BE REMOVED COMPLETELY  
TWO RIGHT TO BE SHORTENED  
ALL IN GOOD CONDITION - REPAIRABLE**

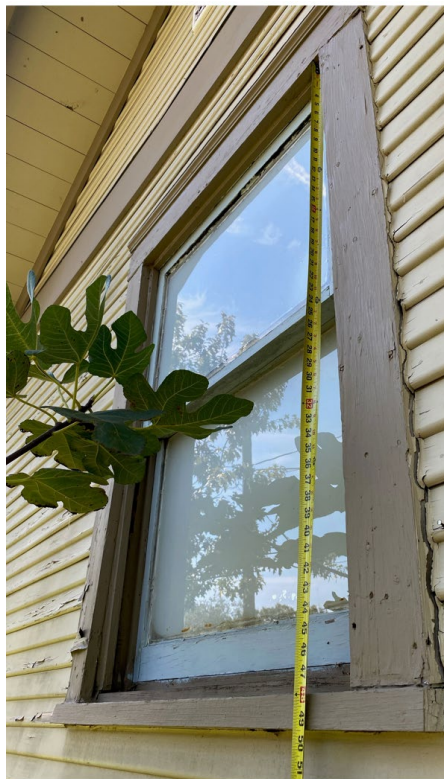
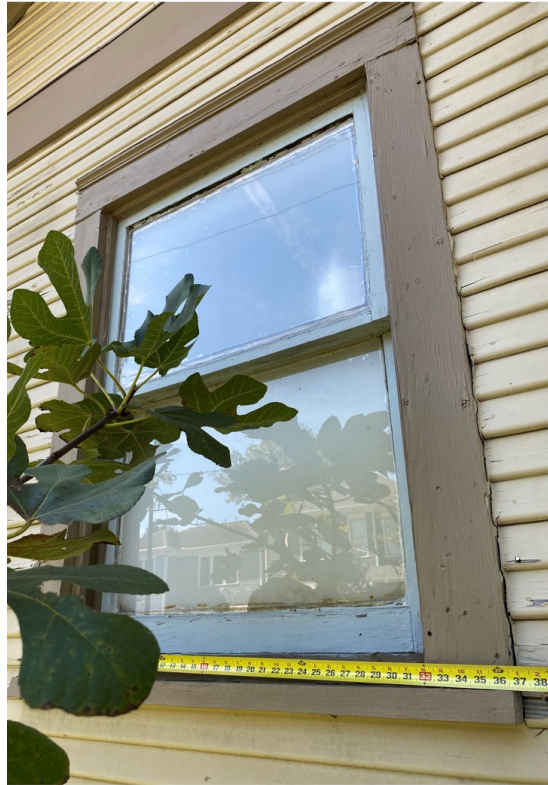
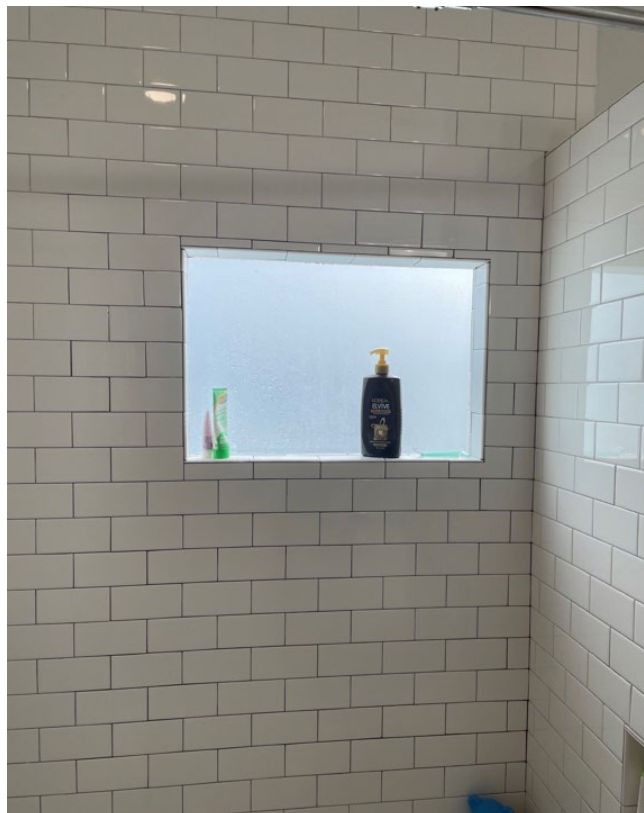
**WINDOW 5 – TO BE REMOVED, REPLACED WITH 3 LARGER RELOCATED HISTORIC WOOD WINDOWS**

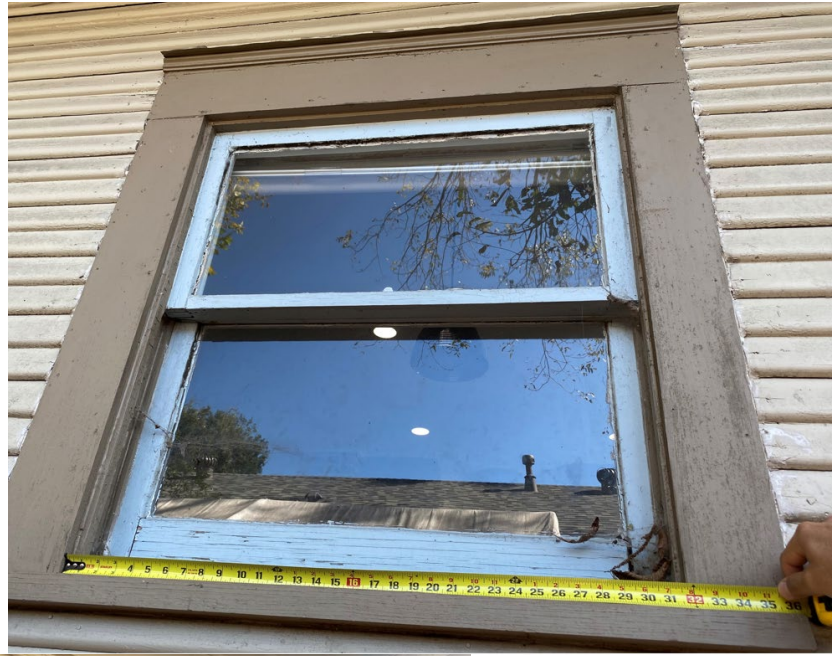
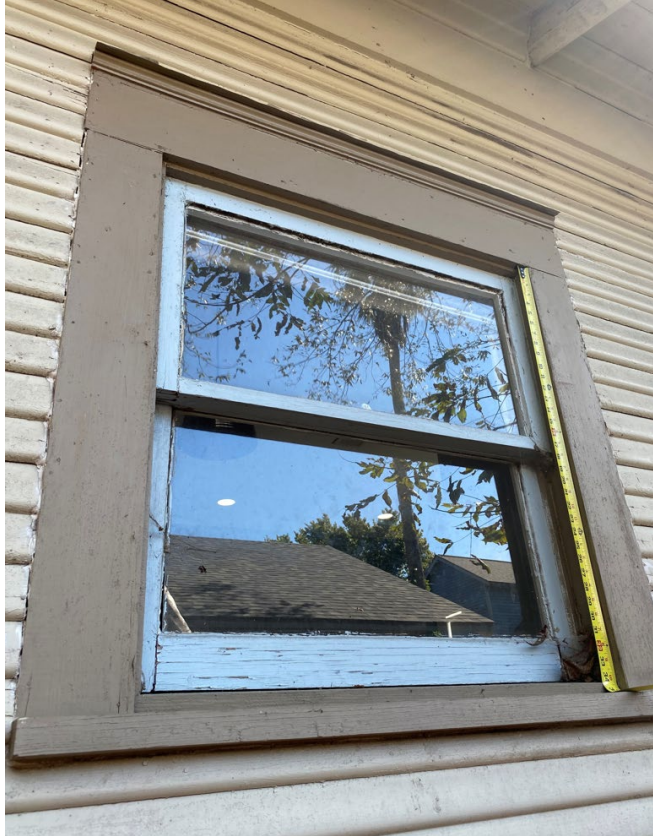
WINDOW 13 (WEST AT REAR) – TO BE REMOVED & COVERED WITH SIDING

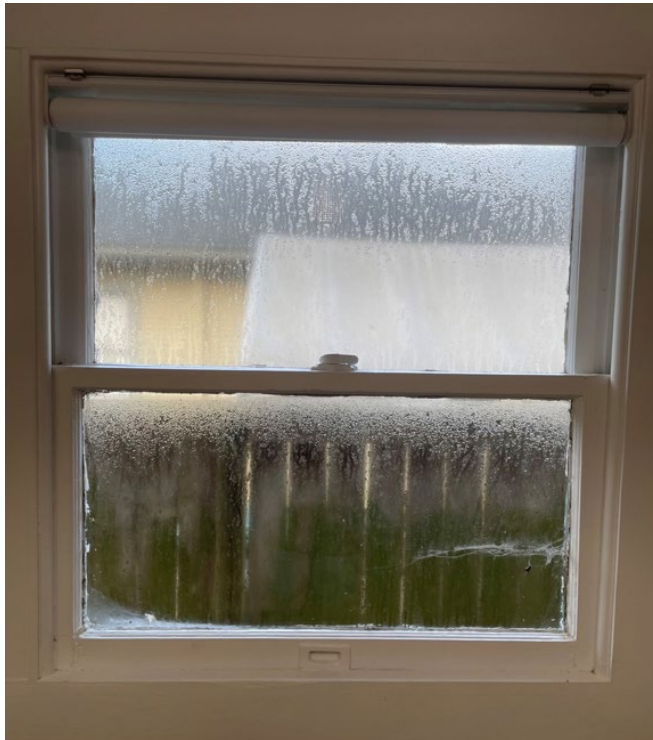
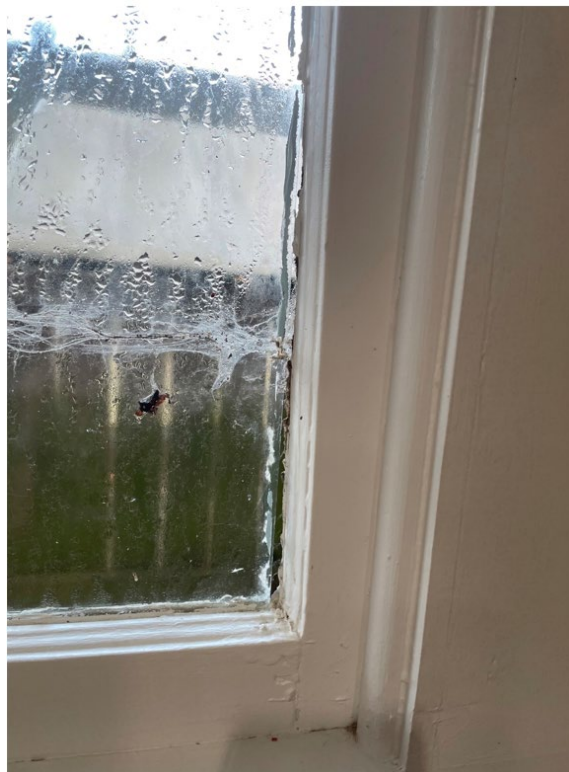
WINDOW 13 (WEST AT REAR) – TO BE REMOVED & COVERED WITH SIDING

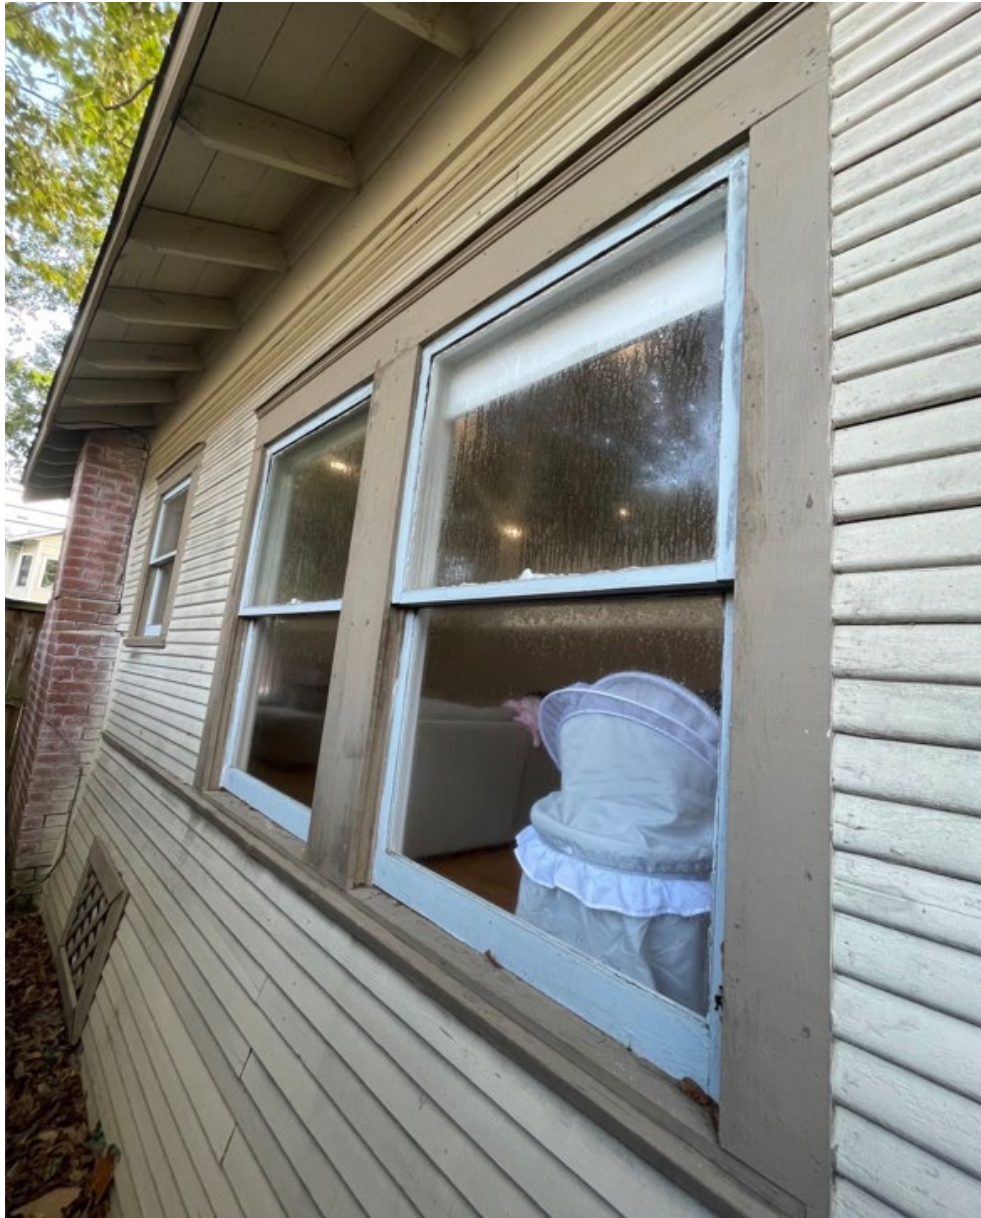
WINDOWS 16,15 (TO BE REPAIRED), 14 (TO BE REMOVED/PATCH SIDING OVER OPENING)
