CERTIFICATE OF APPROPRIATENESS**Application Date:** April 23, 2025**Applicant:** Pawel T. Czekaj, agent for owners, Mrs. Heinrich- Savitz & Mr. Savitz**Property:** Lot 1, Block 8, River Oaks Country Club Estate Subdivision. The property includes an historic 6,751 sq. ft., three-story, with finished attic, brick veneer single-family residence and attached garage situated on a 22,626 sq. ft. (180 ft. x 127 ft.) corner lot.**Significance:** The D.W. Hovey House is a City of Houston Landmark designated by HAHC in May 2012. The D.W. Hovey House was designed and built by Alfred and Ivan Greer as a speculative house in 1937. The Greers designed and built numerous houses in River Oaks. The D.W. Hovey House was designed in the Colonial Revival style.
Addition done in 1999 and renovations in 2015**Proposal:** Remove all windows and several rear doors. Front door to remain.

CERTIFICATE OF APPROPRIATENESS

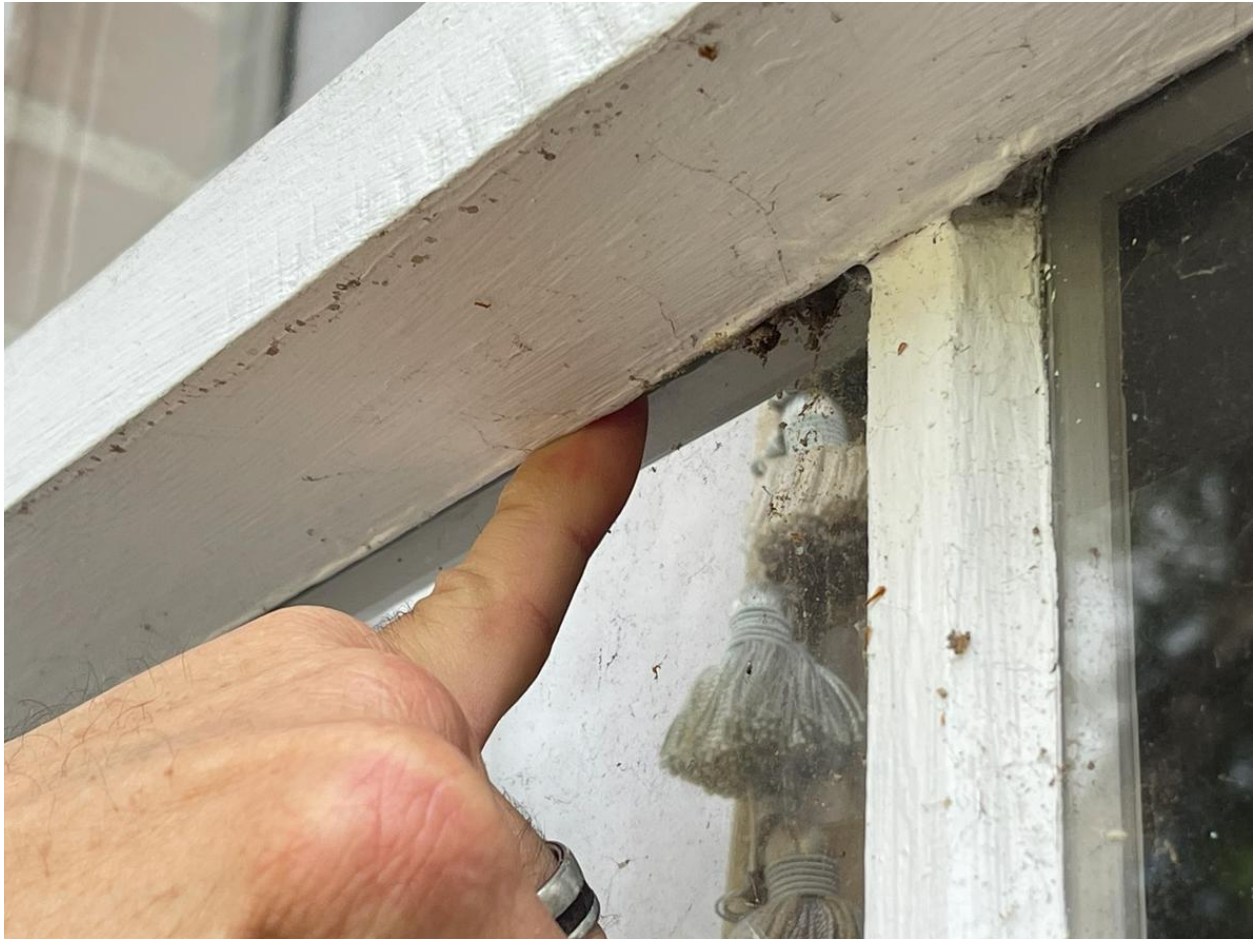
Existing Condition of Windows

Windows do not fully close, leaving a gap. Meeting Rail and Stile Joints have separated.

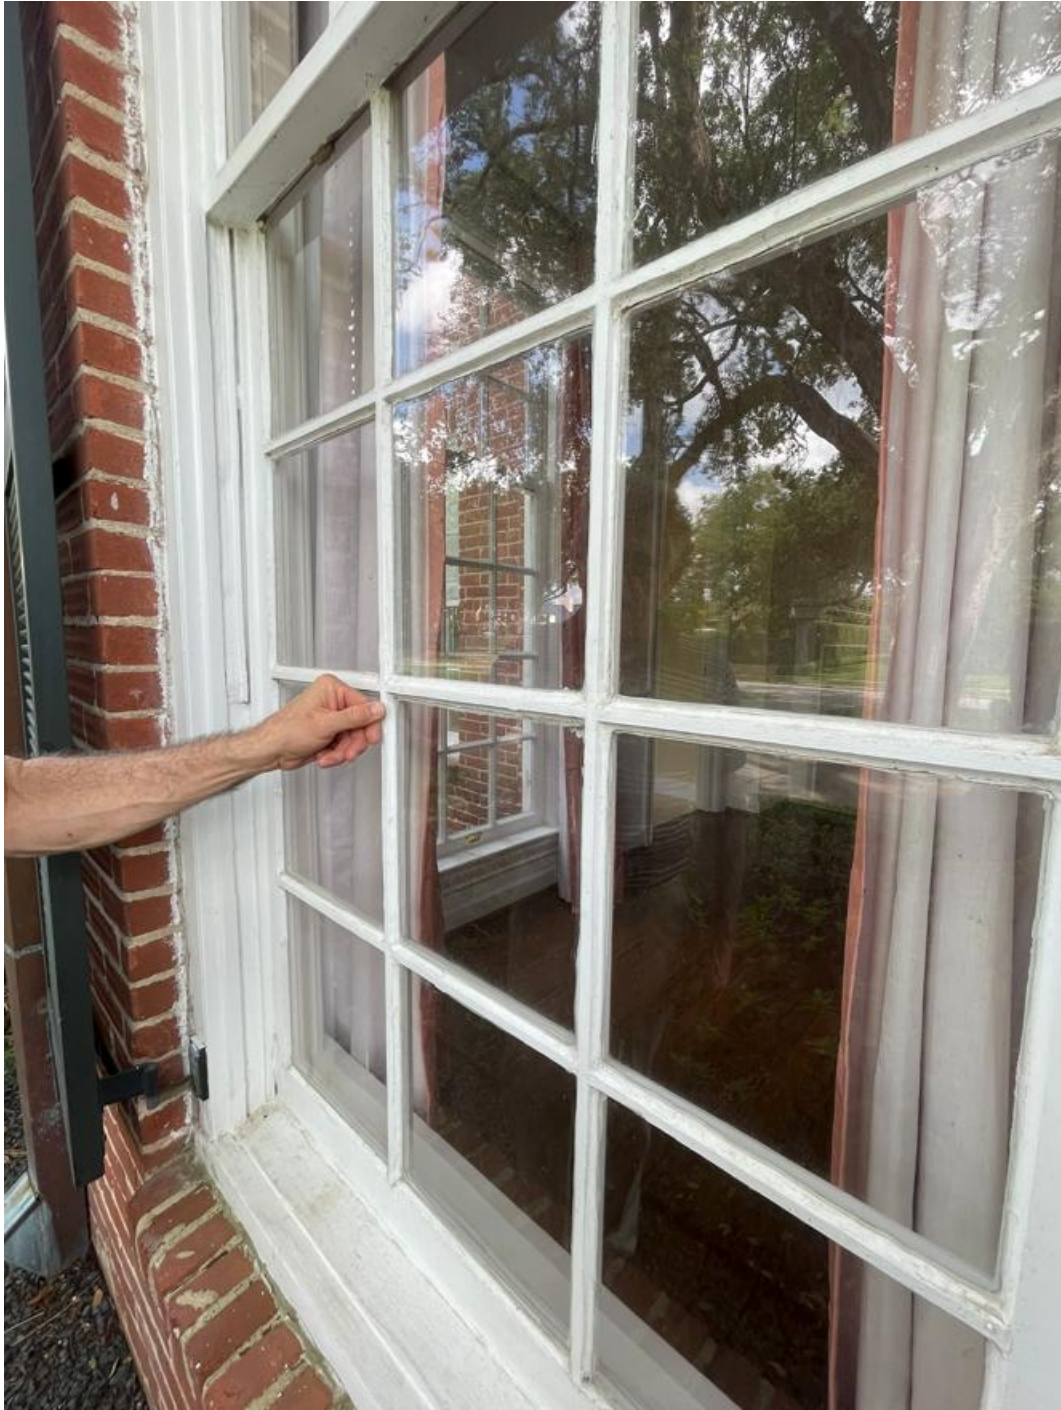
Existing Condition of Windows

Windows wood grid lack structural integrity, they move when touched.

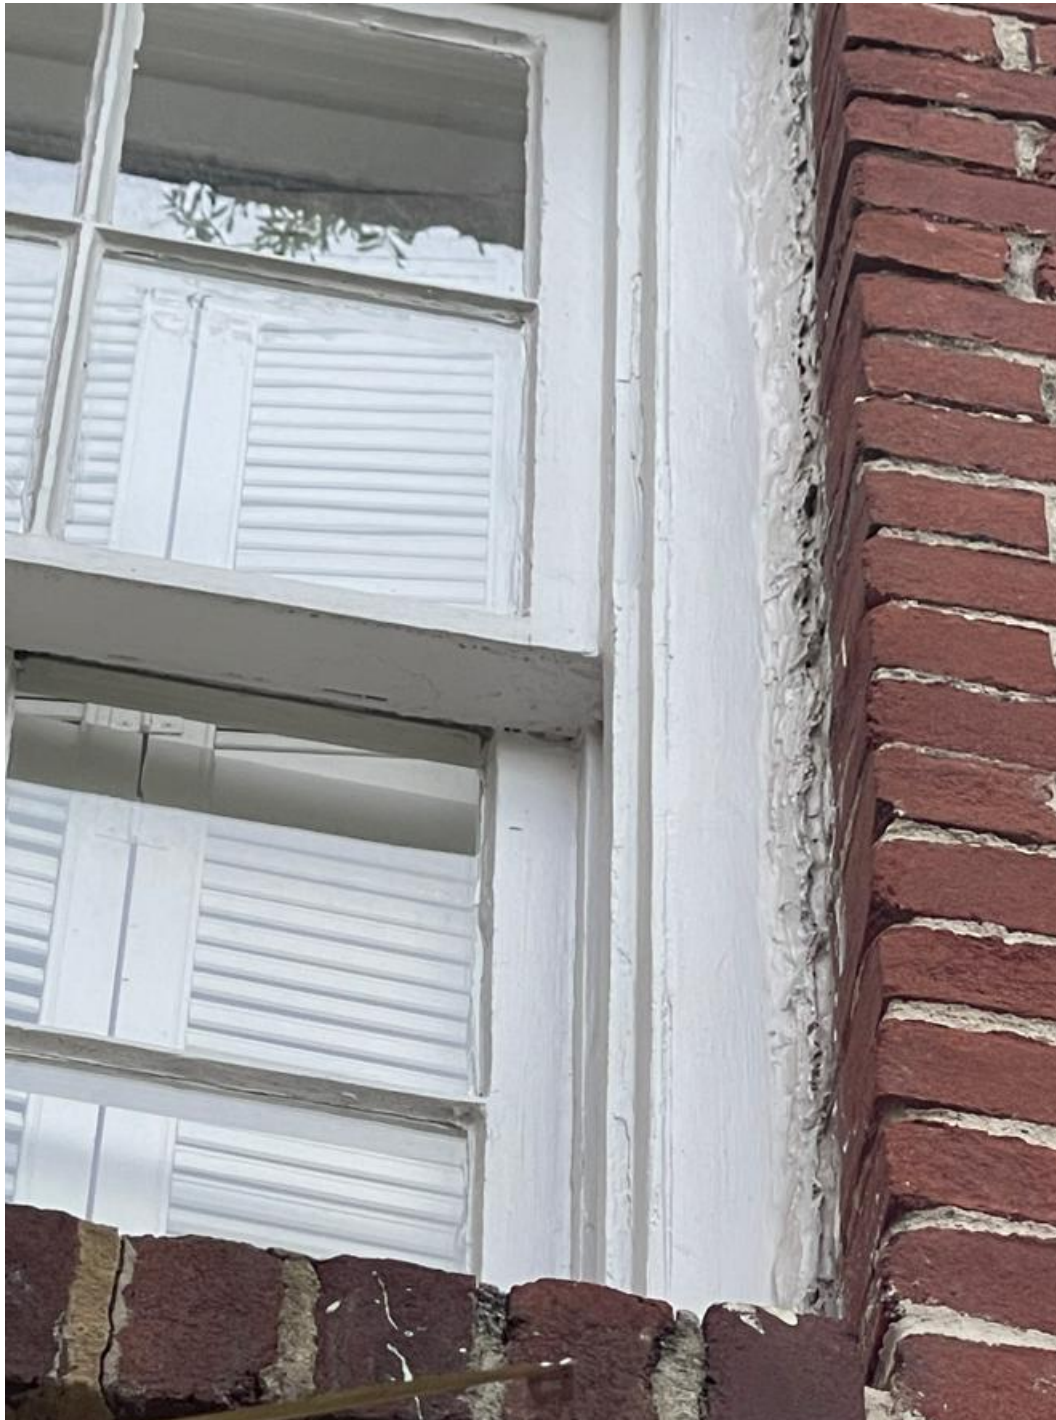
Existing Condition of Windows

Windows exhibiting extensive water damage, repeated caulking fails to seal window casing from water incursion.

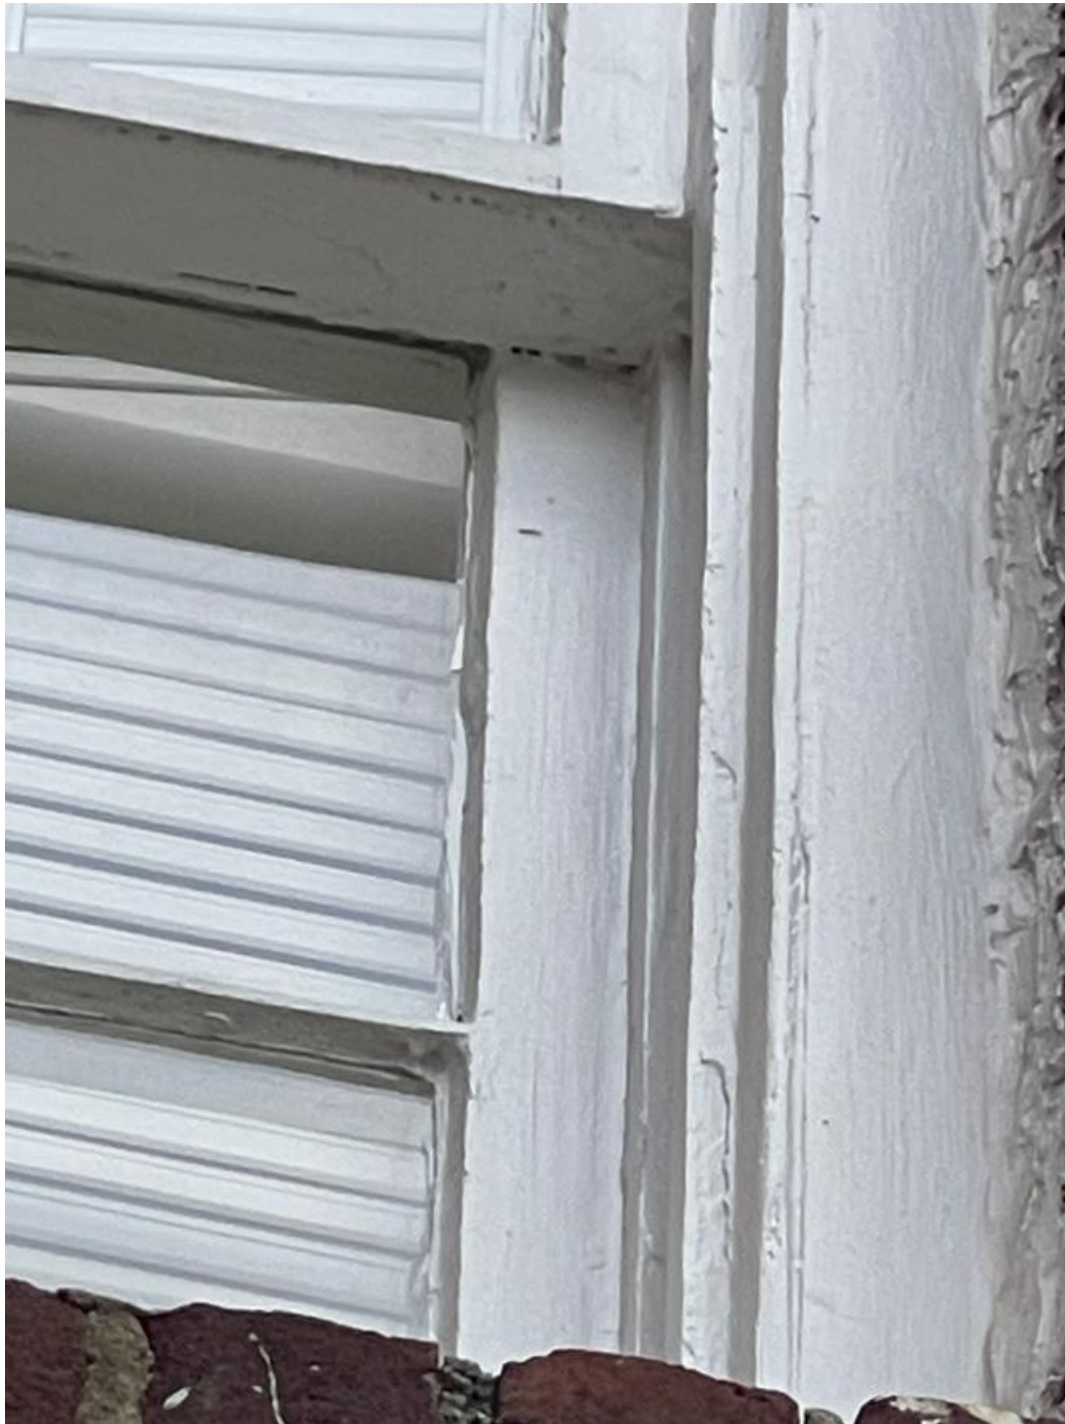
Existing Condition of Windows

Repeated water damage, to window and brick, main house East Elevation, 2nd story front.

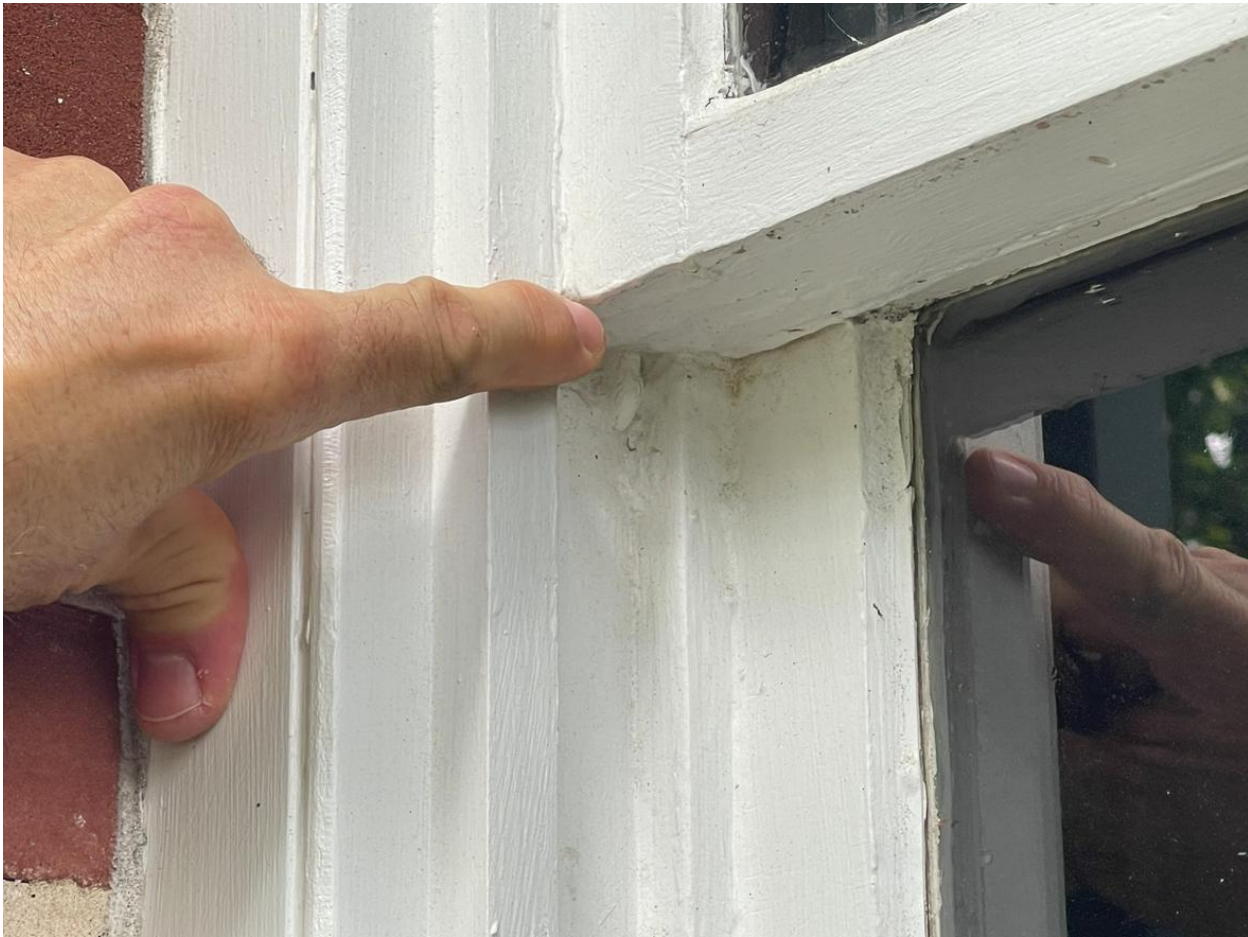
Existing Condition of Windows

Hardware in Sash Channel is either missing or painted over.

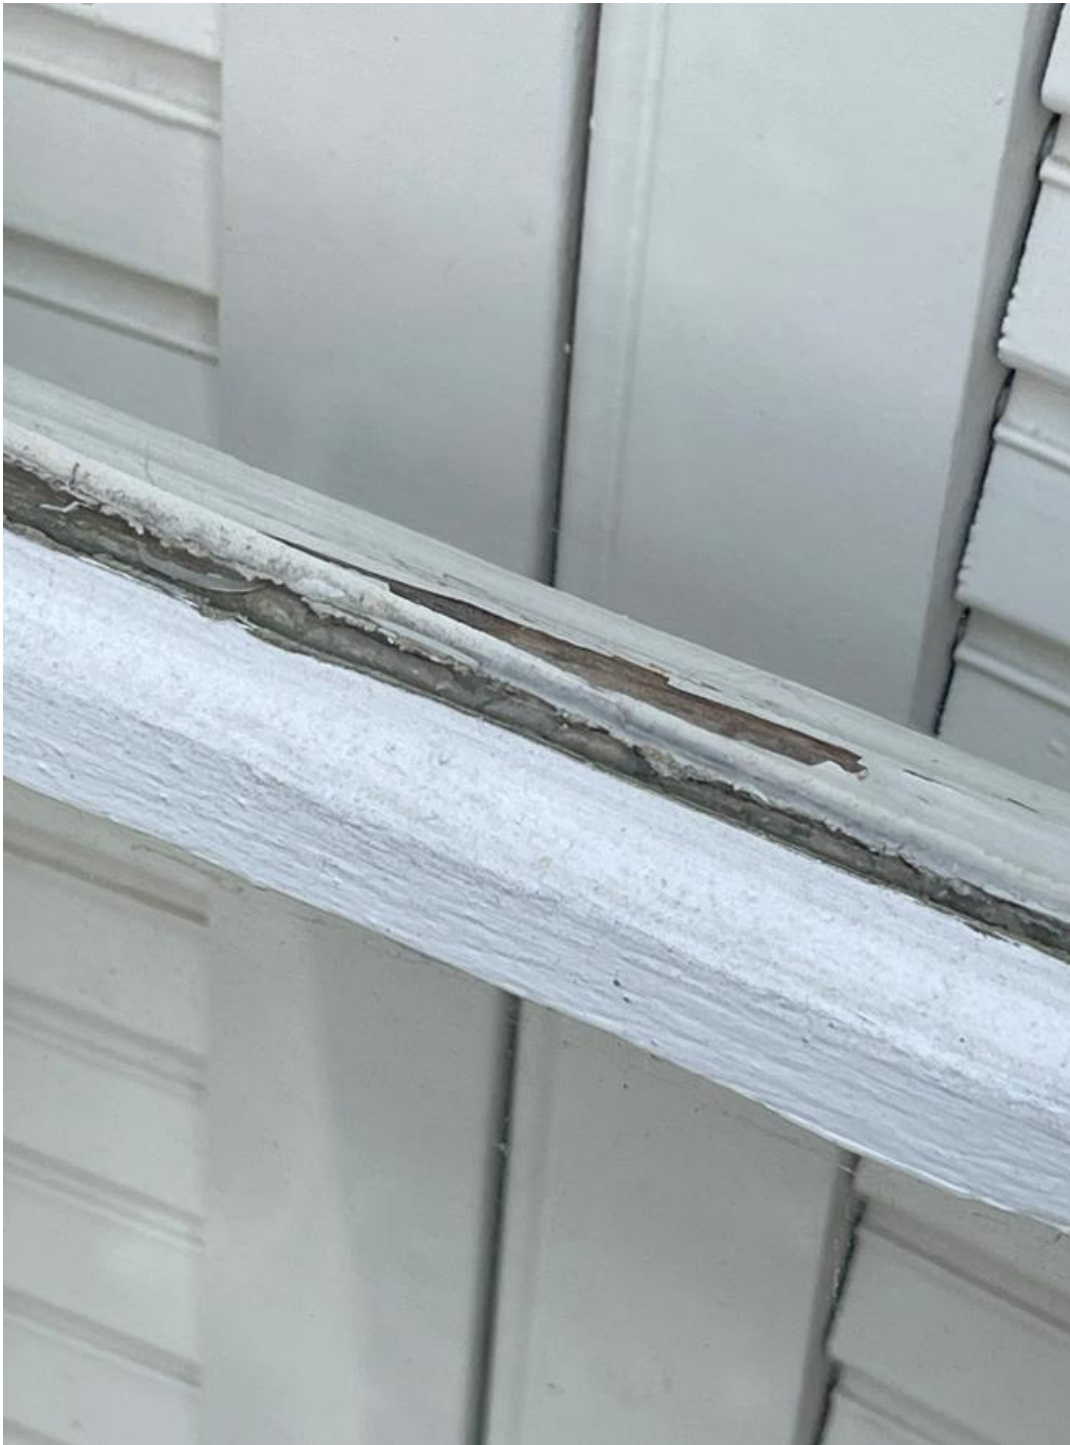
Existing Condition of Windows

Moisture damage to interior of windows. Windows appear to lack airtight seal.

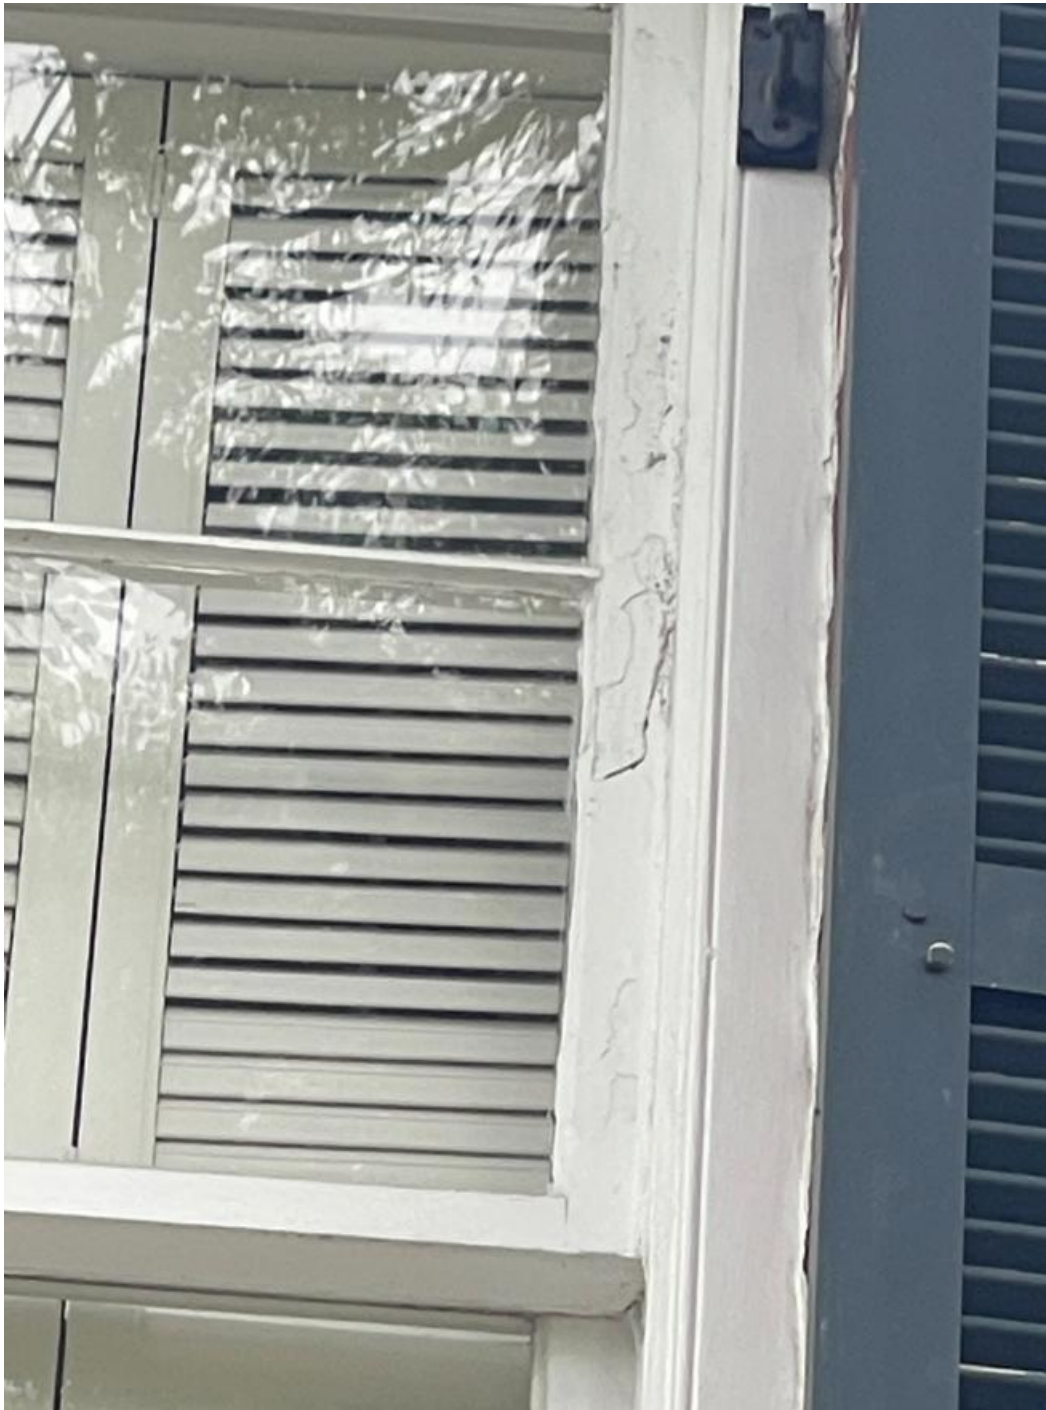
Existing Condition of Windows

Exterior water damage of window. Windows have been repeatedly repaired, despite this they still do not seal properly to keep out rain and moisture.

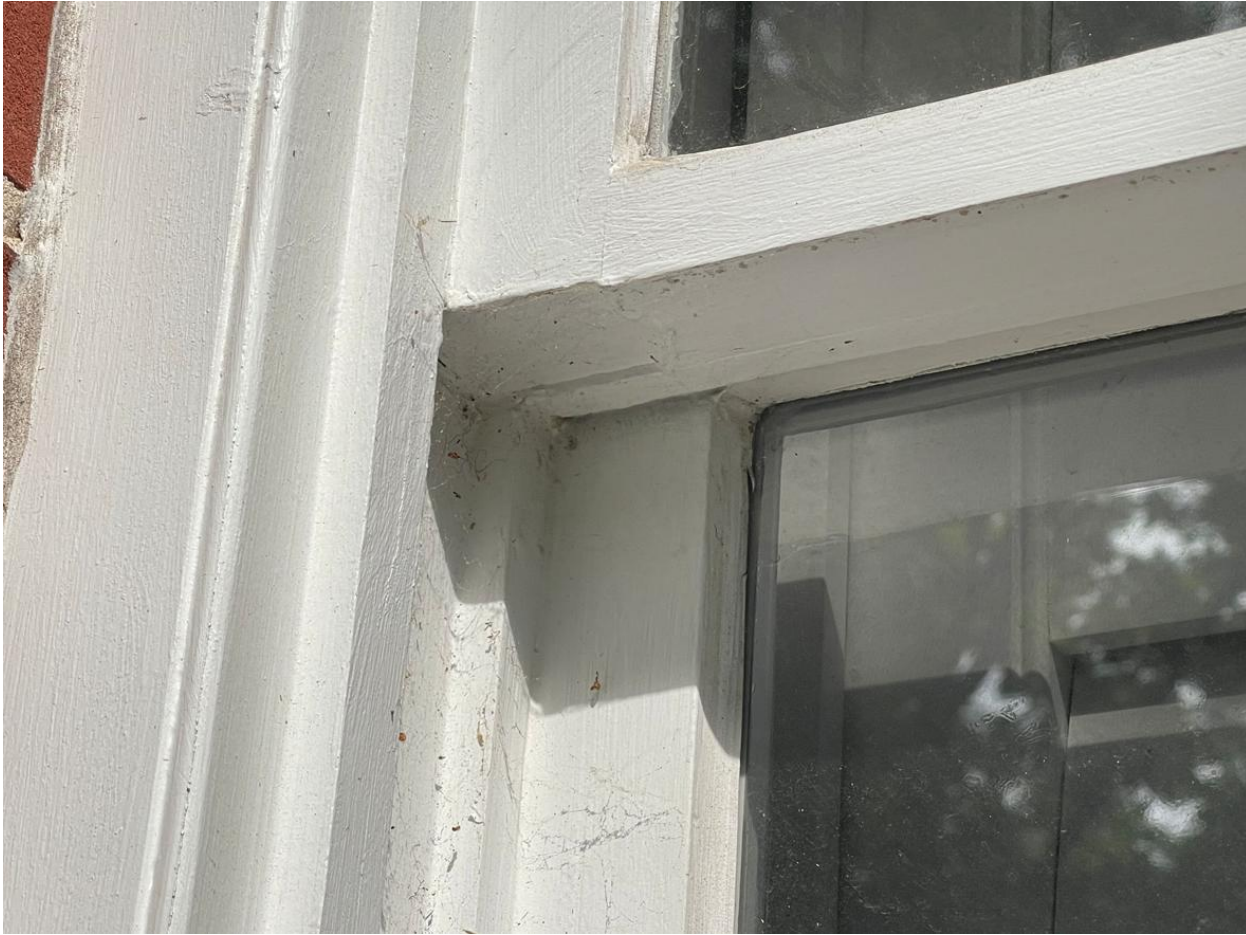
Existing Condition of Windows

Meeting Rail and Stile Joints have separated, Windows do not fully close, leaving a gap.

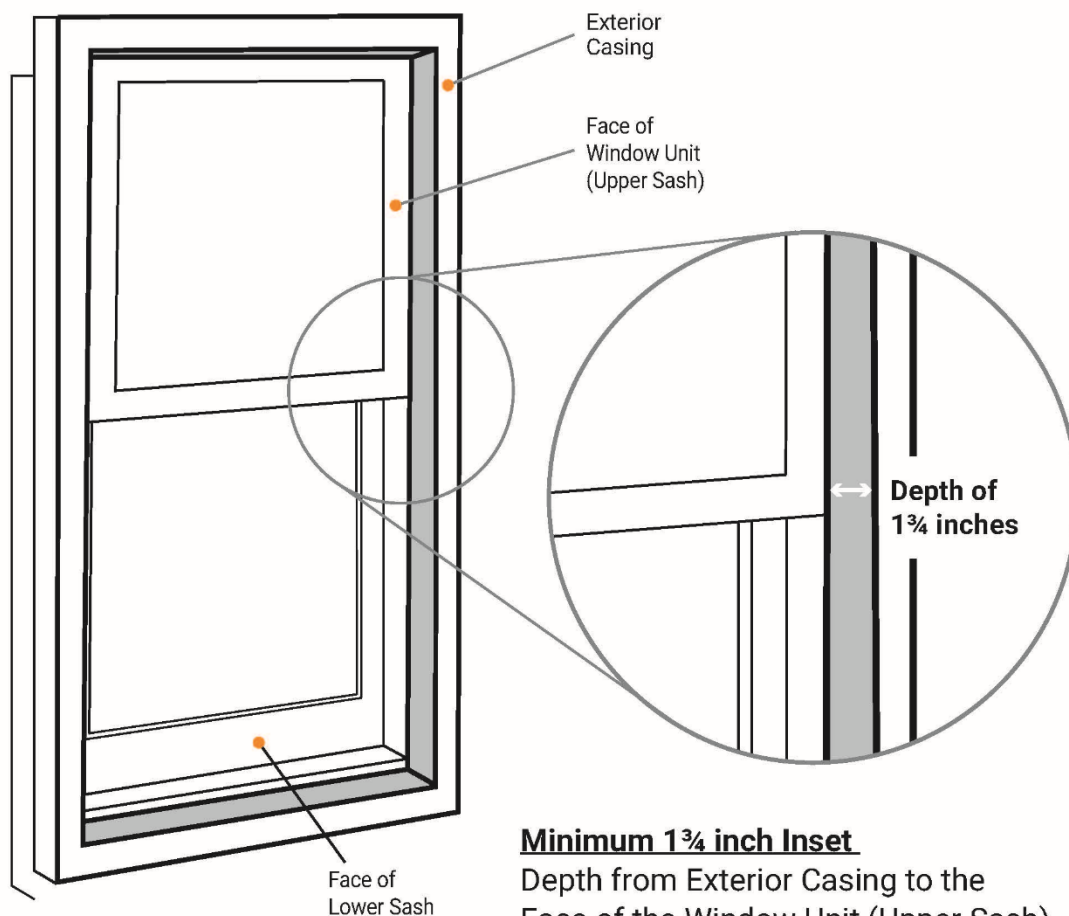
Historic Window Standard: New Construction & Replacement

Minimum 1 3/4 inch Inset

Depth from Exterior Casing to the Face of the Window Unit (Upper Sash)

Windows must be 1-over-1
(equally horizontally divided)

1 3/4 inch minimum inset for Fixed Window
