CERTIFICATE OF APPROPRIATENESS

Property: Lot 9, Block 230, Houston Heights South Subdivision. The property includes a one and a half-story wood frame 2,476 square foot single-family residence and detached garage situated on a 6,600 square foot interior lot.

Proposal: Replace (3) non-original windows West Elevation, facing street, on 2nd story dormer.

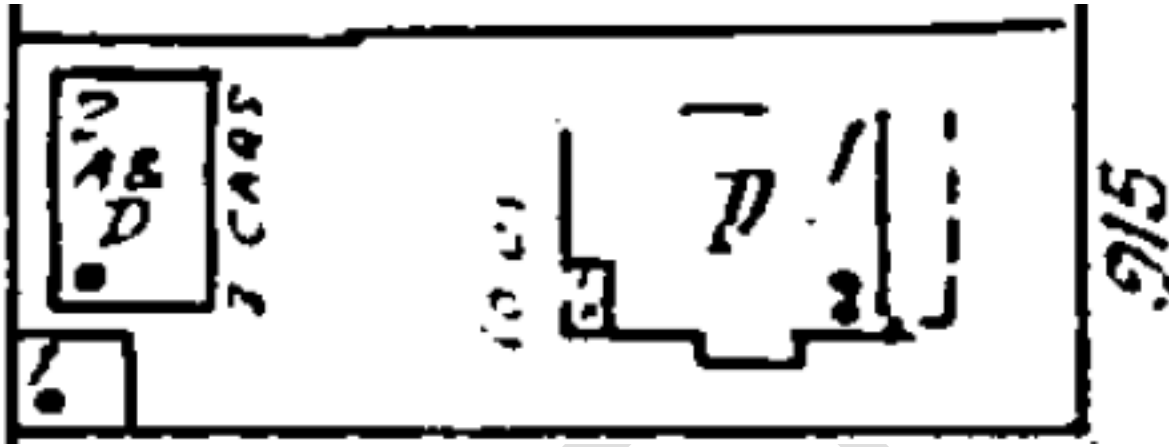
Sanborn Map

1924-1951 – Shows 1 story home, no second story dormer.

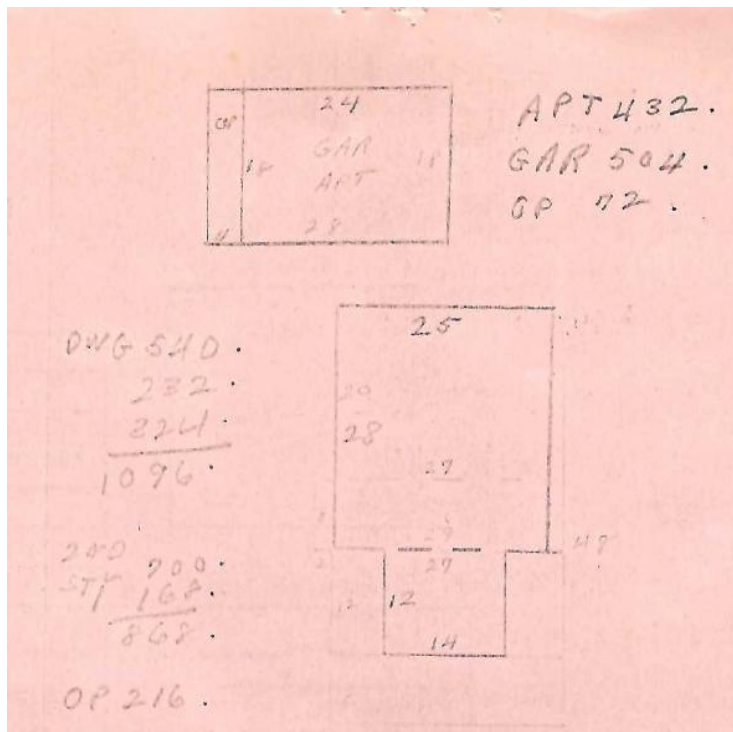
Bureau of Land Assessment

1969 – Duplex shows up in County Records, showing 2nd story
Second story was apparently added sometime after 1951 per BLA document.

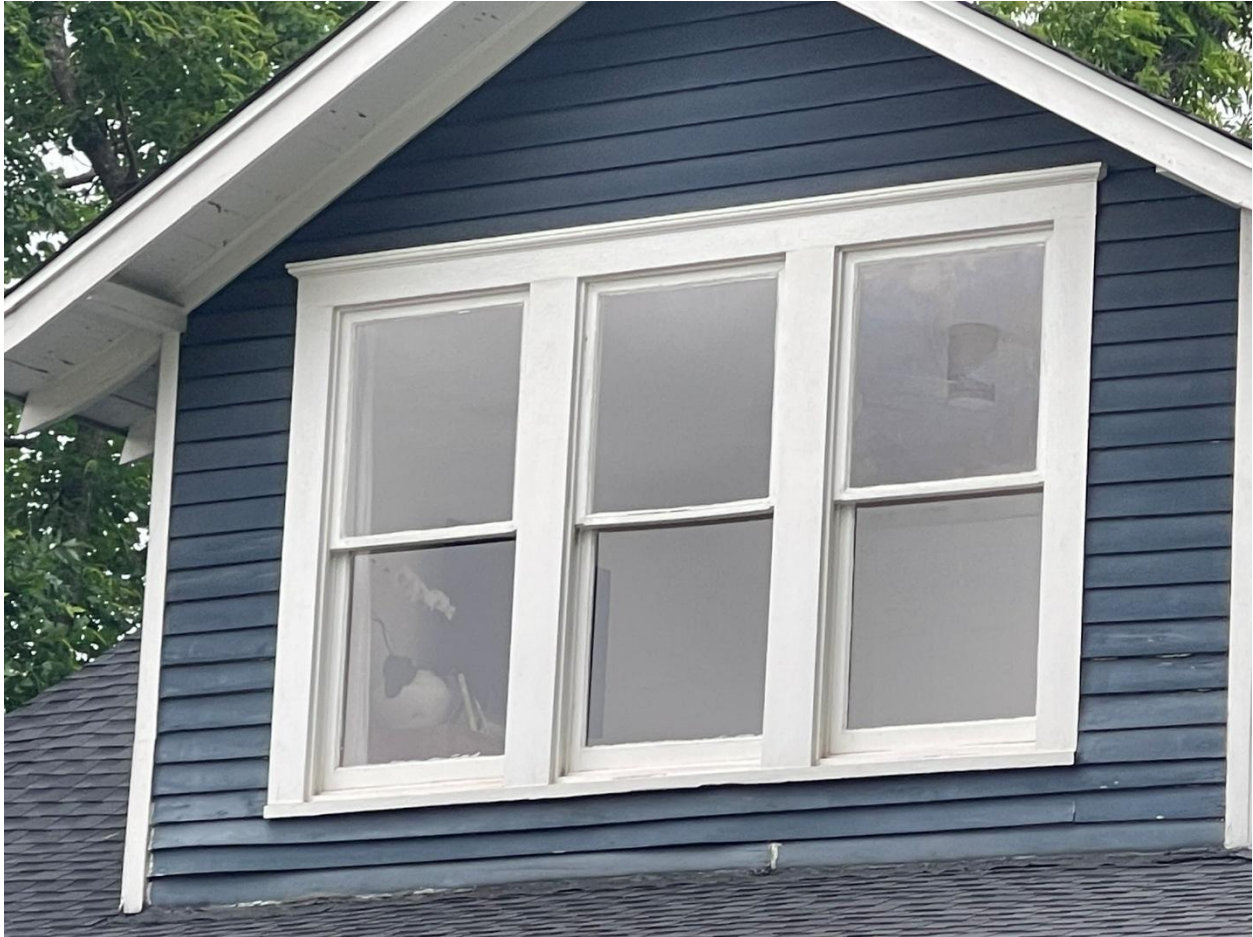
Existing Window Set of 3 (East Elevation)

Some of the existing windows have wavy glass.

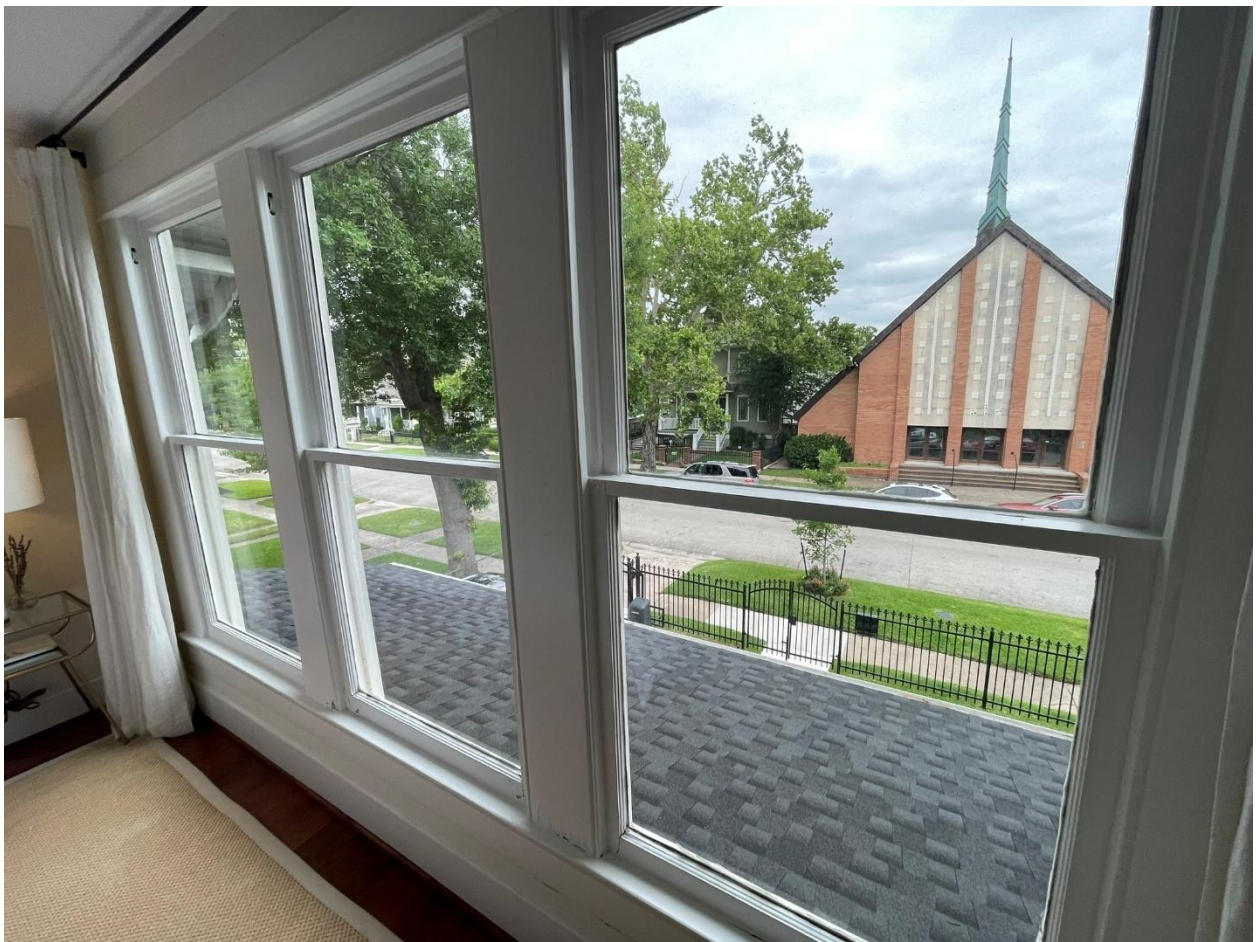
Existing Window Set of 3 (East Elevation)

Interior water damage to window units

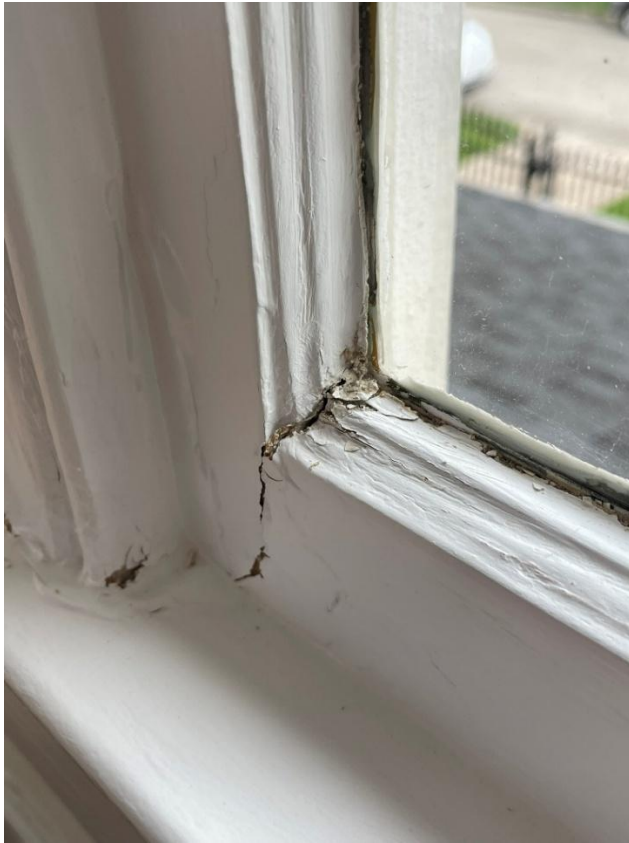
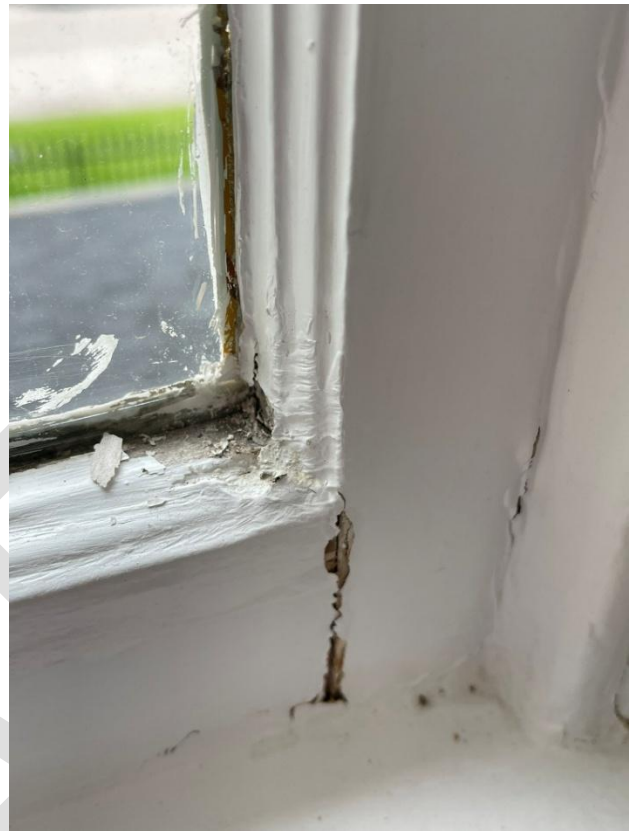
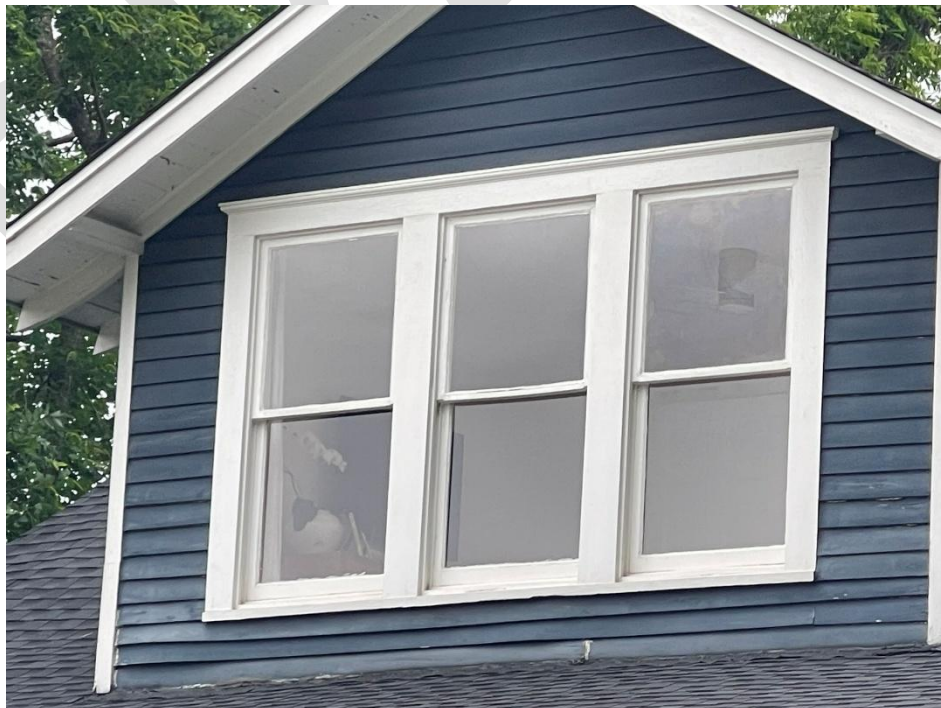
Existing Windows – Damage (East Elevation)

Exterior water damage to siding and window units
