CERTIFICATE OF APPROPRIATENESS

Property: 1810 Kane Street, Lot 6, Block 443, Baker W R SSBB Subdivision. The property includes a 2,050 SF, one-story, wood frame, single-family residence situated on a 5,000 square foot (50' x 100') interior lot.

Proposal: Alteration

- Remove and replace 9 original but severely deteriorated orated windows with high quality, wood replacement windows with a matching lite patter to the original windows.

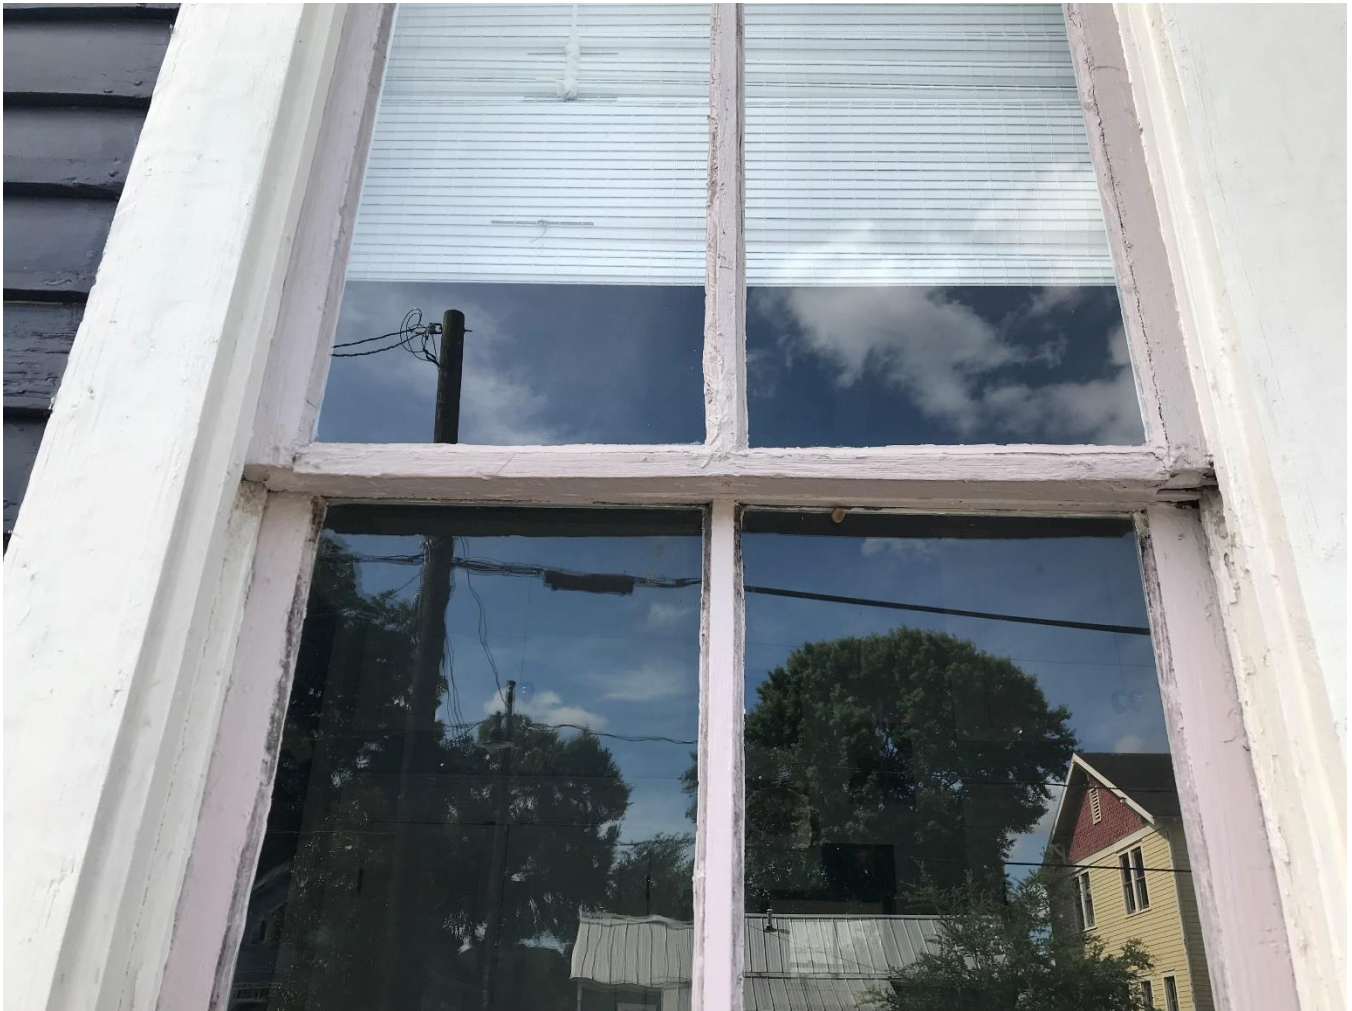
Figure 4 - Upper sash meeting rail needs replacement, lower portion of sash sides and middle muntin need significant repairs.

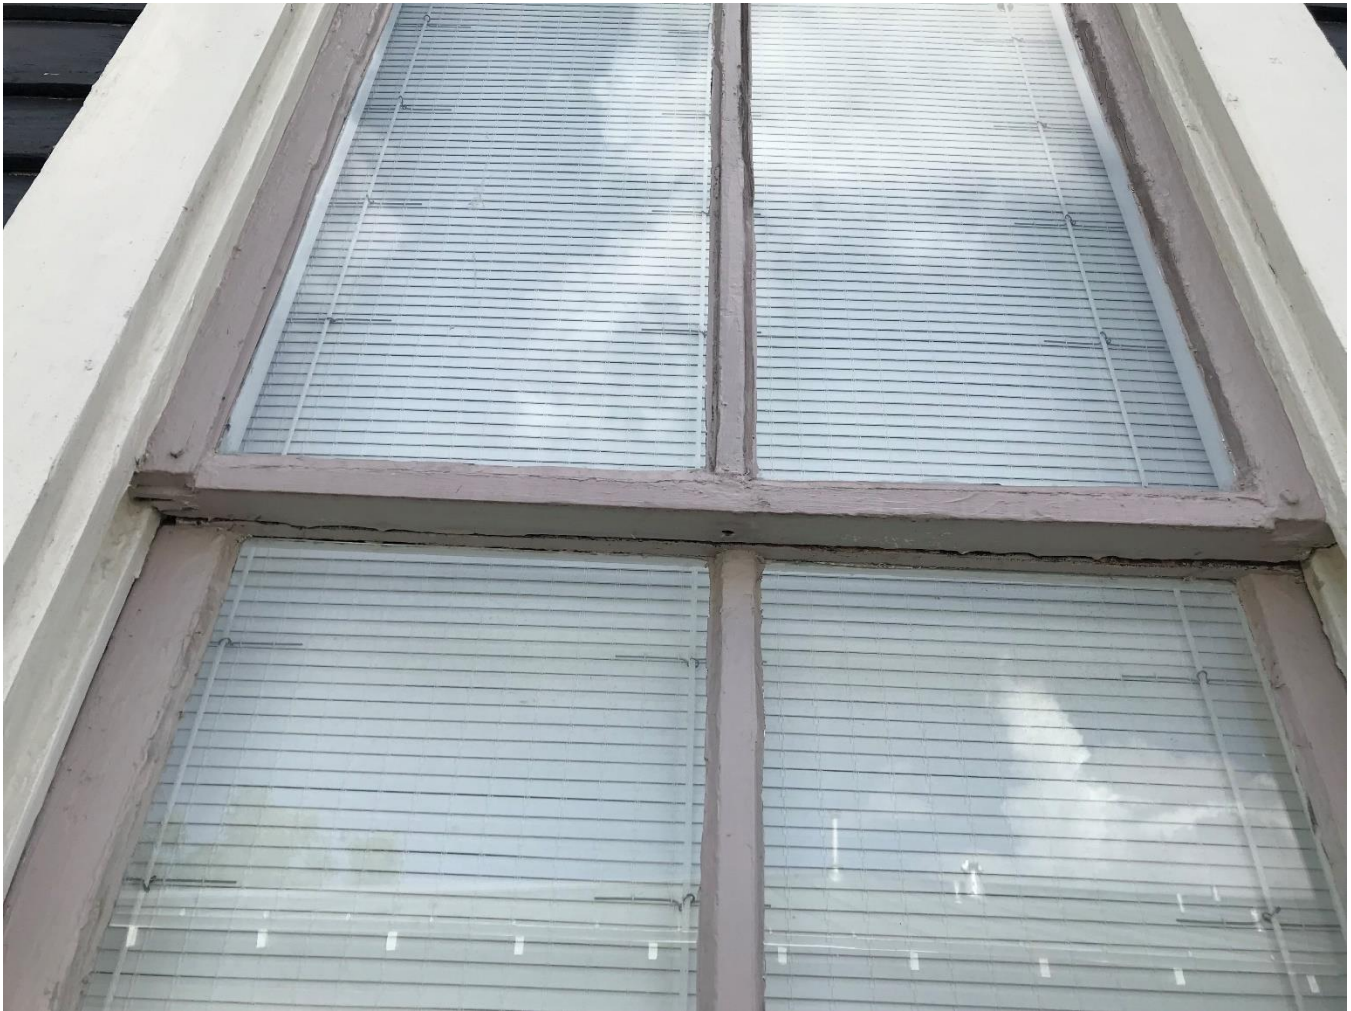
Figure 5 - Upper sash meeting rail needs replacement, lower portion of sash sides and middle muntin need significant repairs

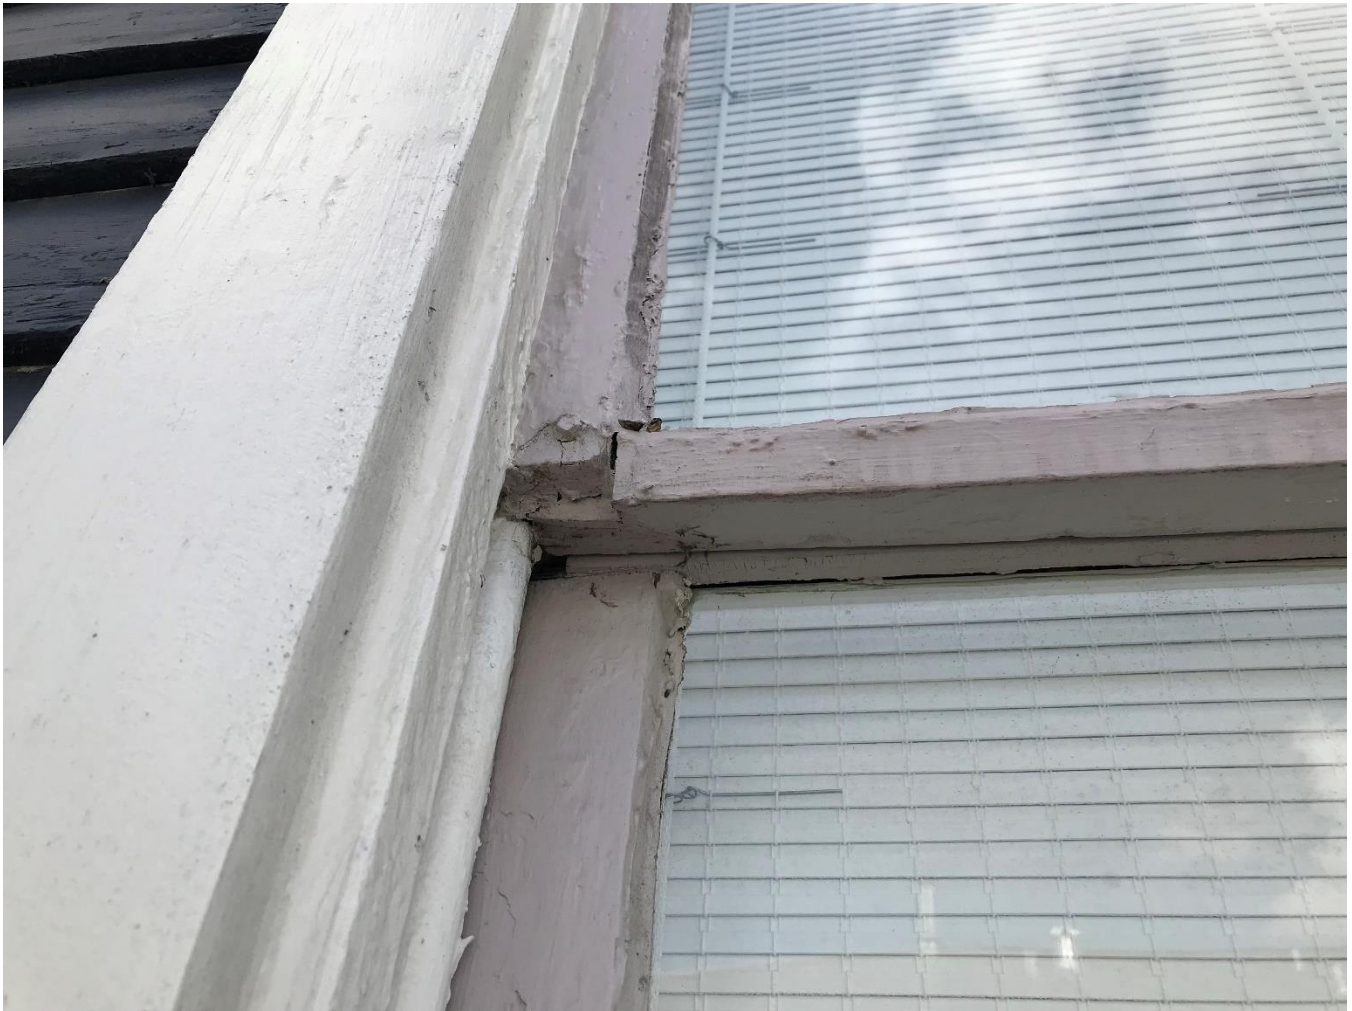
Figure 6 - Meeting rails need replacement, side rails upper and lower significantly damaged

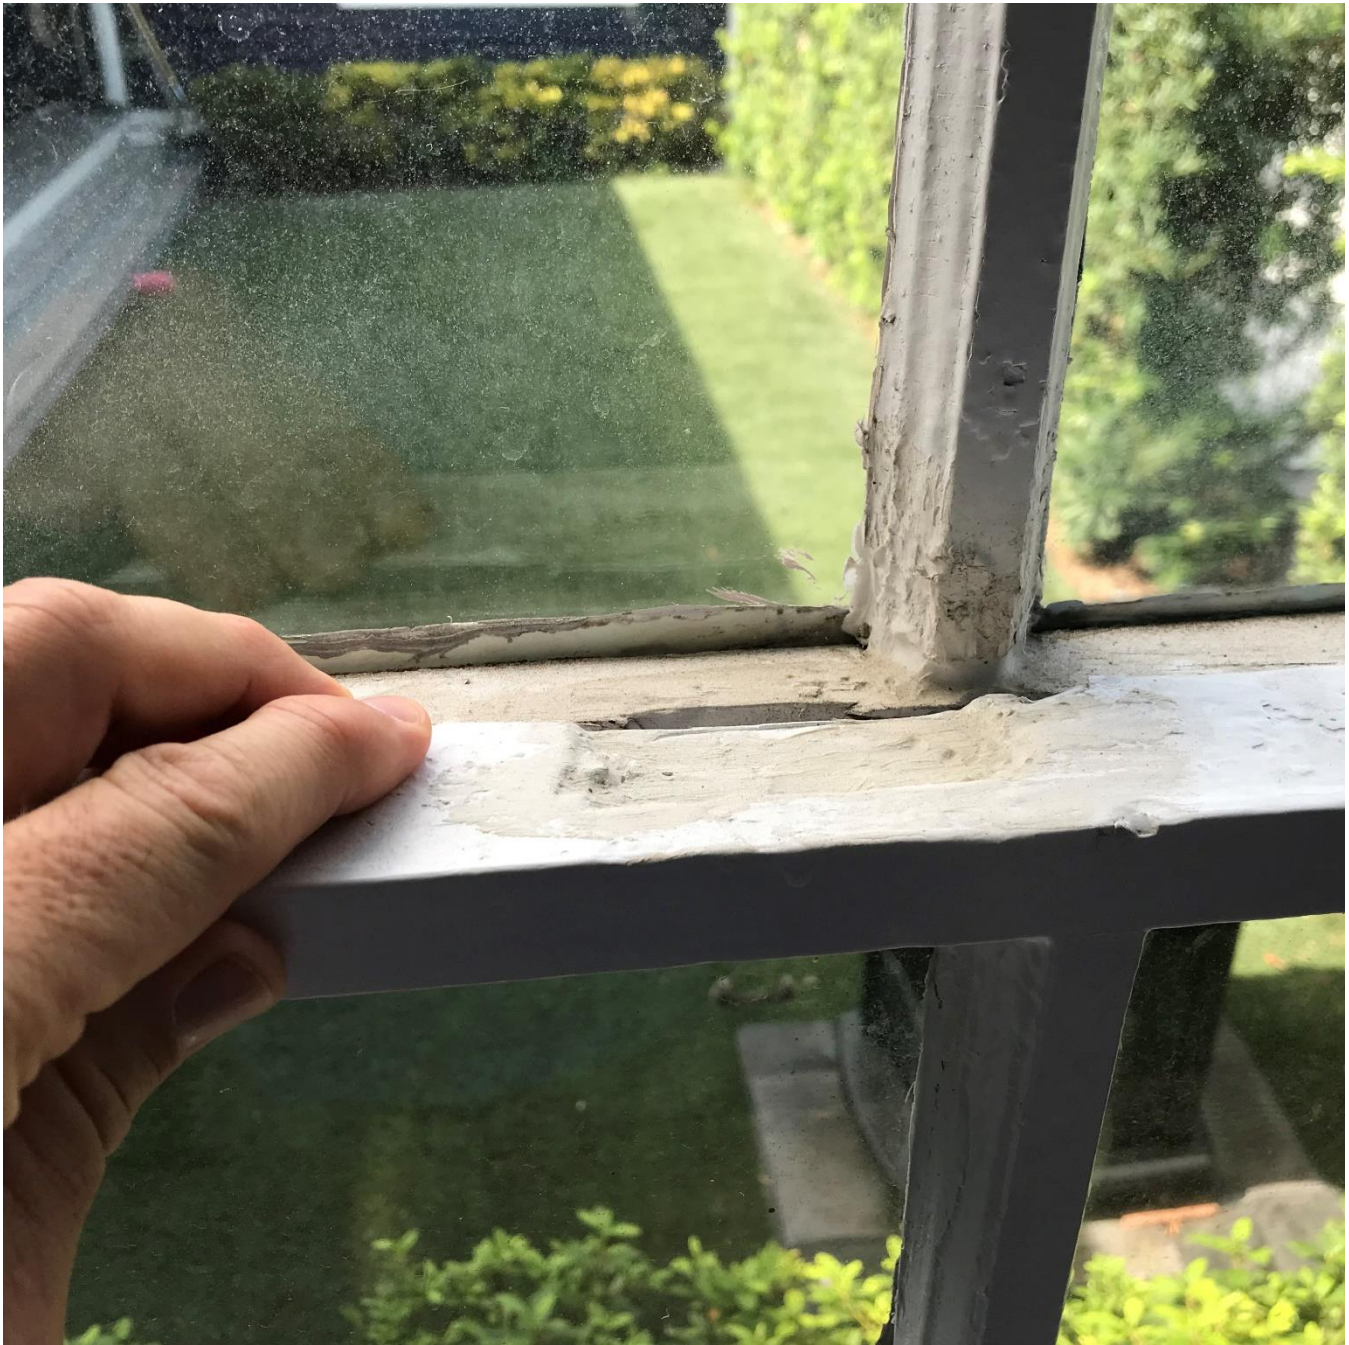
Figure 7 - lower portion of upper sash muntin significant damage

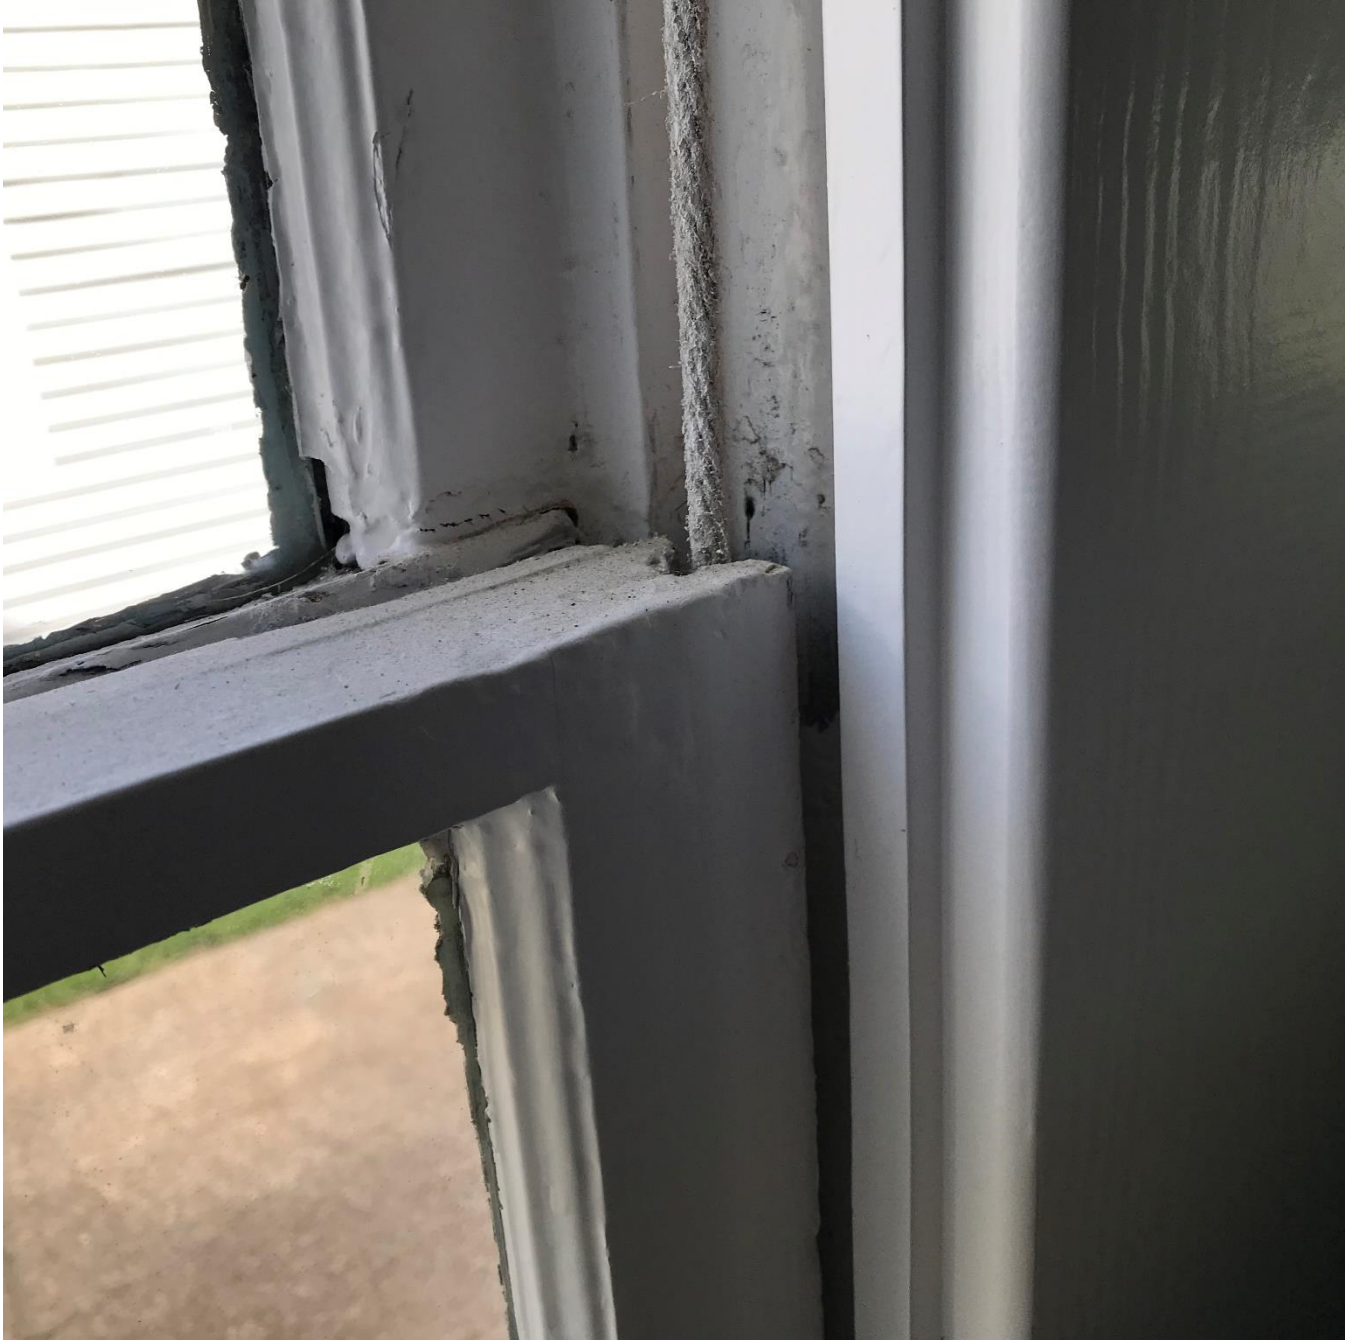
Figure 8 - meeting rails and side rails need replacement or significant repairs.
