CERTIFICATE OF APPROPRIATENESS

Property: 1810 Kane Street, Lot 6, Block 443, Baker W R SSBB Subdivision. The property includes a 2,050 SF, one-story, wood frame, single-family residence situated on a 5,000 square foot (50' x 100') interior lot.

Proposal: Alteration

- Remove and replace 9 original windows with 9 replacement windows custom made to fit in the same window openings. One of the windows to be replaced is rear facing and not visible from the right of way (ROW).

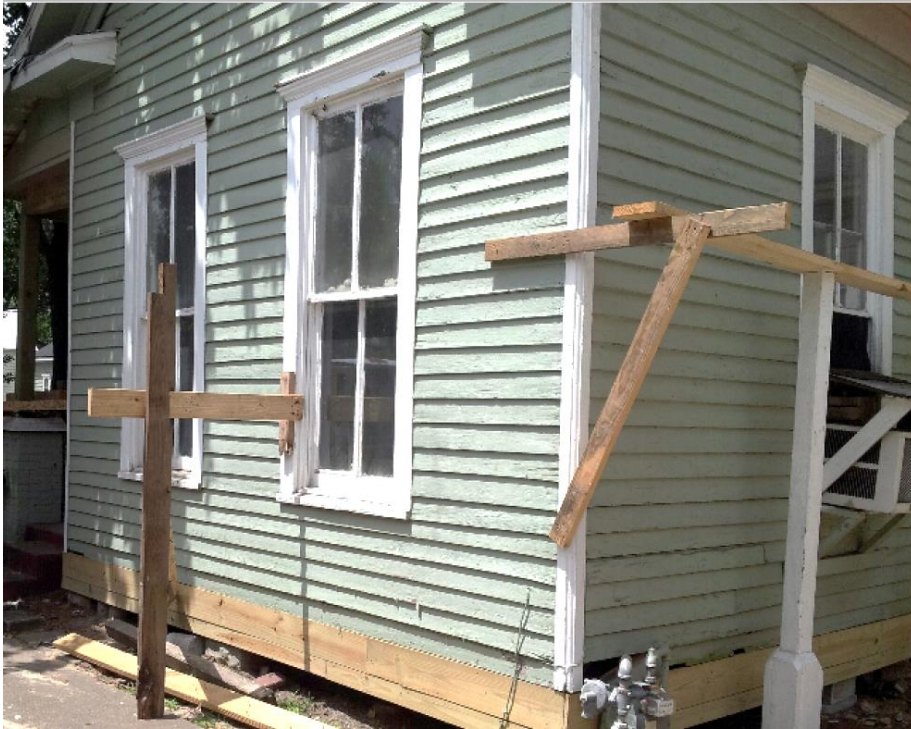
Figure 2 - Windows in 2015

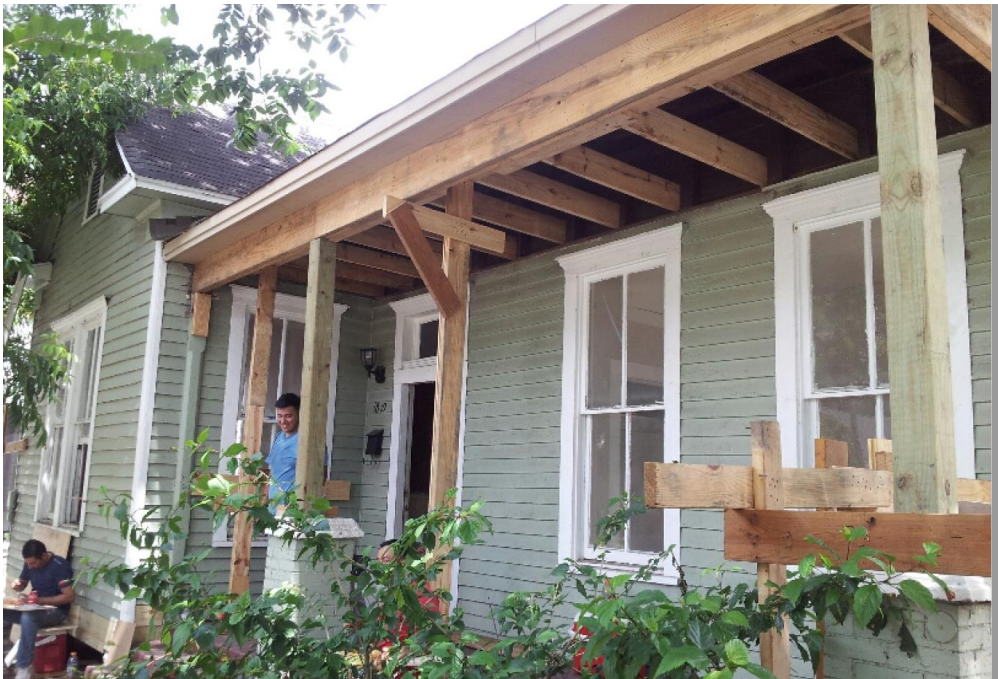
Figure 3- Windows in 2015

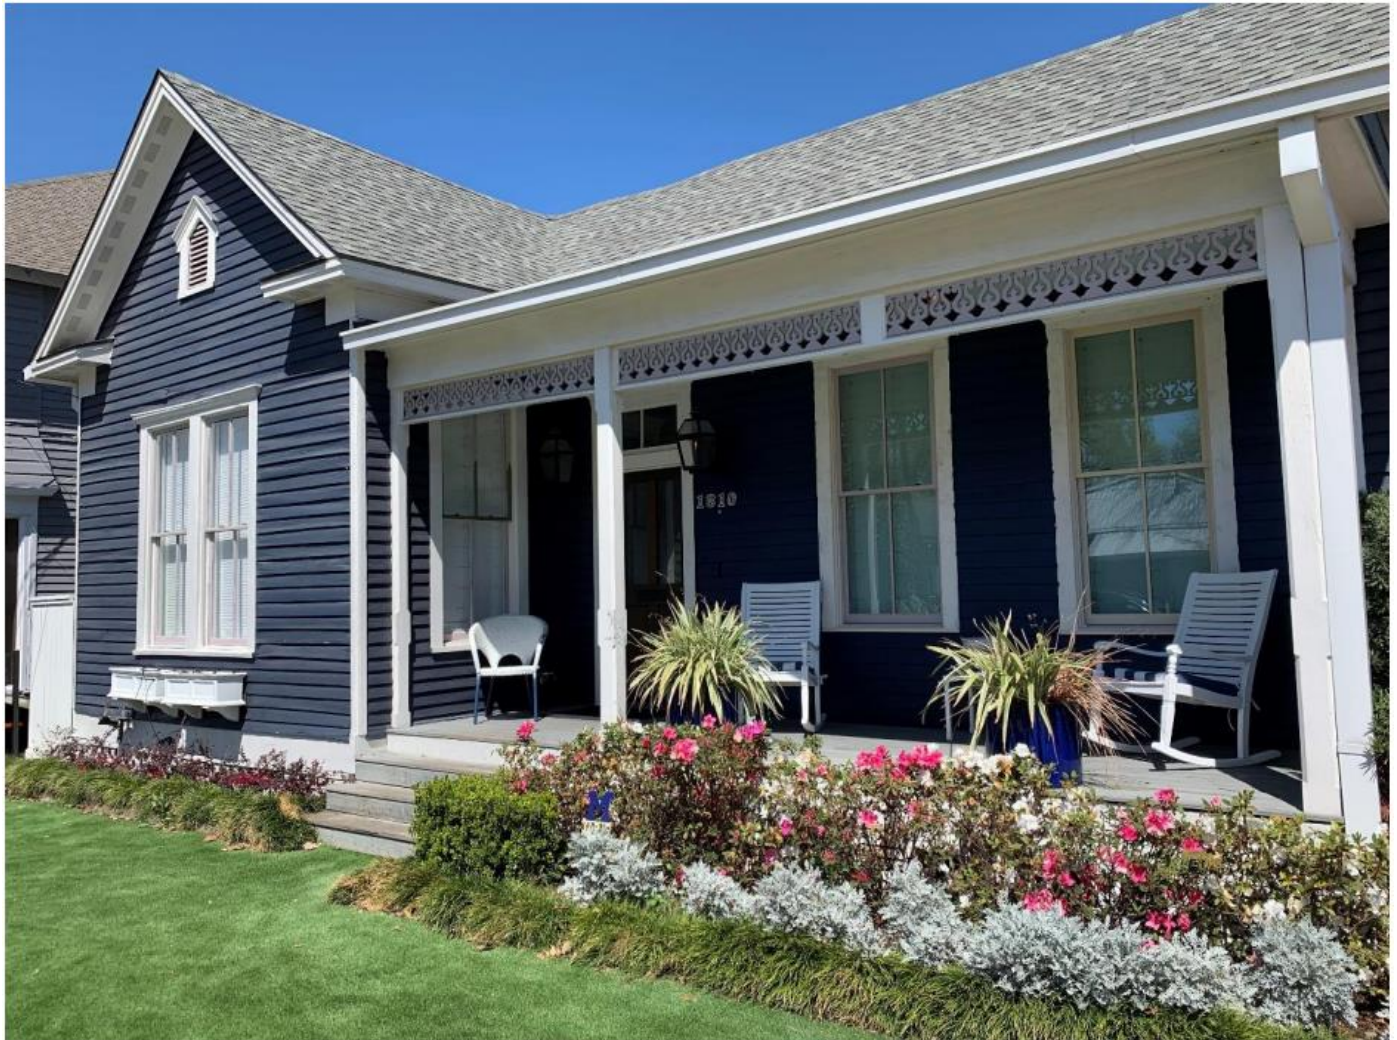
Figure 4 - Applicant Supplied Photo

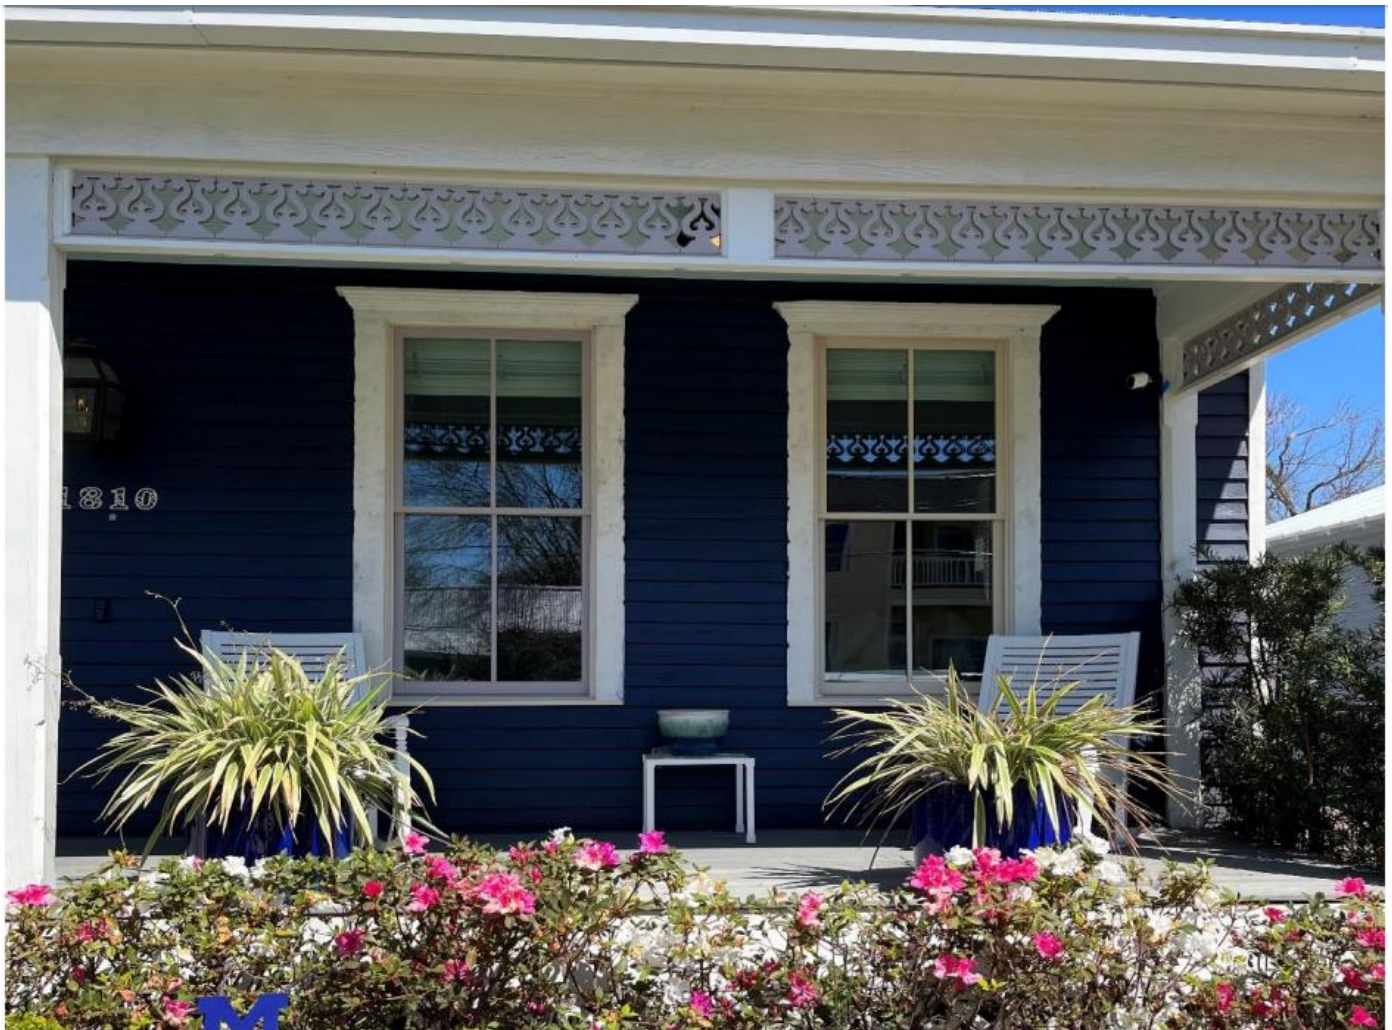
Figure 5 - Applicant Supplied Photo with New Windows on Porch

Our contractor began installation of 2 windows on the front porch when someone called 311. An inspector from the city asked that we stop further work until this project is reviewed by the committee. A permit and sign were obtained from the City of Houston on March 21st (attached)

Attached for review are pictures of the front of 1810 Kane showing two of the existing windows as well as the two new windows that were installed on the front porch. As you can see from the pictures, there is no apparent difference between the old and new windows. The new windows are as architecturally correct as possible, and as you can see are both recessed and inset as the existing windows.

Recommendation: Denial of COA and issuance of a COR to re-install the 2 original windows that were replaced with new ones on the front porch and approval to replace the 1 rear facing, non-visible from the ROW, window.

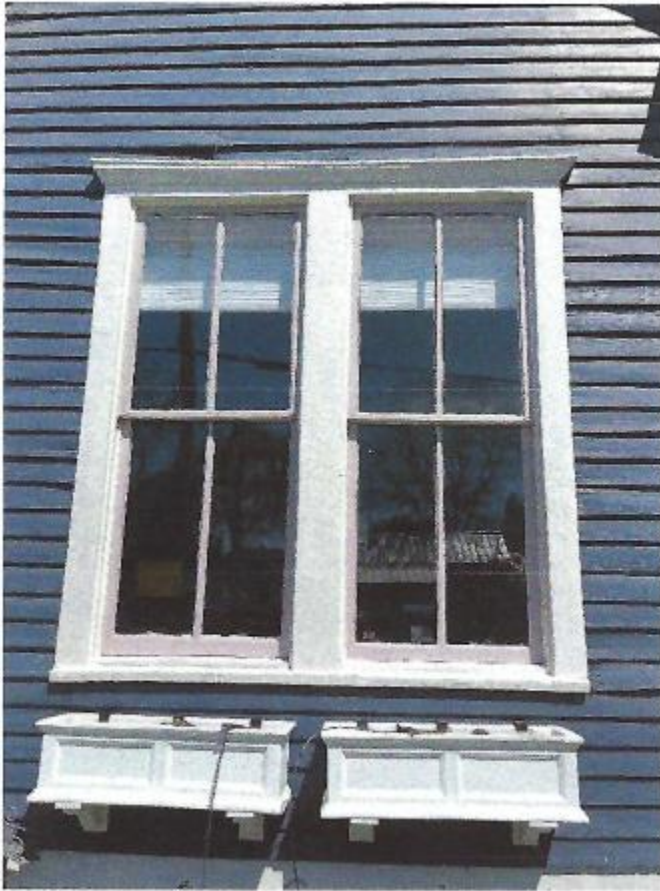
Windows 2 & 3 – (existing)

DAMAGE TO EXISTING WINDOWS	
Window	Describe Damage
<i>Ex. A1</i>	<i>Glass is broke, window is Inoperable, rail is rotten, and frame is broken</i>
1	window is inoperable, will not close properly allowing air and insects into home
2	window is inoperable, will not close properly allowing air and insects into home
3	window is inoperable, will not close properly allowing air and insects into home
4	window is inoperable, will not close properly allowing air and insects into home
5	window is inoperable, will not close properly allowing air and insects into home
6	window is inoperable, will not close properly allowing air and insects into home
7	window is inoperable, will not close properly allowing air and insects into home
8	window is inoperable, will not close properly allowing air and insects into home
9	window is inoperable, will not close properly allowing air and insects into home

Figure 7 - Applicant Supplied Image

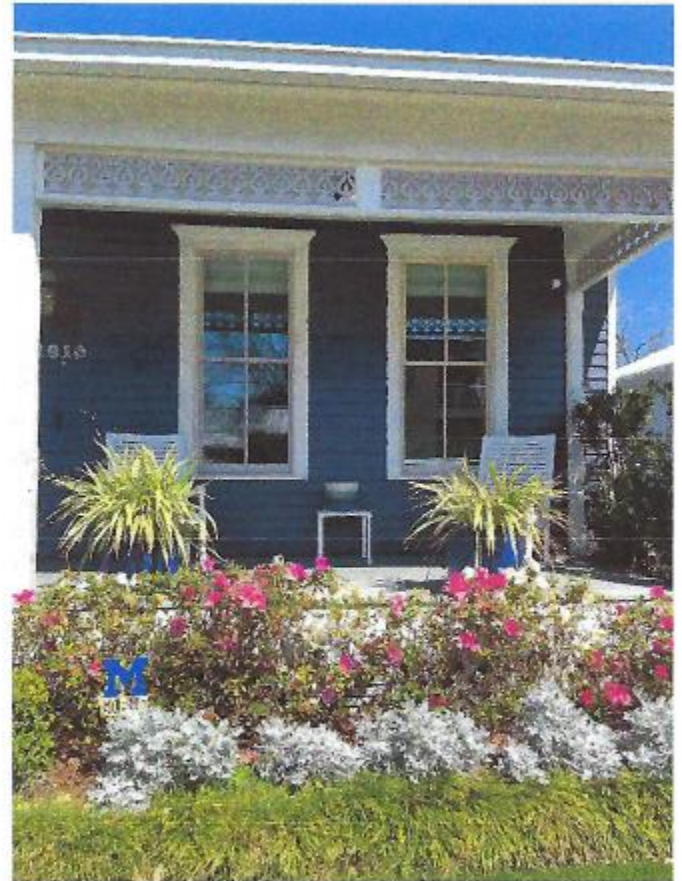
Windows 5&6 (new)

Figure 6 - Applicant Supplied Image

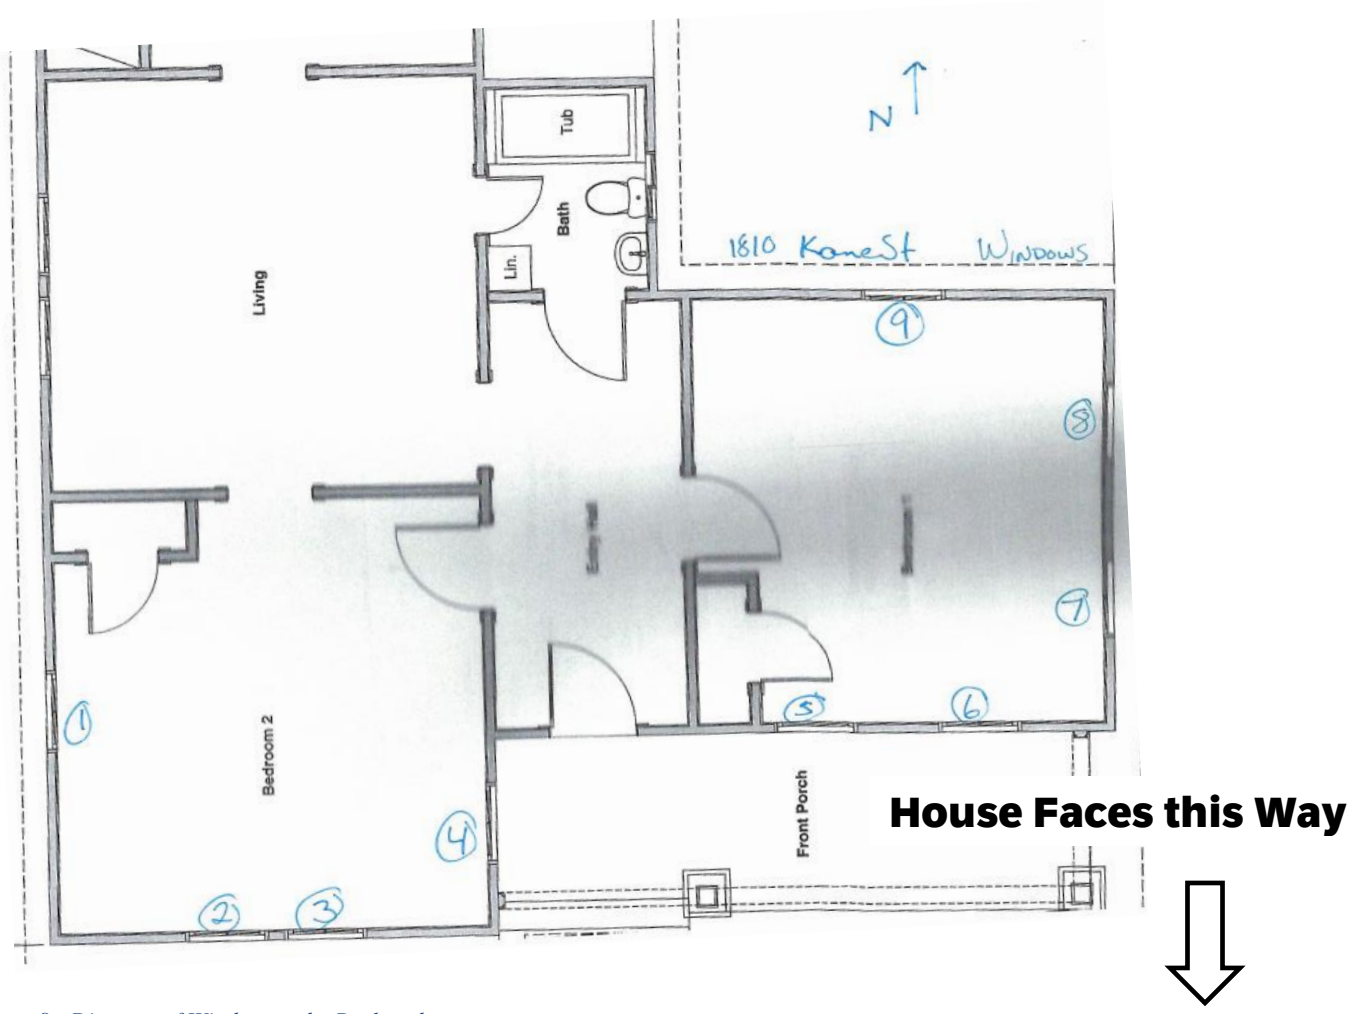
Figure 8 - Diagram of Windows to be Replaced
