CERTIFICATE OF APPROPRIATENESS

Applicant: Sanobar Bhaidani, owner
Property: 815 Harold Street, Lot 4, Block 22, Montrose Neighborhood Subdivision.
The property includes a historic 3,834 square foot, two-story wood frame single-family residence and a detached garage situated on a 6,000 square foot (50' x 120') interior lot.

Significance: Contributing Craftsman style residence, constructed circa 1920, located in the Audubon Place Historic District.

Proposal: Alteration: Reconstruction of Rear Addition, Front Door, and Windows
Tagged for work w/out permits: 11/16/22; 11/30/22; 12/05/22;1/17/23; 2/7/23

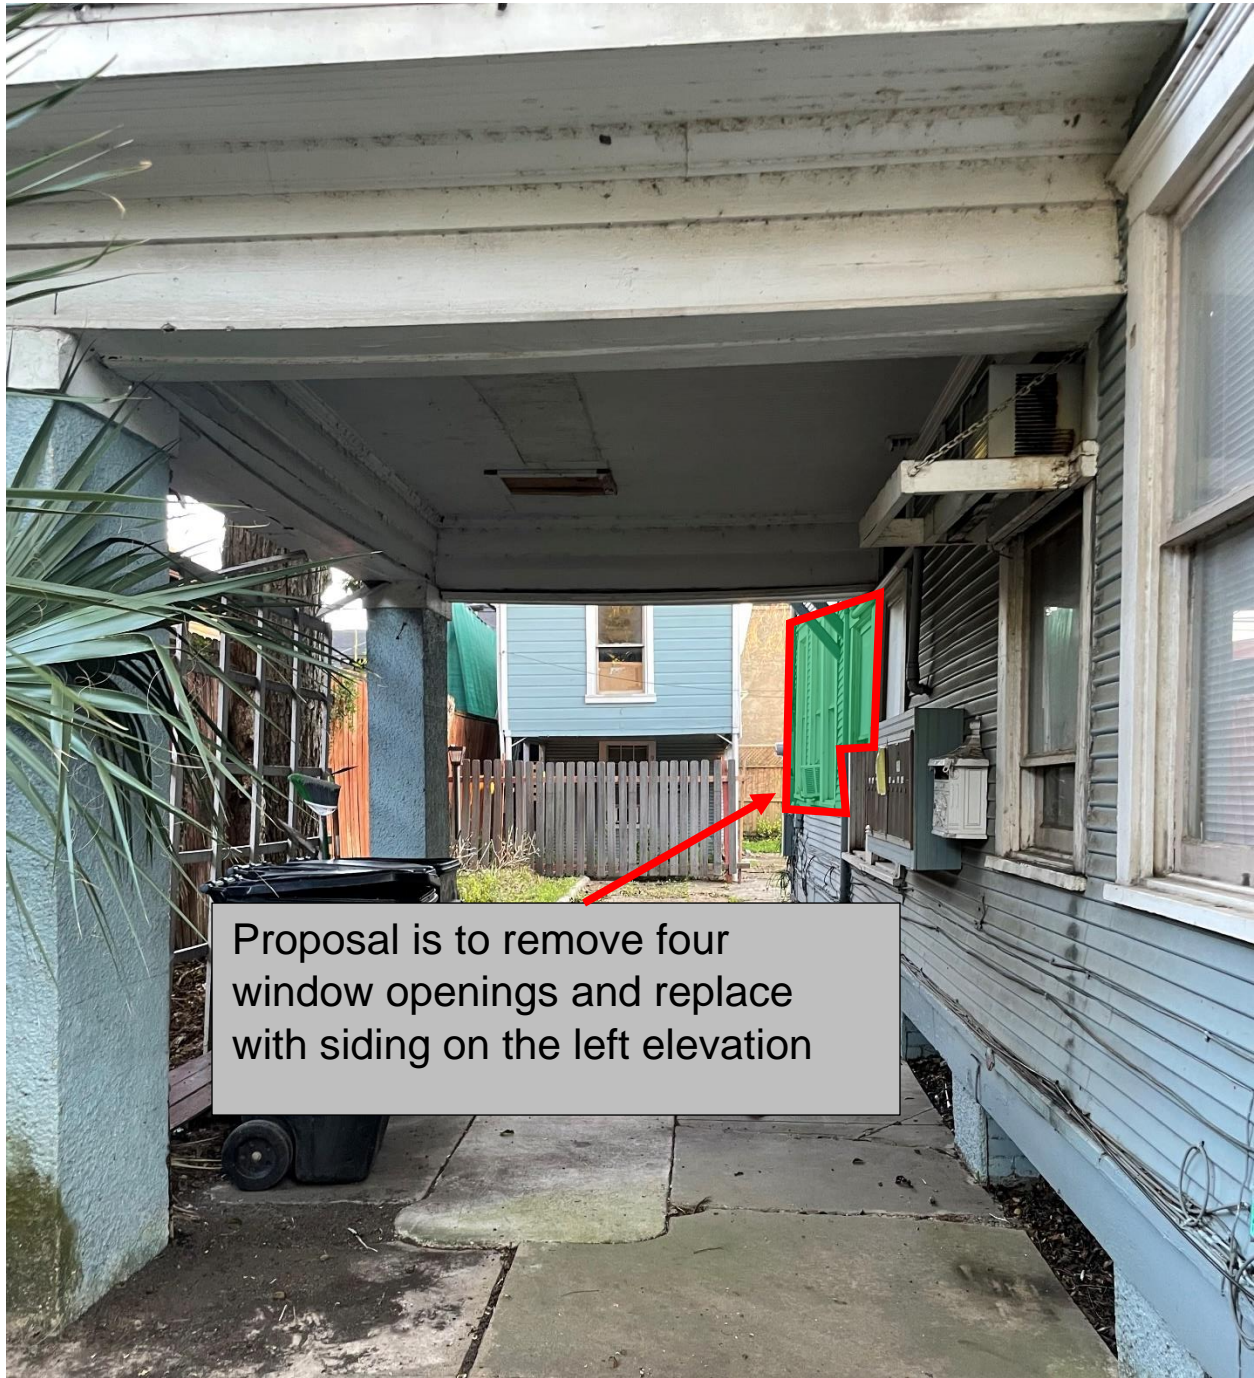
Proposal is to remove four window openings and replace with siding on the left elevation

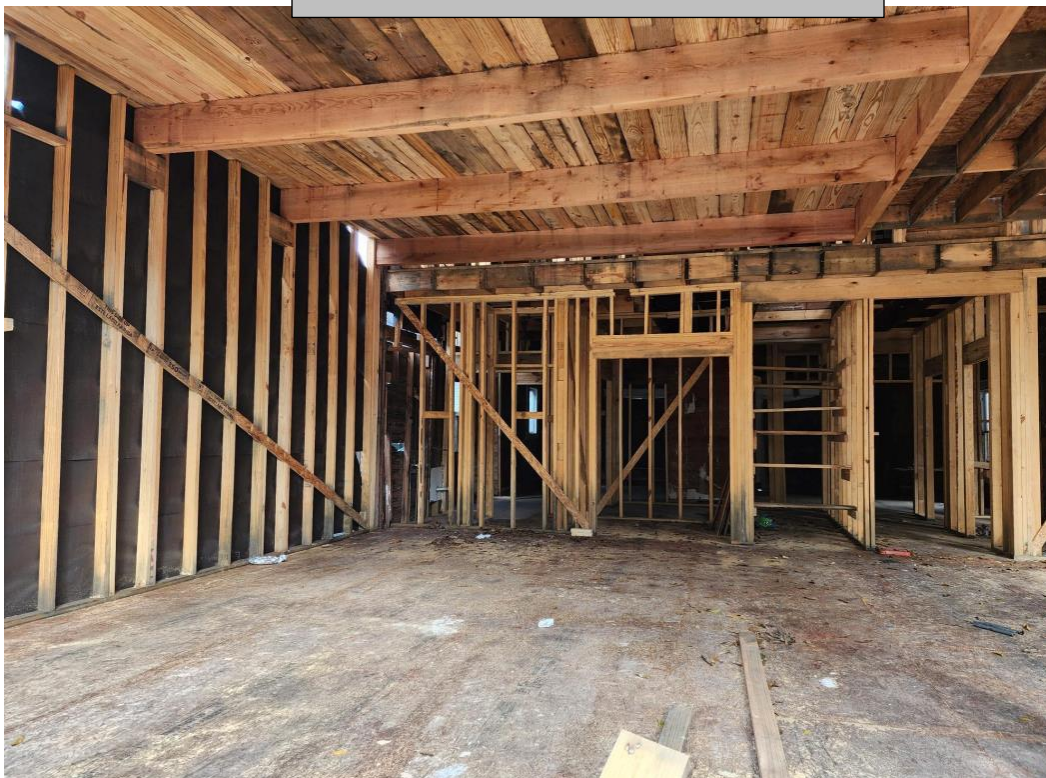
Right Rear Elevation.  
Window Openings Removed

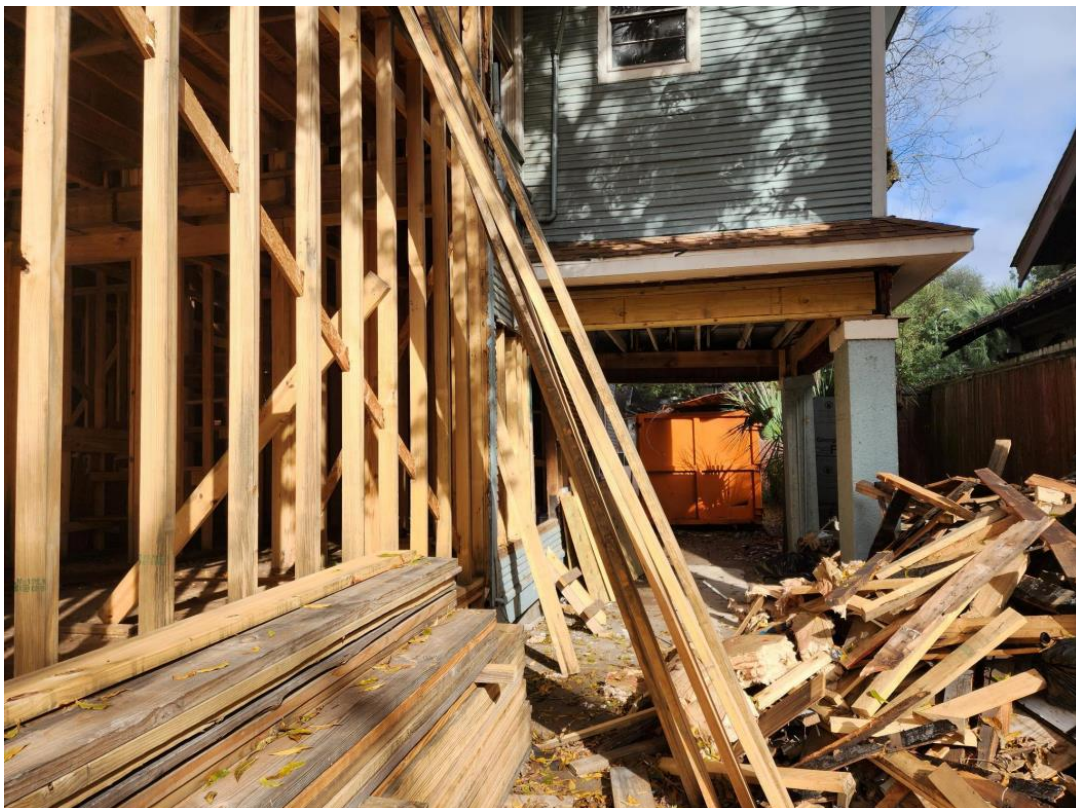
Left Rear Elevation.  
Port Cochere in  
background. Window  
Openings Removed.

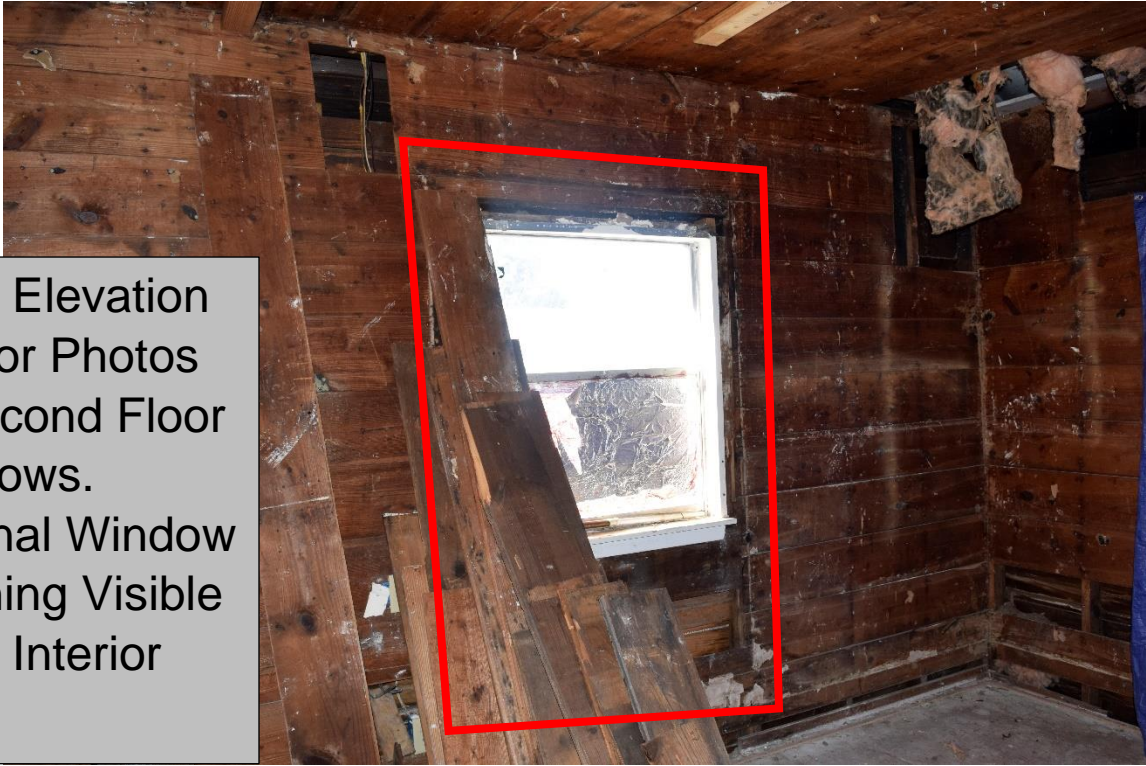
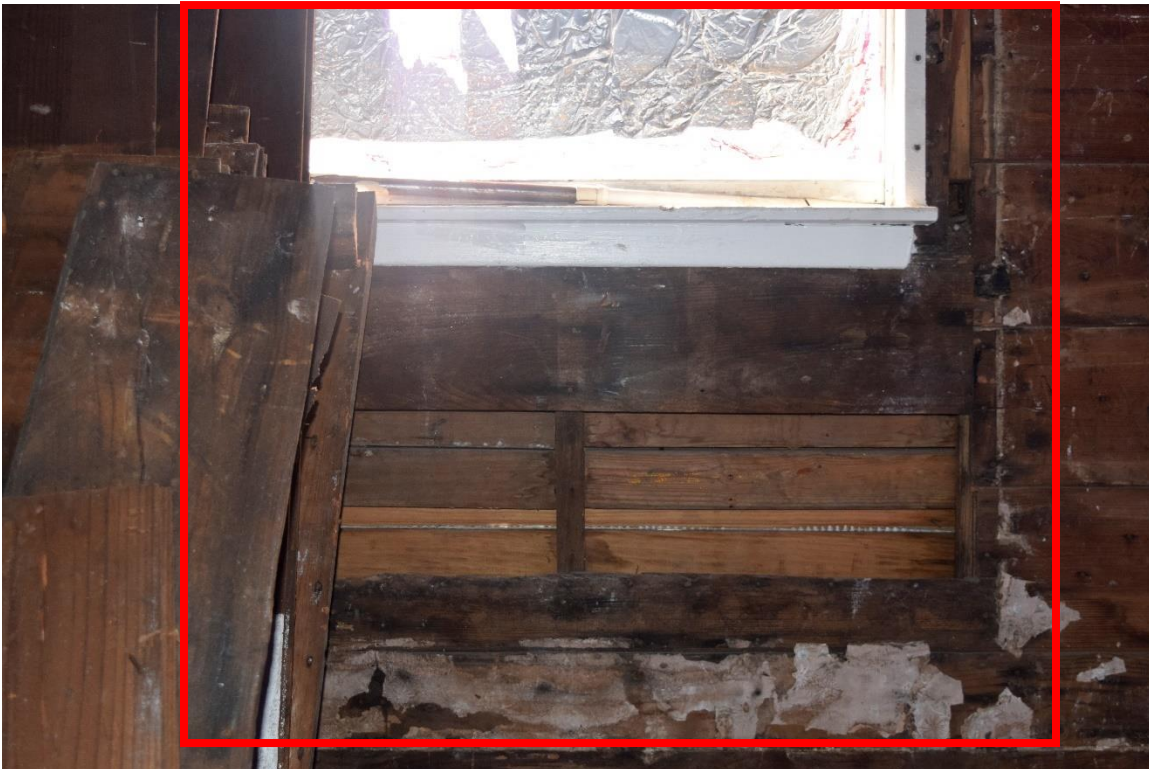
Right Elevation  
Interior Photos  
of Second Floor  
Windows.  
Original Window  
Opening Visible  
From Interior

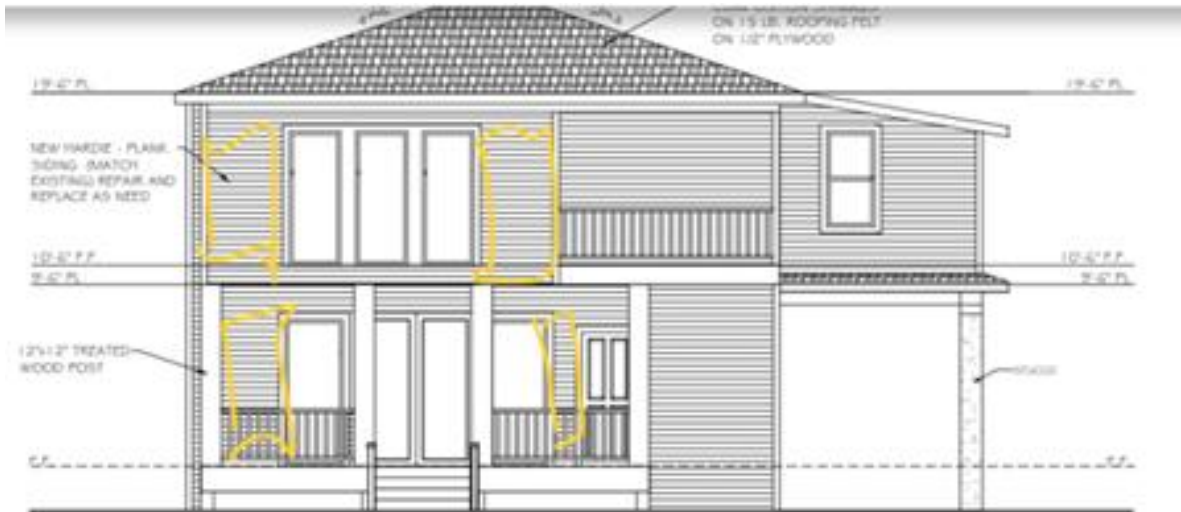
Proposed Rear Elevation

Smooth, cementitious siding on rear addition with a 5" lap reveal

Only one window opening exists as seen in photos

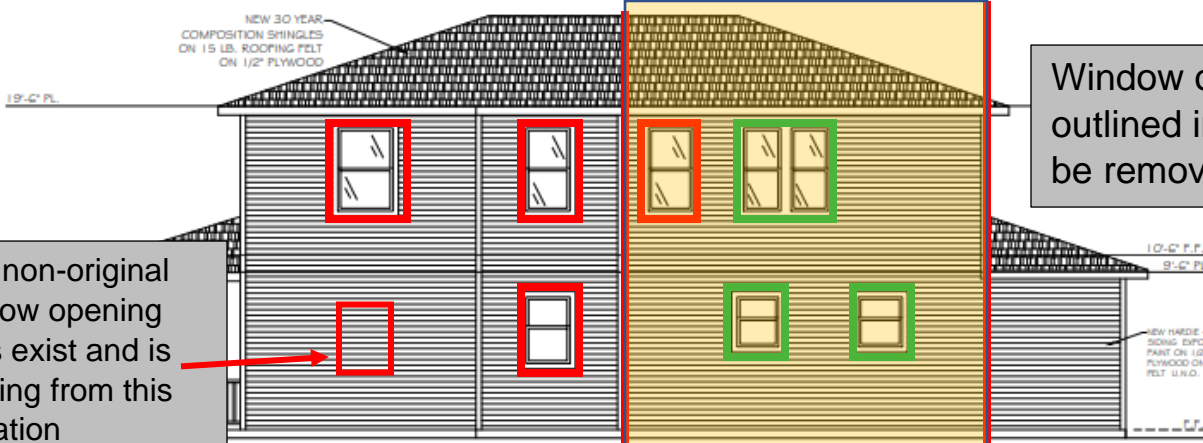
Existing Right Elevation

Window openings outlined in green to be removed

This non-original window opening does exist and is missing from this elevation

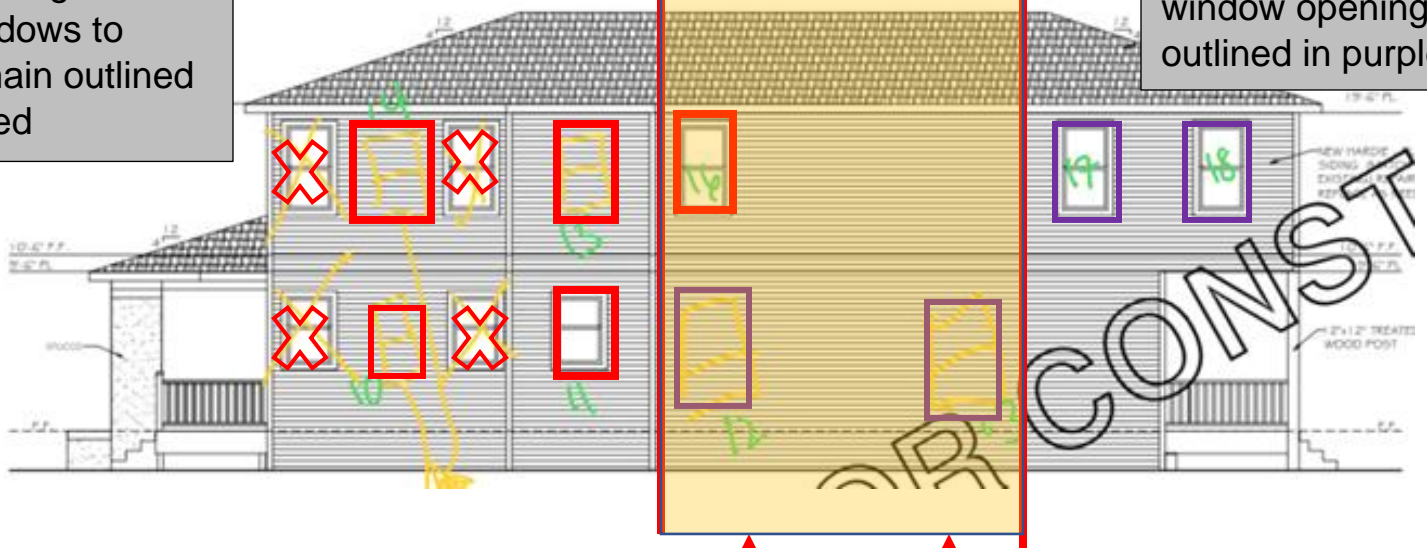
Proposed Right Elevation

Proposed window openings outlined in purple

Existing windows to remain outlined in red

This portion of the structure's rear half has already been removed and reframed
