CERTIFICATE OF APPROPRIATENESS

Property: 825 Bayland Avenue, Lot 8, Tract 9A, Block 41, Woodland Heights Subdivision. The property includes a historic 2,802 square foot, one-and-a-half-story wood frame single-family residence and a detached garage situated on a 12,543.75 square foot (100.35' x 125') corner lot.

Proposal: Alteration – Addition. The applicant is proposing a small rear addition and the construction of a rear deck. The applicant is also proposing the following alterations to the original structure and previous addition:

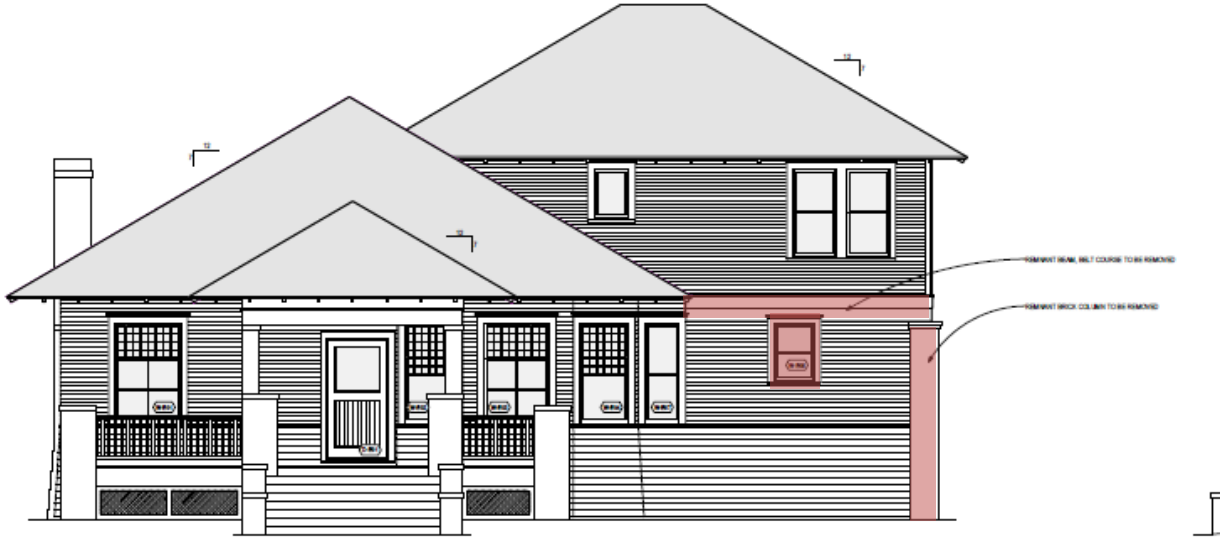
23 SOUTH ELEVATION - EXISTING
SCALE: 1/4" = 1'-0"

DESCRIPTION OF WORK:
 1. THE BELT COURSE AND BRICK CHIMNEY WILL BE REMOVED. THE CORNER BOARDING WILL EXTEND FROM THE SECOND FLOOR TO THE FIRST AND A NEW BELT COURSE WILL BE ADDED TYPICAL TO THE EXISTING FIRST FLOOR FINISH LOCATION.
 2. THE SMALL WINDOW INTO THE MATCH BOX WILL BE REMOVED. A NEW LARGER WINDOW MATCHING OTHERS TYPICAL ON THE HOUSE WILL BE INSTALLED IN THE MATCH BOX.

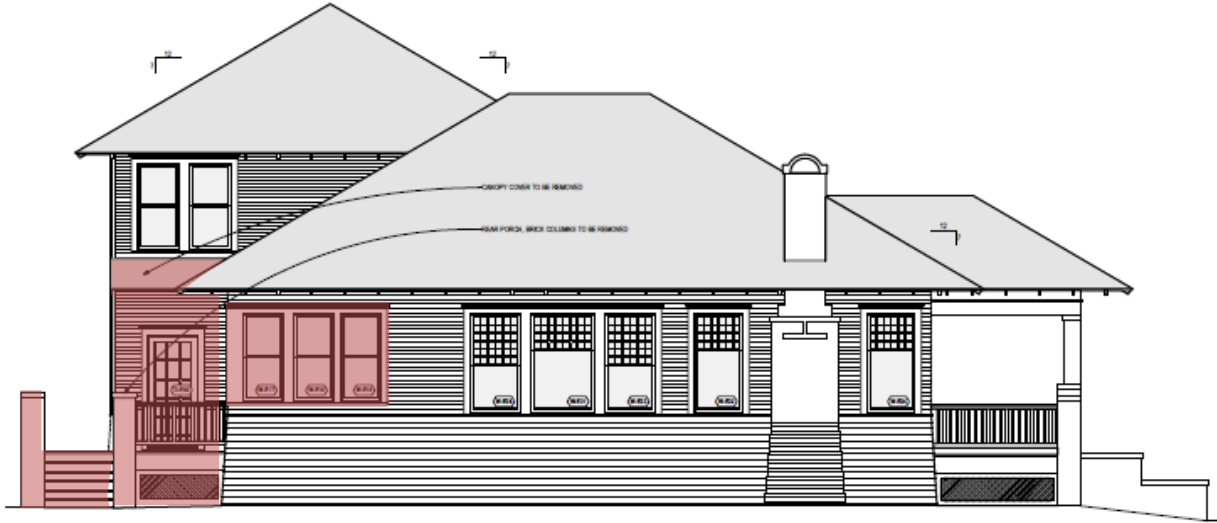
11 WEST ELEVATION - EXISTING
SCALE: 1/4" = 1' - 0"

DESCRIPTION OF WORK:
1. THE REAR PORCH WILL BE REMOVED AS WELL AS THE PORCH LEANS TO SOUP OVER THE SIDE DECK INTO THE EXISTING MASTER SUITE. A NEW REAR PORCH WILL BE CONSTRUCTED.
2. ALL WINDOWS AND EXTENDED DOORS IN THE KITCHEN AND MASTER BEDROOM WILL BE REMOVED AND REPLACED WITH NEW.

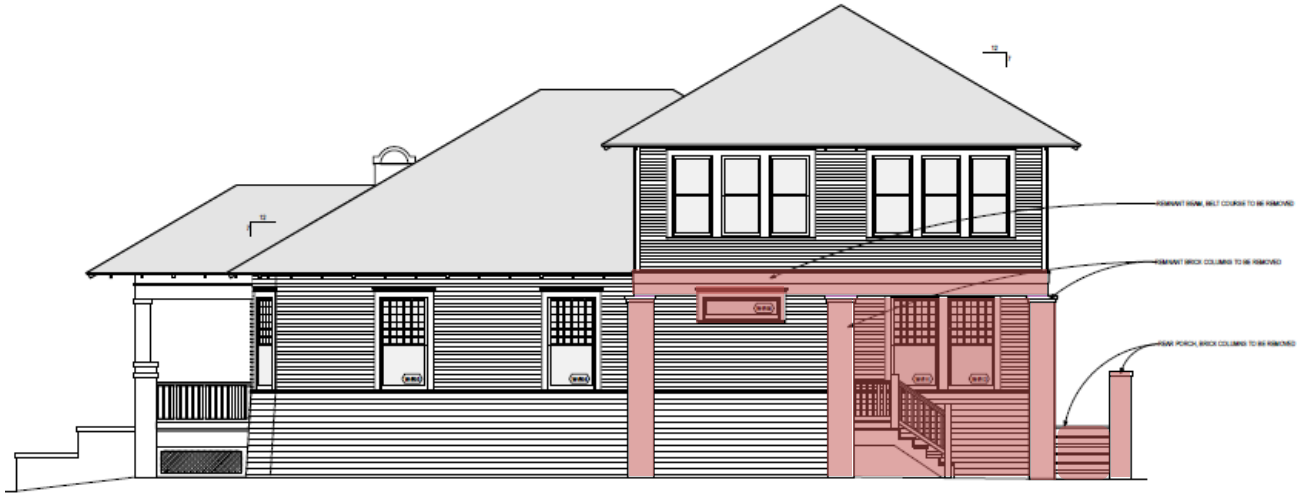
11 EAST ELEVATION - EXISTING
SCALE: 1/4" = 1' - 0"

- DESCRIPTION OF WORK:
1. THE MANTLE, COLUMNS AND BRICK COLUMNS WILL BE REMOVED. THE CORNER BOARD WILL EXTEND FROM THE SECOND FLOOR TO THE FIRST AND A NEW MANTLE COURSE WILL BE ADDED TO THE EXISTING FIRST FLOOR FRONT LOCATION.
 2. THE EXISTING CHIMNEY BRICK COURSE UNDER THE SECOND FLOOR WILL BE TIED IN AS A COMPONENT OF THE NEW 2ND STORY. ALL THE EXISTING SECOND FLOOR BRICK WILL BE REMOVED AND NEW WINDOWS WILL BE INSTALLED IN THE REVISION.
 3. THE FRONT PORCH WILL BE REMOVED.
 4. THE TANKARD BRICKS WITH THE MANTLE WITH BE REMOVED. A NEW LARGER WINDOW MATCHING OTHERS TYPICAL ON THE HOUSE WILL BE INSTALLED IN THE MANTLE WITH.
 5. THE EXISTING HISTORICAL WINDOWS WITH GREENED UPPER PARTS THAT ARE TO BE REMOVED AT THE COVERED PORCH WILL BE RETAINED BY THE OWNER FOR POTENTIAL FUTURE USE OR NUMBER OF OTHER HISTORICAL WINDOWS ON THE HOUSE.

- Remove three remnant brick columns at outside corner and remnant wood beam that was previously added to support a second floor above a porte-cochere on the east elevation.

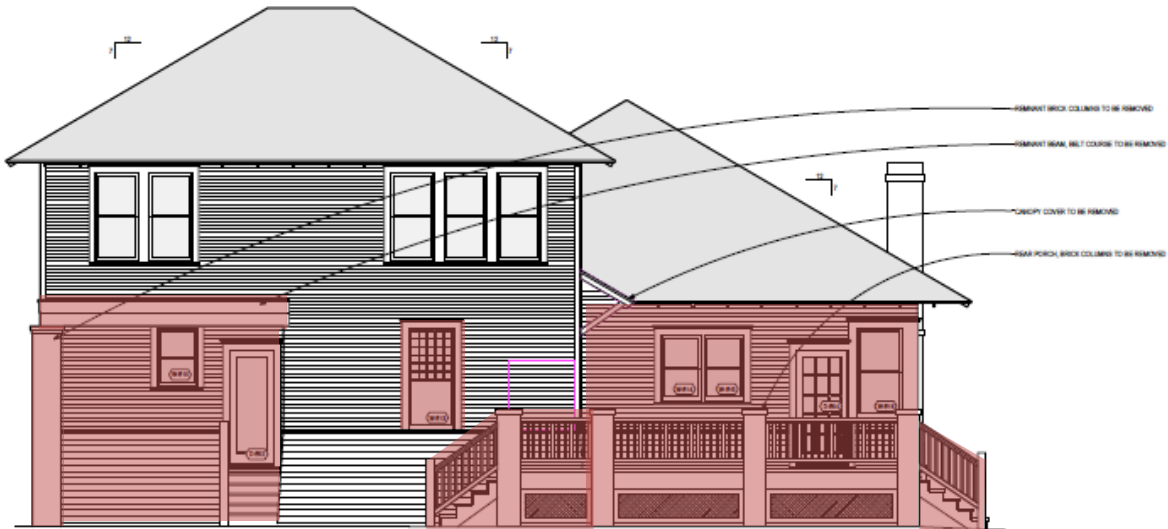
23 NORTH ELEVATION - EXISTING
SCALE: 1/4" = 1' - 0"

DESCRIPTION OF WORK:
 1. THE BELT COURSE AND BRICK COLUMNS WILL BE REMOVED. THE CORNER BOARD WILL EXTEND FROM THE SECOND FLOOR TO THE FIRST AND A NEW BELT COURSE WILL BE ADDED THIRD INTO THE EXISTING FIRST FLOOR FINISH LOCATION.

2. THE BRICK COVERED WOOD UNDERBATH THE SECOND FLOOR WILL BE DEMOLISHED AS AN EXPANSION OF THE MASTER SUITE. ALL RELEVANT EXISTING WINDOWS WILL BE REMOVED AND NEW WINDOWS WILL BE INSTALLED IN THE ADDITION.

3. THE REAR PORCH WILL BE REMOVED AS WELL AS THE PORTAL LAMB TO ROOF OVER THE SIDE DOOR WITH THE EXISTING MASTER SUITE. A NEW REAR PORCH WILL BE CONSTRUCTED.

4. ALL WINDOWS AND EXTERIOR DOORS IN THIS ELEVATION AND REAR PORCH WILL BE REMOVED AND REPLACED WITH NEW.
 5. THE EXISTING HORIZONTAL WINDOW WITH BRICKED UPPER SASH SHALL BE TO BE REMOVED FROM THE MASTER BEDROOM WILL BE RETAINED BY THE OWNER FOR POTENTIAL FUTURE USE OR REPAIR OF OTHER HISTORICAL WINDOWS ON THE HOUSE.

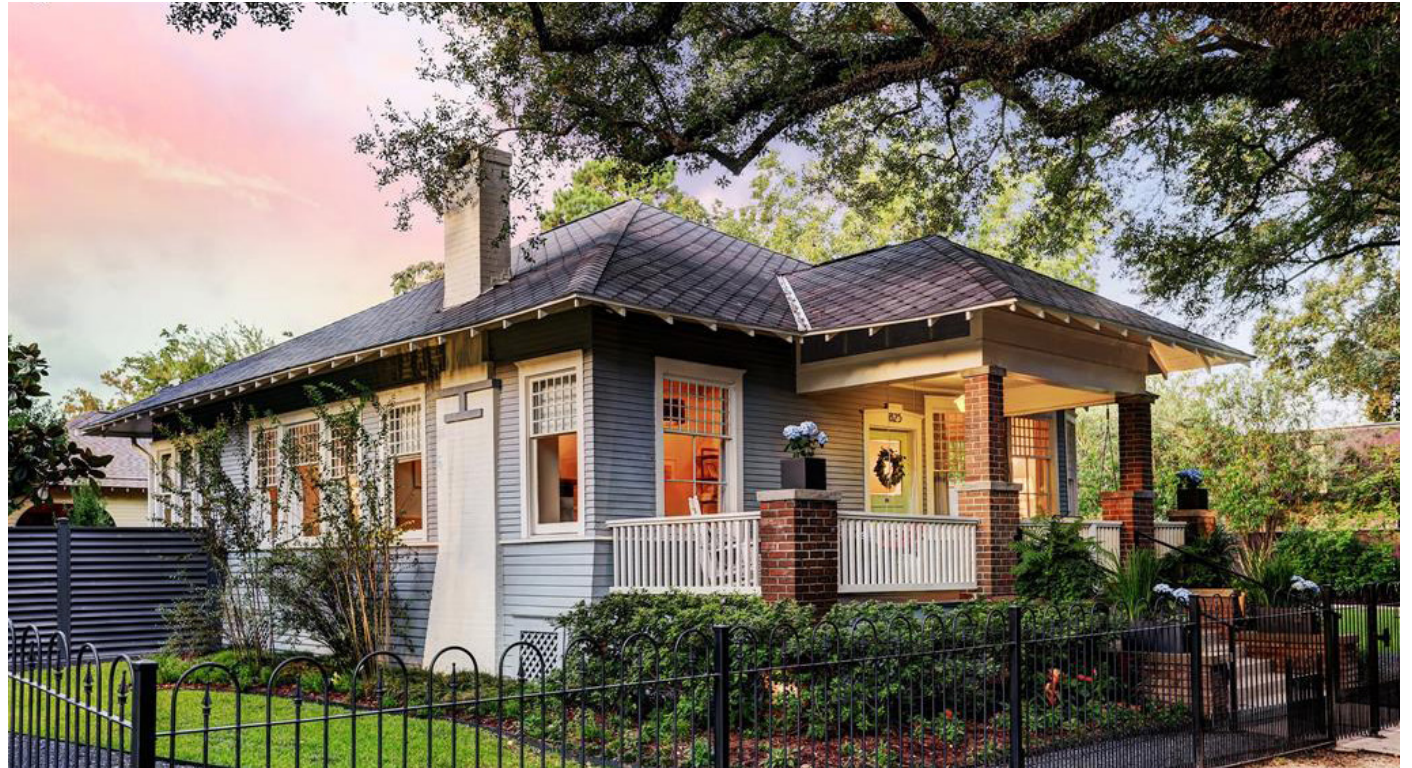
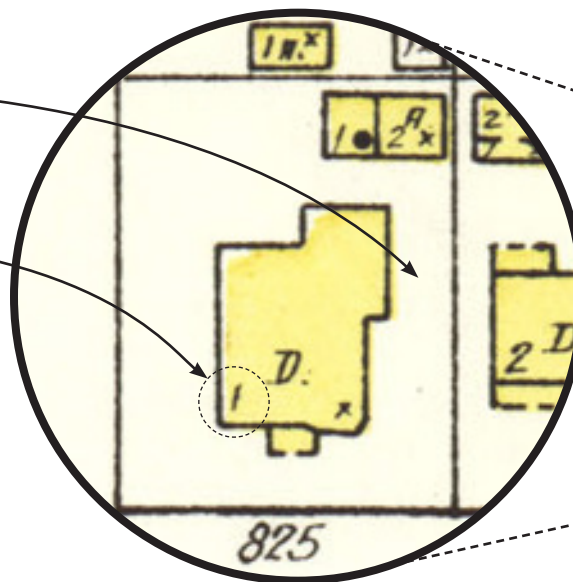
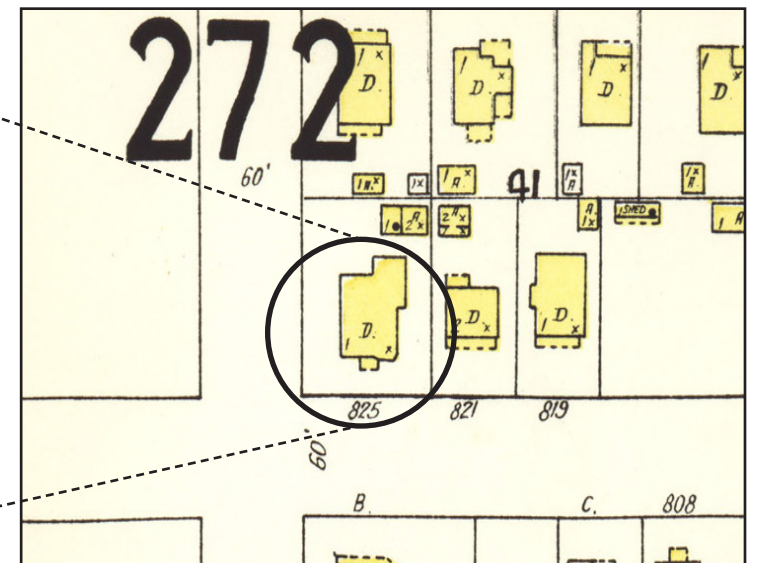
825 Bayland as viewed from the corner of Bayland & Julian. This view conceals later additions that diminish the integrity of the original one-story bungalow structure.

- Architectural Features Include:
 - Flared skirt of wide exposure wood siding
 - Window sill belt course
 - Mitred siding corners
 - Densely gridded upper sashes on DH windows
 - Hip roof with wide overhangs and exposed rafter tails

- No porte-cochere yet

- One-story dwelling

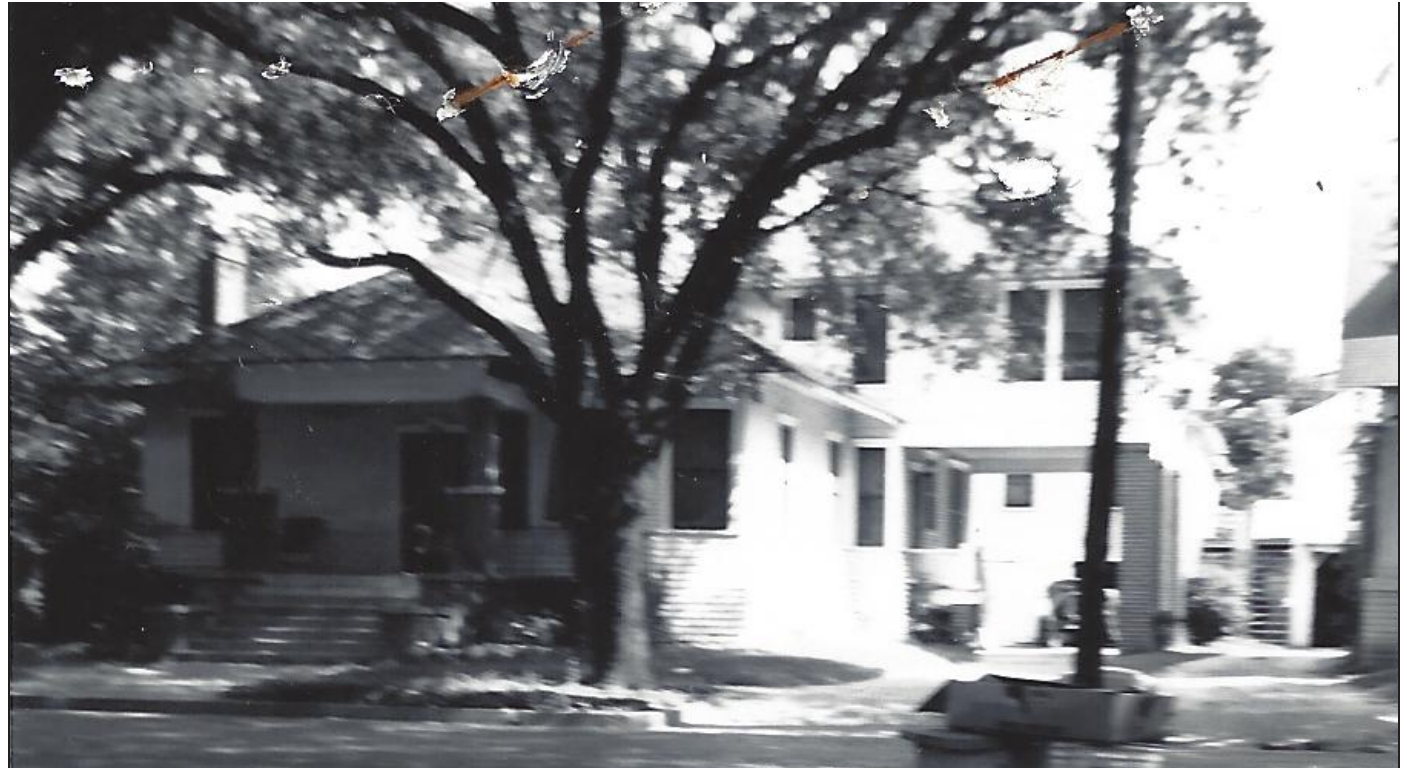
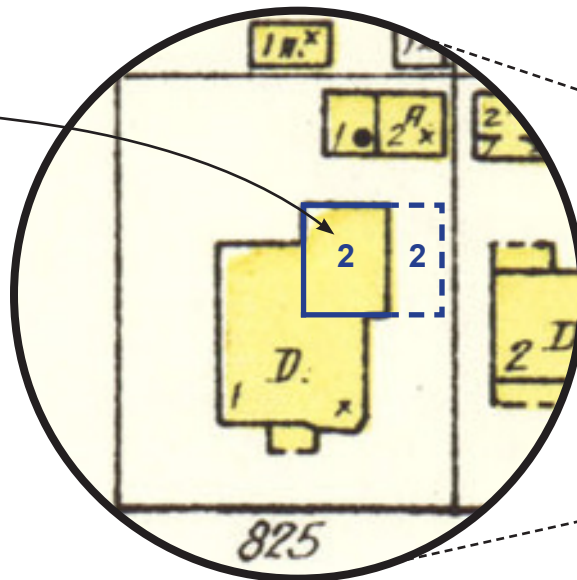
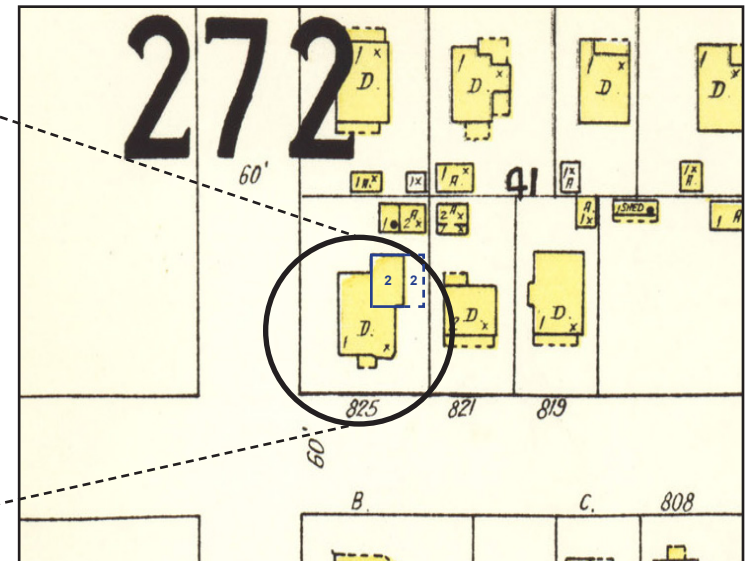
825 Bayland in 1965 from east lot line along Bayland with pre-1960s addition of porte-cochere and second floor.

- Addition Features Include:
 - Stacks directly above existing walls of offset rectangle at right-rear of plan
 - Creates two-story coplanar front and back walls
 - 3 brick columns with ± 4 " projection beyond wall surface above
 - Painted wood entablature (beam) spanning from existing house corners to brick columns

- Addition of porte-cochere and 2nd floor at right-rear, first evidenced in early 1960s tax record

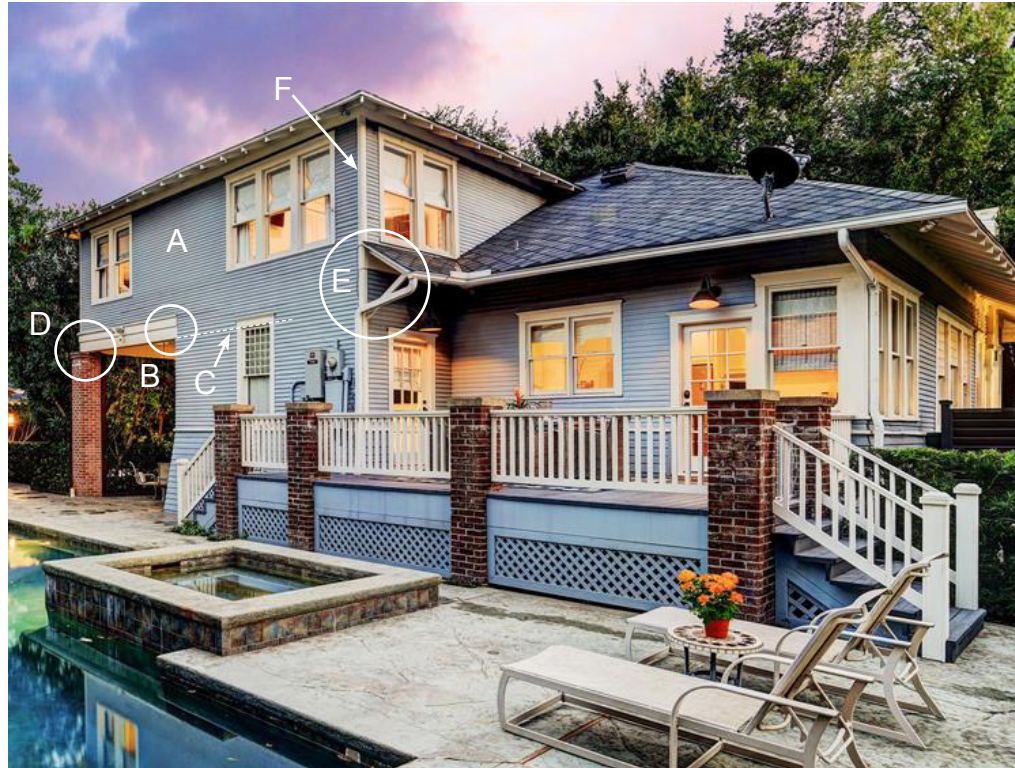
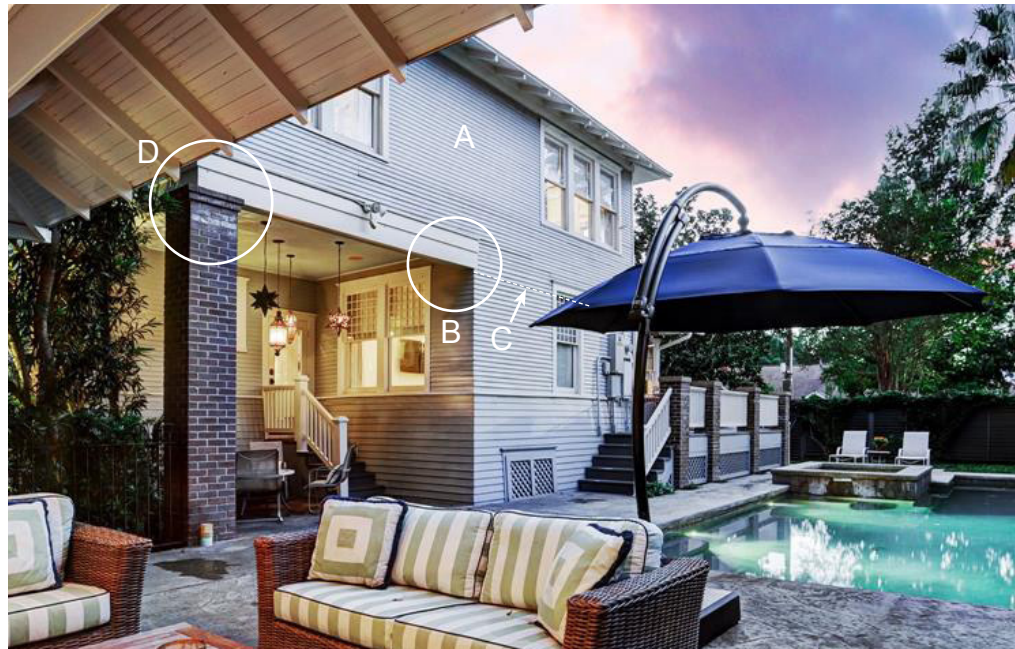
Features of pre-1960s addition had cumulative negative effect on integrity of original bungalow.

- A. Two-story wall of siding with no differentiation between original first floor and two-story addition
- B. Entablature (beam) emerges from existing outside corner
- C. Bottom of beam height conflicts with top of window trim height
- D. Brick columns project beyond wall plane insufficiently to receive flared skirt of original house
- E. Original roof over offset rear room haphazardly cut-off at corner
- F. Two-story corner board haphazardly added to original bungalow corner to reconcile coplanar 2nd floor walls

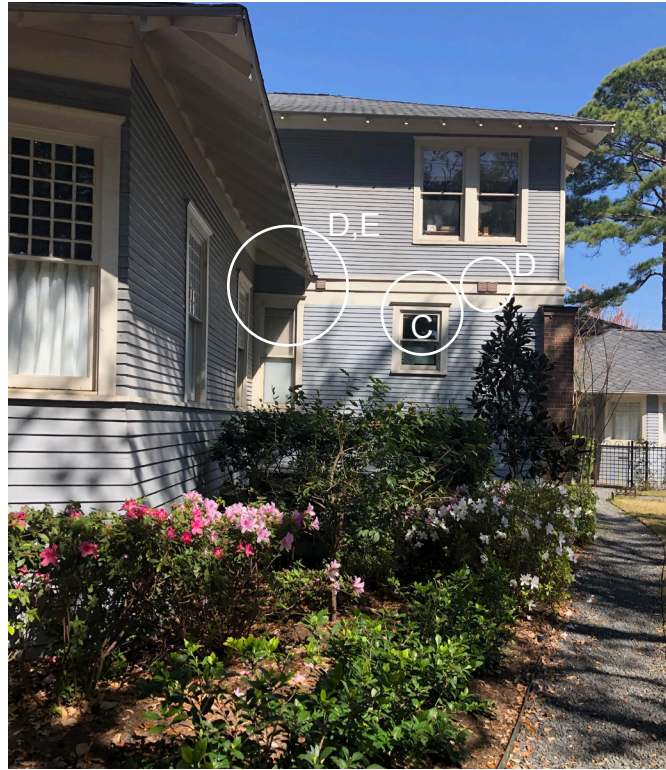
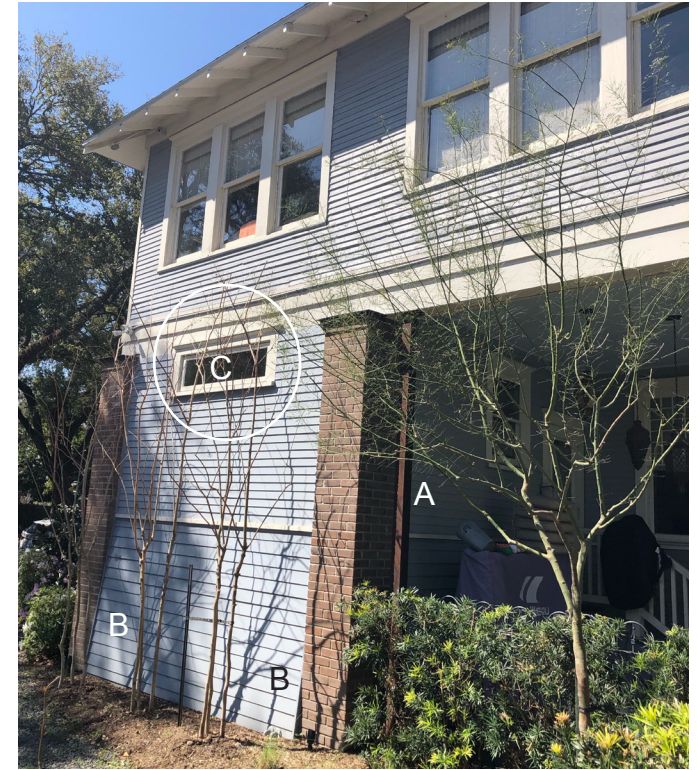
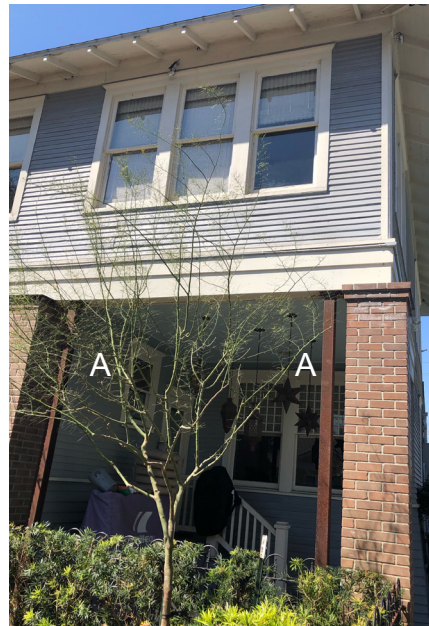
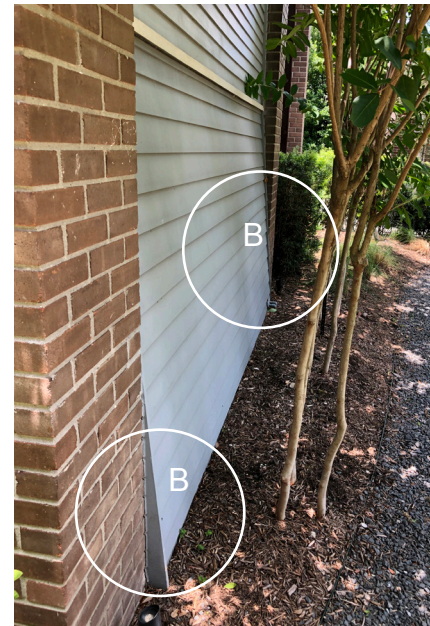
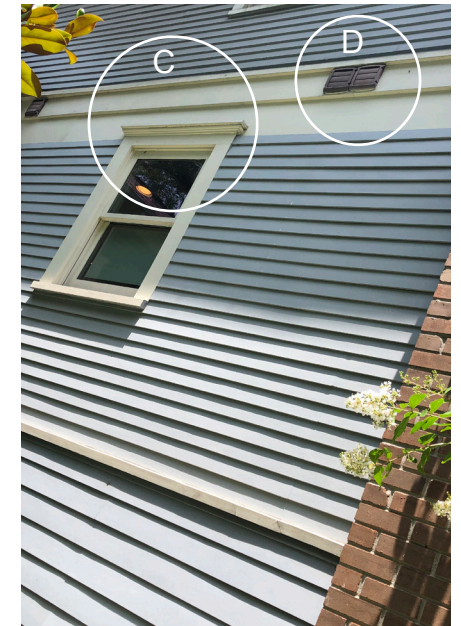
2013 addition had further cumulative negative effect on integrity of original bungalow.

- A. Brick columns' structural inadequacy requires steel support
- B. Flared skirt inartfully collides with brick columns
- C. Head trim at modern windows overlap entablature
- D. Bathroom vent fans exit through entablature on front of house
- E. Entablature abruptly ends at collision with window trim

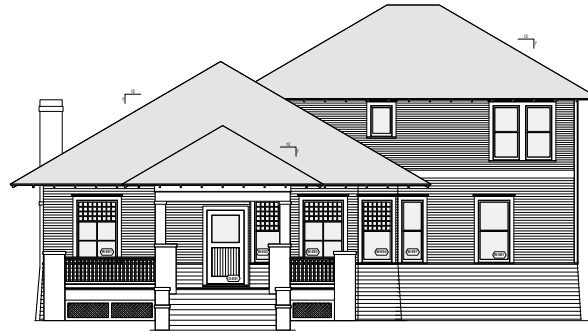
- Modest square footage increase—entirely under existing roof
- Premium building materials & construction practices
- Structurally failed brick columns to be removed
- Flared skirt with windowsill cap to wrap full perimeter of building
- Establish clear differentiation between original one-story bungalow and later addition with:
 - Densely gridded versus one-over-one windows
 - Corner board above flared skirt on two-story addition
 - Horizontal trim board at height of original frieze board to separate original first floor from added second floor

Proposed South Elevation

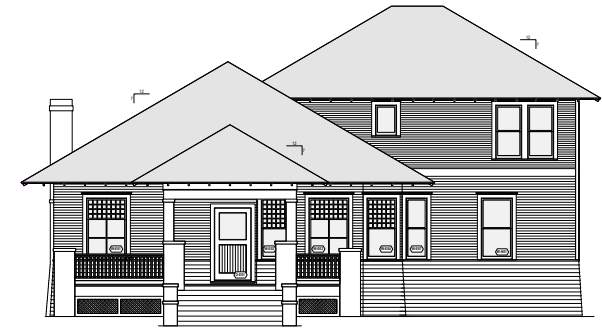
Proposed East Elevation

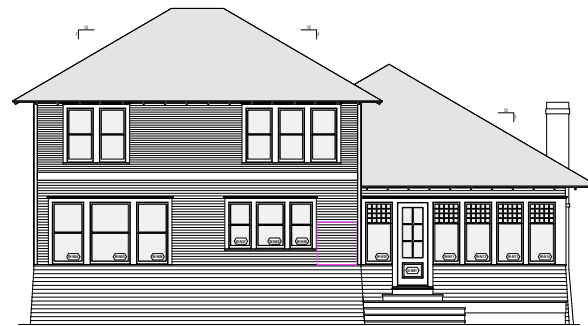
Proposed North Elevation

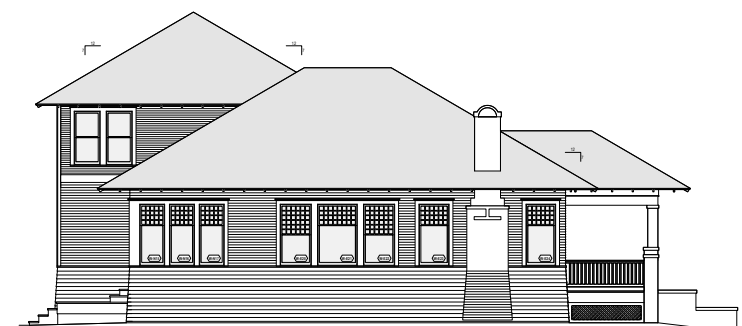
Proposed West Elevation
