**CERTIFICATE OF APPROPRIATENESS**

**Property:** 602 Highland Street Lot 1, Block 29, Woodland Heights Subdivision. The property includes a historic 1,243 square foot one story single-family residence situated on a 5,000 square foot (50' x 100') corner lot.

**Significance:** Contributing Bungalow residence, constructed circa 1920, located in the Woodland Heights Historic District.

**Proposal:** Alteration – Repair, Replace, Relocate windows/doors/openings with Rear Addition

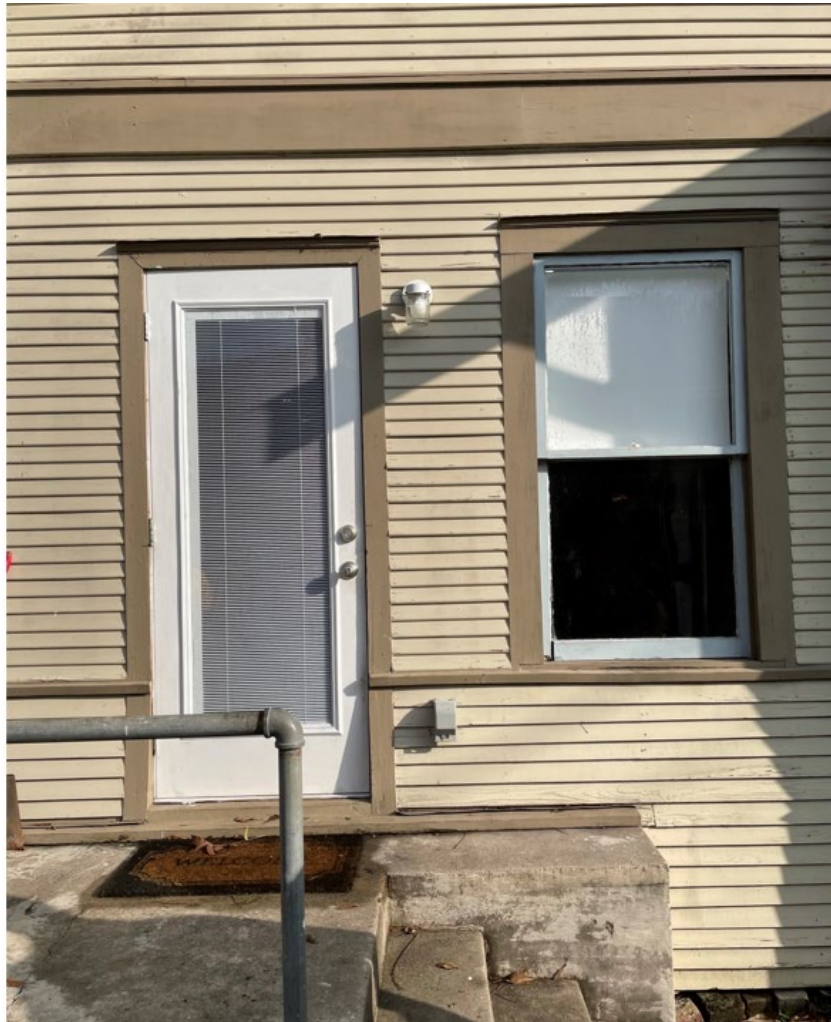
WINDOW 13 (WEST AT REAR) – TO BE REMOVED & COVERED WITH SIDING

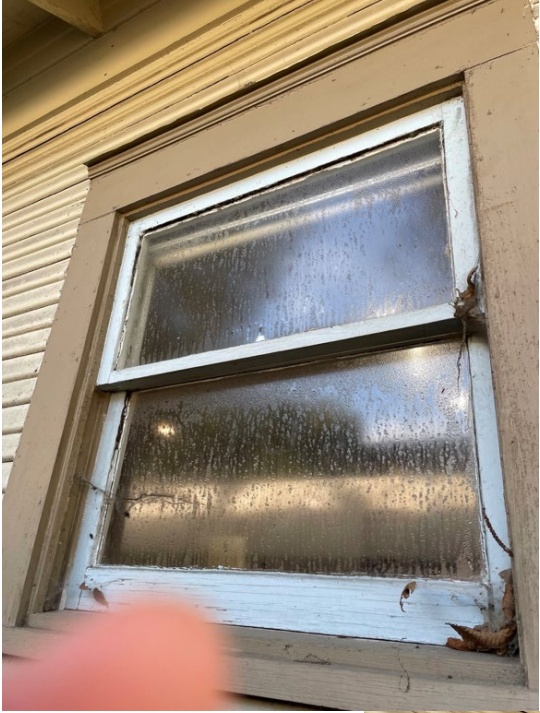
INTERIOR

WINDOW 13 (WEST AT REAR) – TO BE REMOVED & COVERED WITH SIDING
